INFN GEM Chambers – 14/Nov/2018

Report on ongoing GEM Commissioning

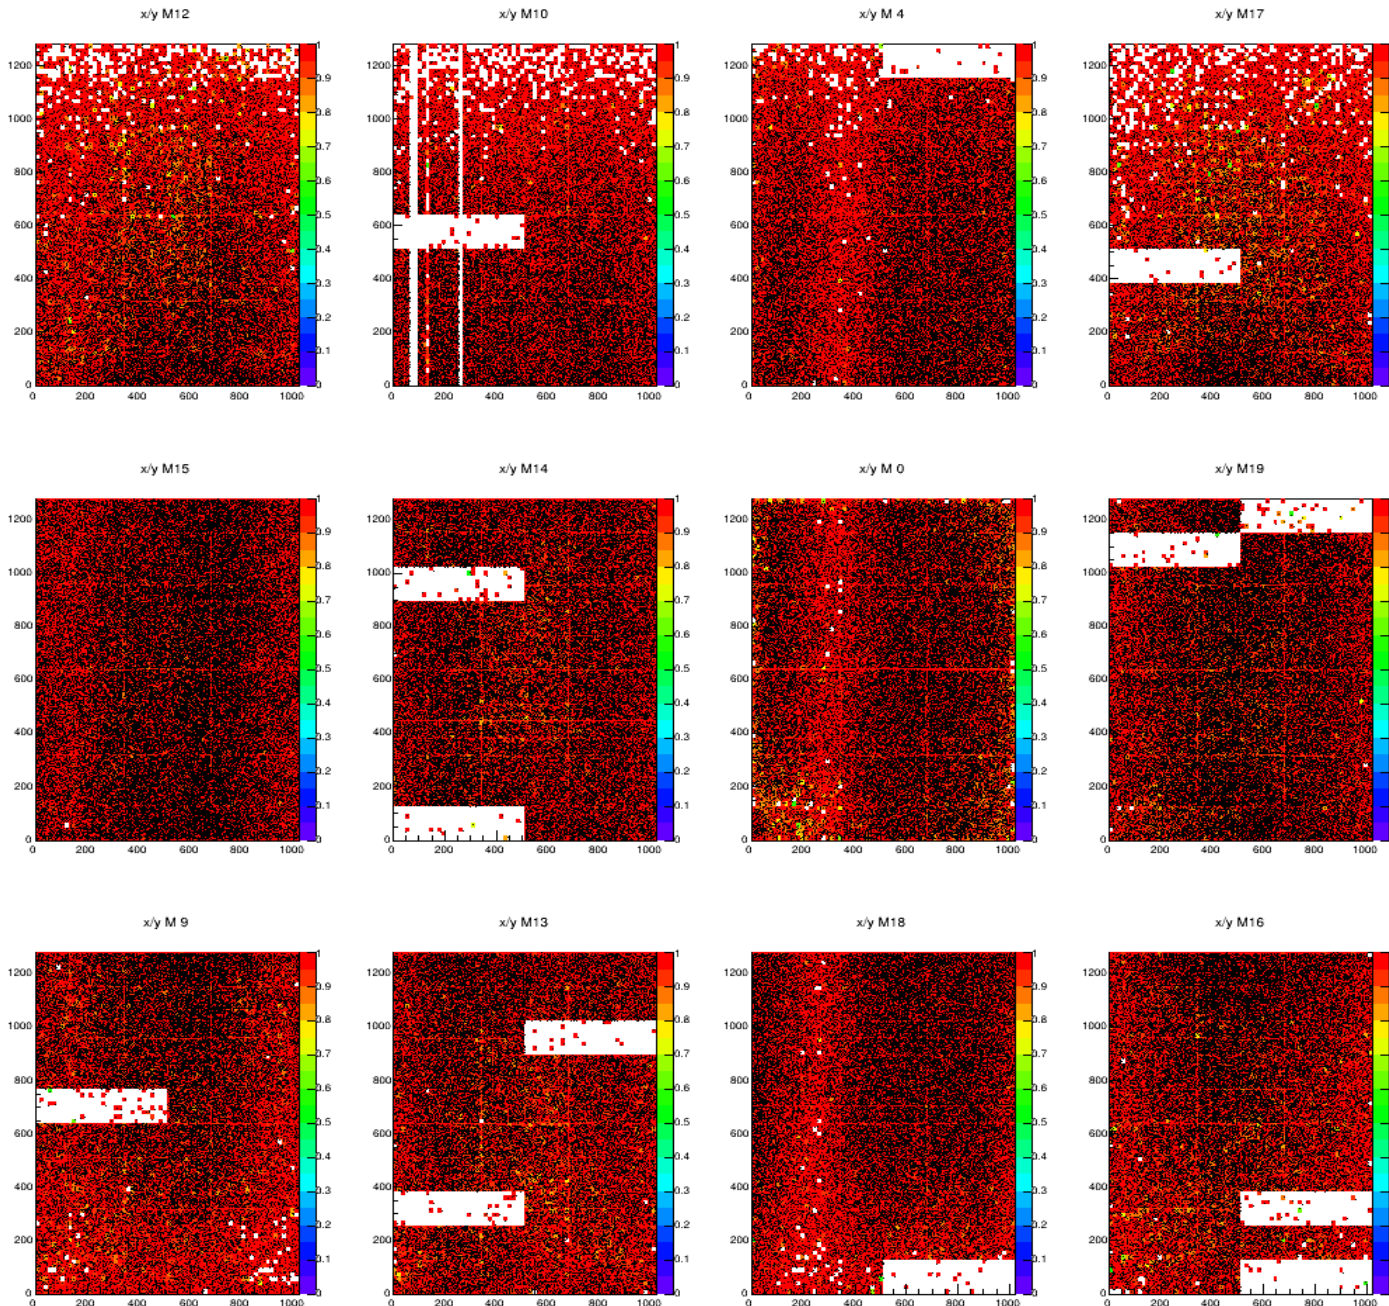
GEM Hit Map – 13/Nov/2018

Apparent MPD7 problem causing half of chamber J1 being off

(Vertical) blank bands

Puzzling, partially dead GEM module_6 (J2M0)

Short in one GEM module_1 (J0M1)

Apparent MPD7 problem causing half of chamber J1 being off
bad trigger distribution in a digital patch panel - replaced

(Vertical) blank bands
Flex strip terminals brushed and reconnected into ZIF with additional care

Puzzling, partially dead GEM module_6 (J2M0)
Module replaced (but source of the problem remains unclear)

Short in one GEM module_1 (J0M1)
protective resistor identified and removed; modules in J0 reorganized

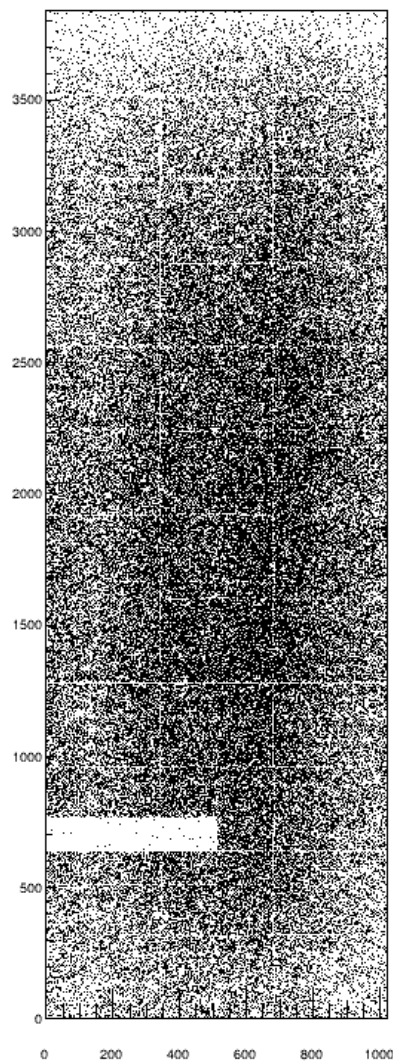
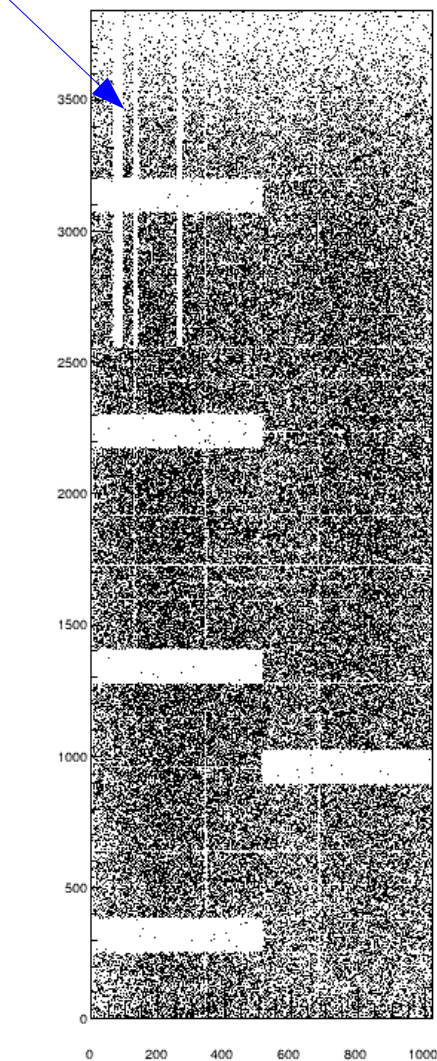
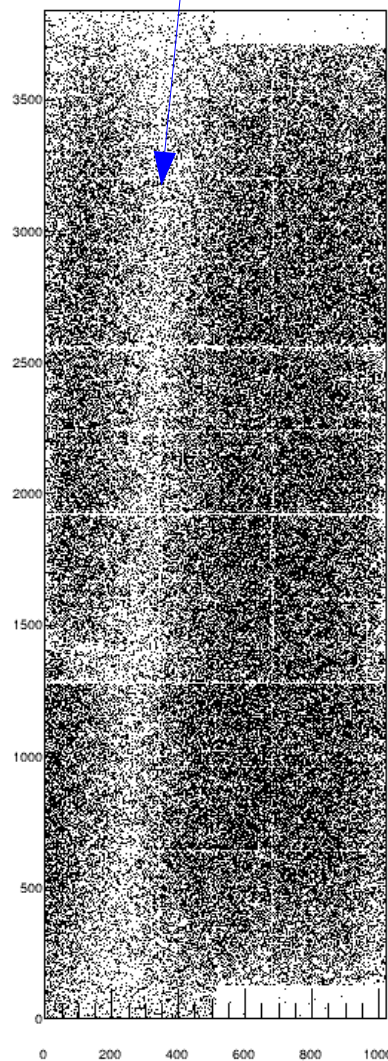
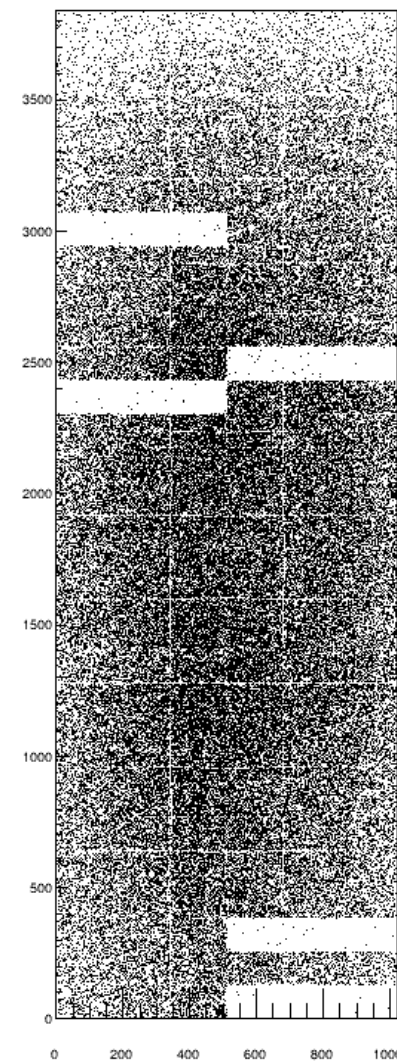
GEM Hit Map – chamber view

Strip paths likely damaged, need closer inspection

White sectors have shorts; they cannot be recovered (as far as we know)

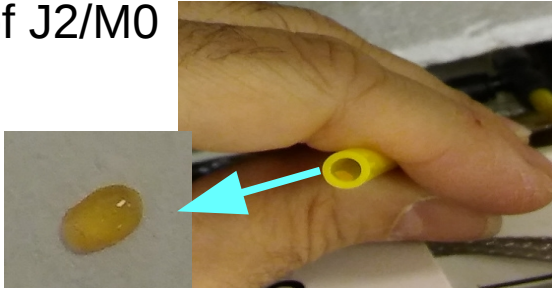
Intruder in the gas pipe
of J2/M0

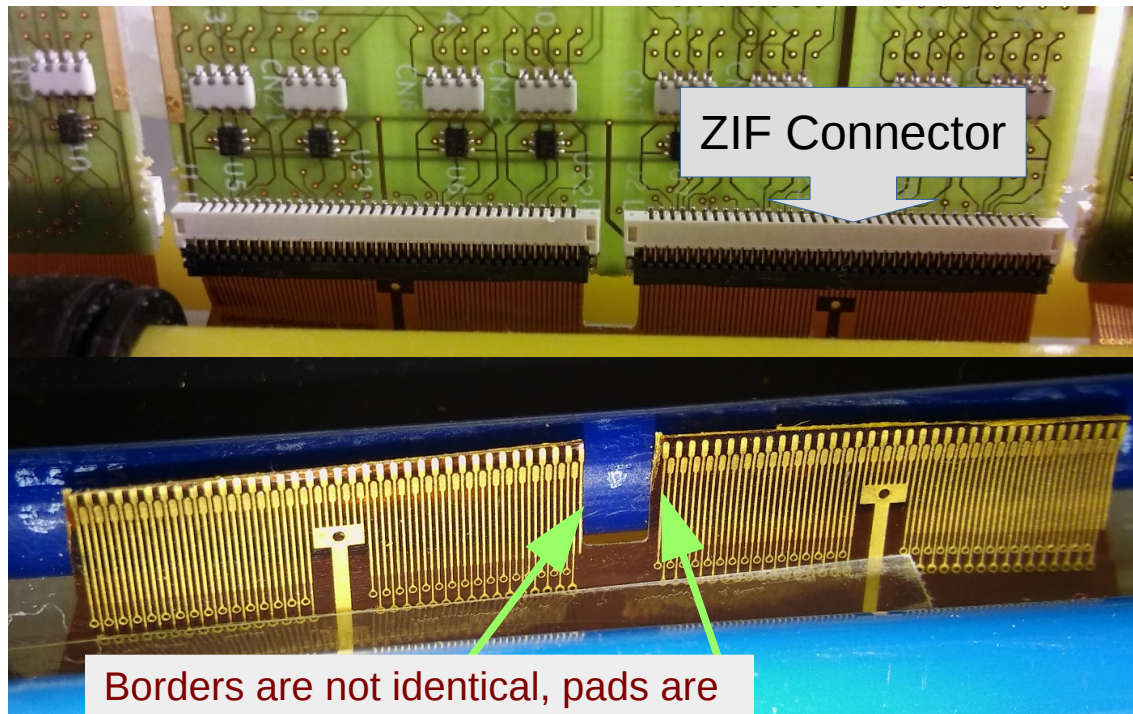
Some flat terminals not properly cut

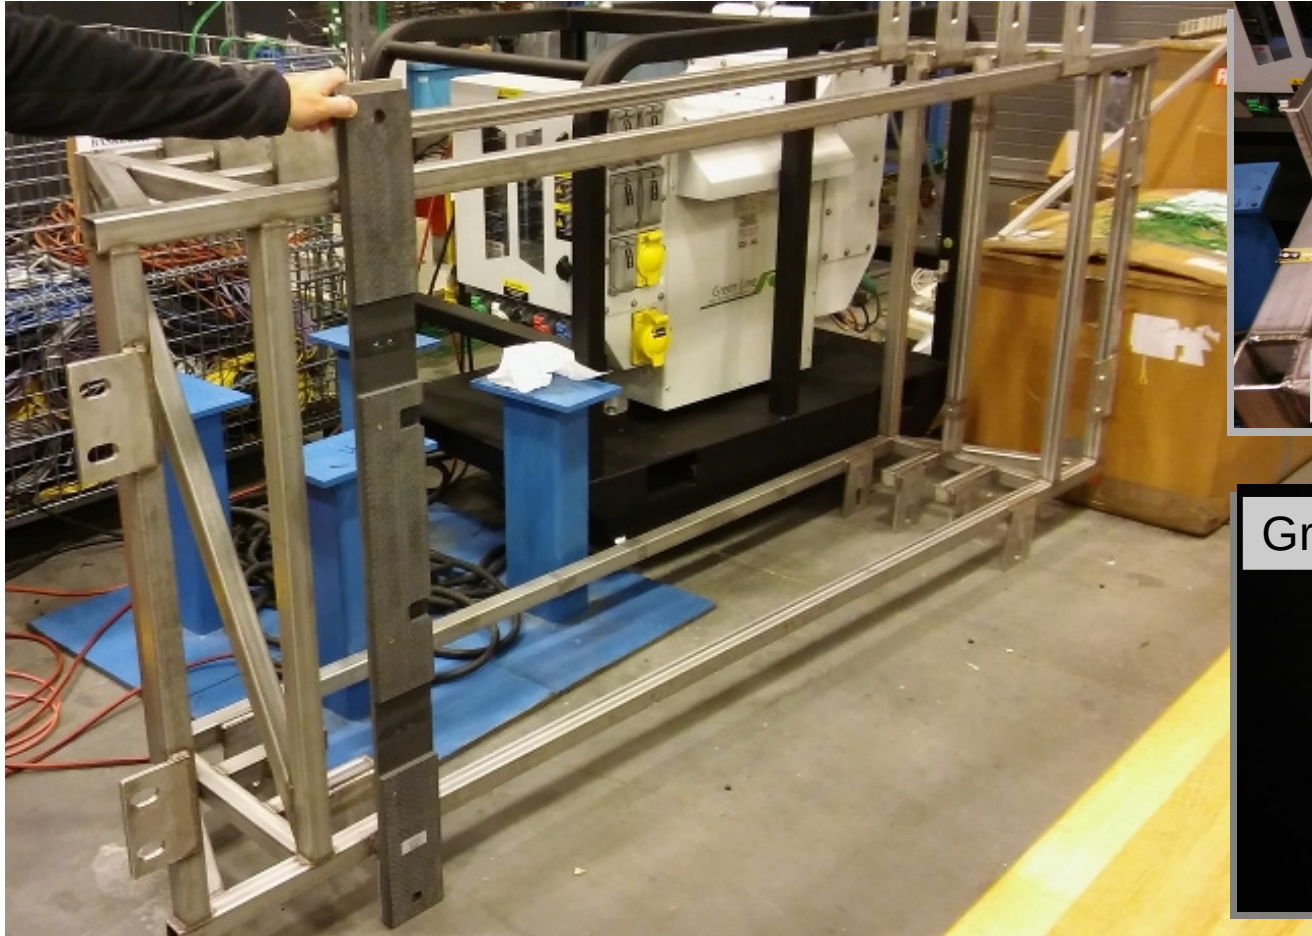
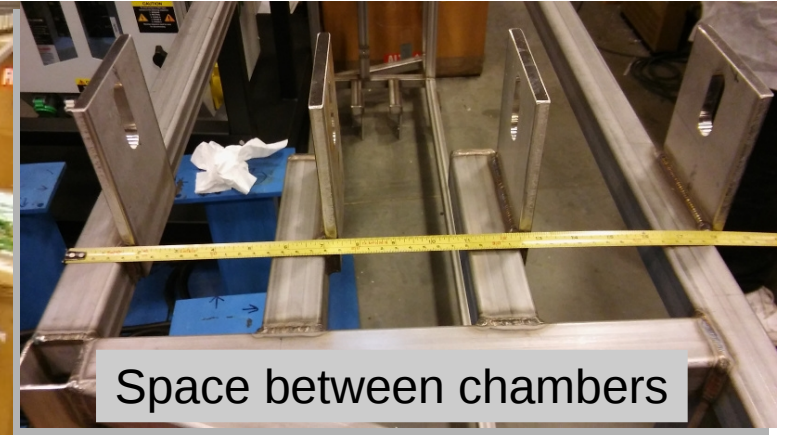
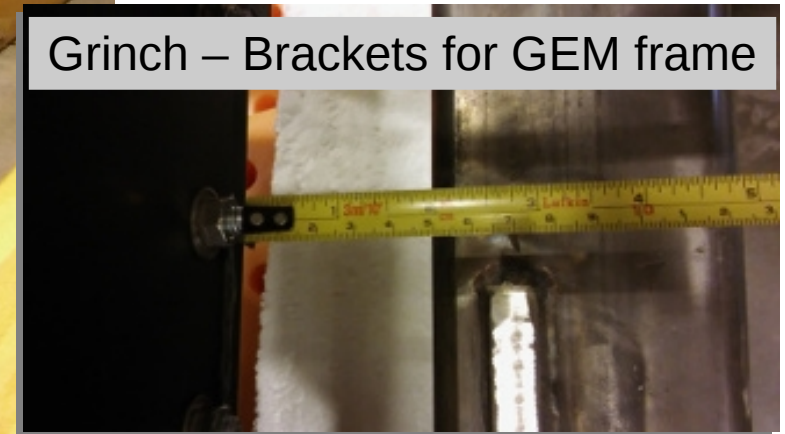
BigBite Frame

First impressions after closer look at the BigBite frame for the front-tracker:

- integration and cabling/piping of the GEM chambers look very tricky!
- space between frame and GRINCH (~6.5 cm), where the last chamber shall seat, is not enough (should be ~13 cm at least)
- the last chamber is critically exposed
