GRINCH Status

Bradley Yale

11/16/2020

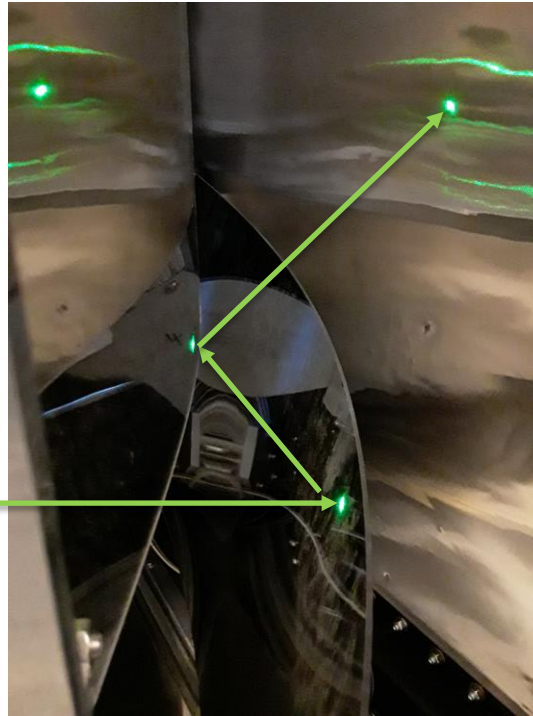
~6 deg. blind spot

Moving from the bottom mirror upward, there is a blind spot of ~6deg. where reflected light hits the back of the next mirror, missing the PMT array

$\pm 6\text{deg.}$ ~ Cherenkov cone...

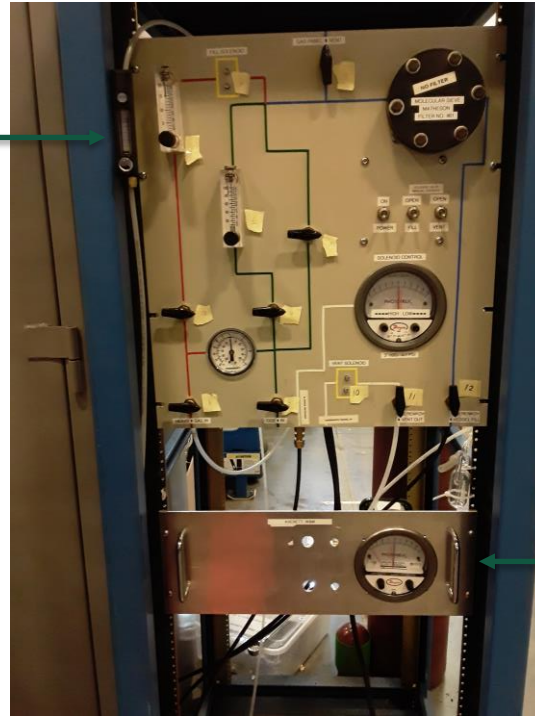
New gauge connected directly to the GRINCH for pressure monitoring

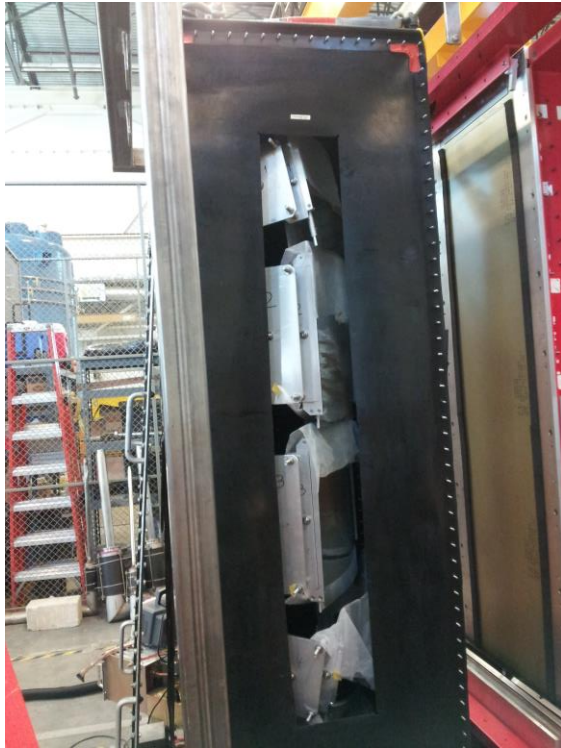
Cracks appeared in the Viton© used to leak-proof the sides of the GRINCH door, so it needs to be replaced.

But first, the question is what caused this: a chemical reaction or handling?

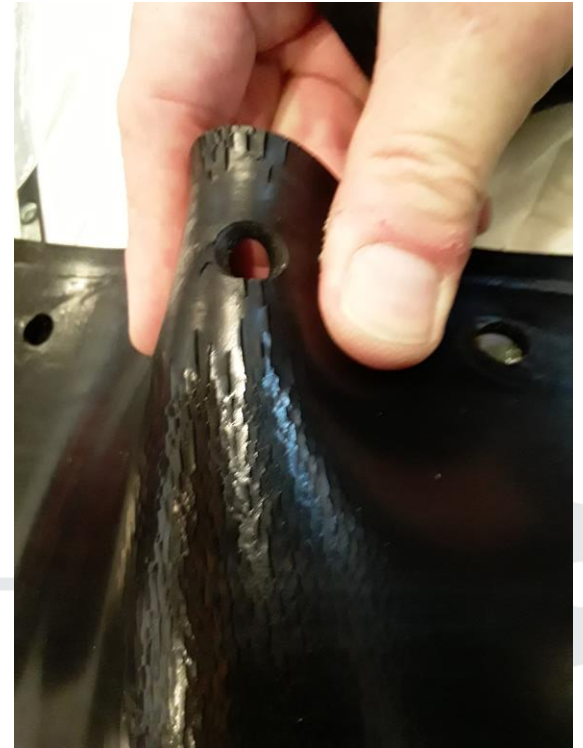
The cracking is probably from long-term folding/storage

It should be installed and left alone
