BigBite Timing Hodoscope SBS Weekly Meeting Update

Hall A Jefferson Lab

Ralph Marinaro

September 21, 2020

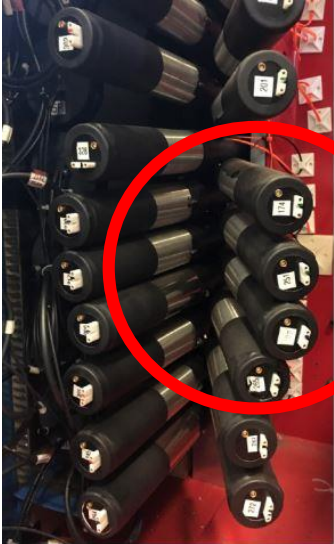
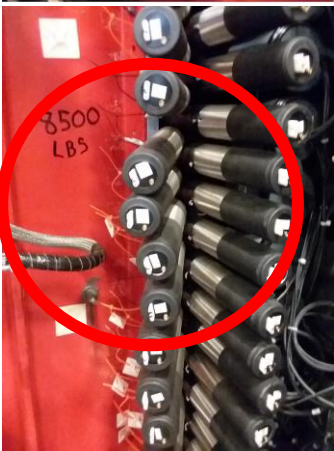
Problems - PMTs

- 20 broken glue joints on right hand side
- 7 broken glue joints on left hand side
- Photos taken as of December 2019
- Caused by bumping against PMTs
- Choice of smooth surfaces not sufficient for long term wear
- No external protection for PMTs

- Study conducted by Rachel at Glasgow*
- Tests with roughened surface conducted with same optical glue
- Decided to roughen surface of light guide and scintillating bar
- Additional guarding attached preventing future accidents
- Flexible supports between PMTs for extra reinforcement

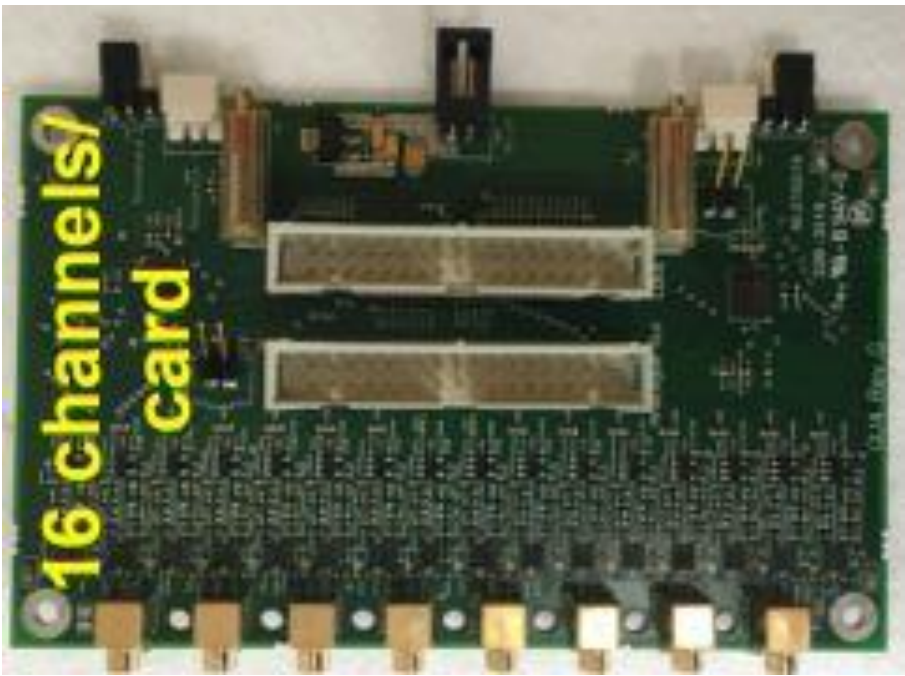
Problems - NINOs

- Not enough solder on connector joints from Zott manufacturer on pins
- Prone to damages from screw attachments which secure card to frame plate

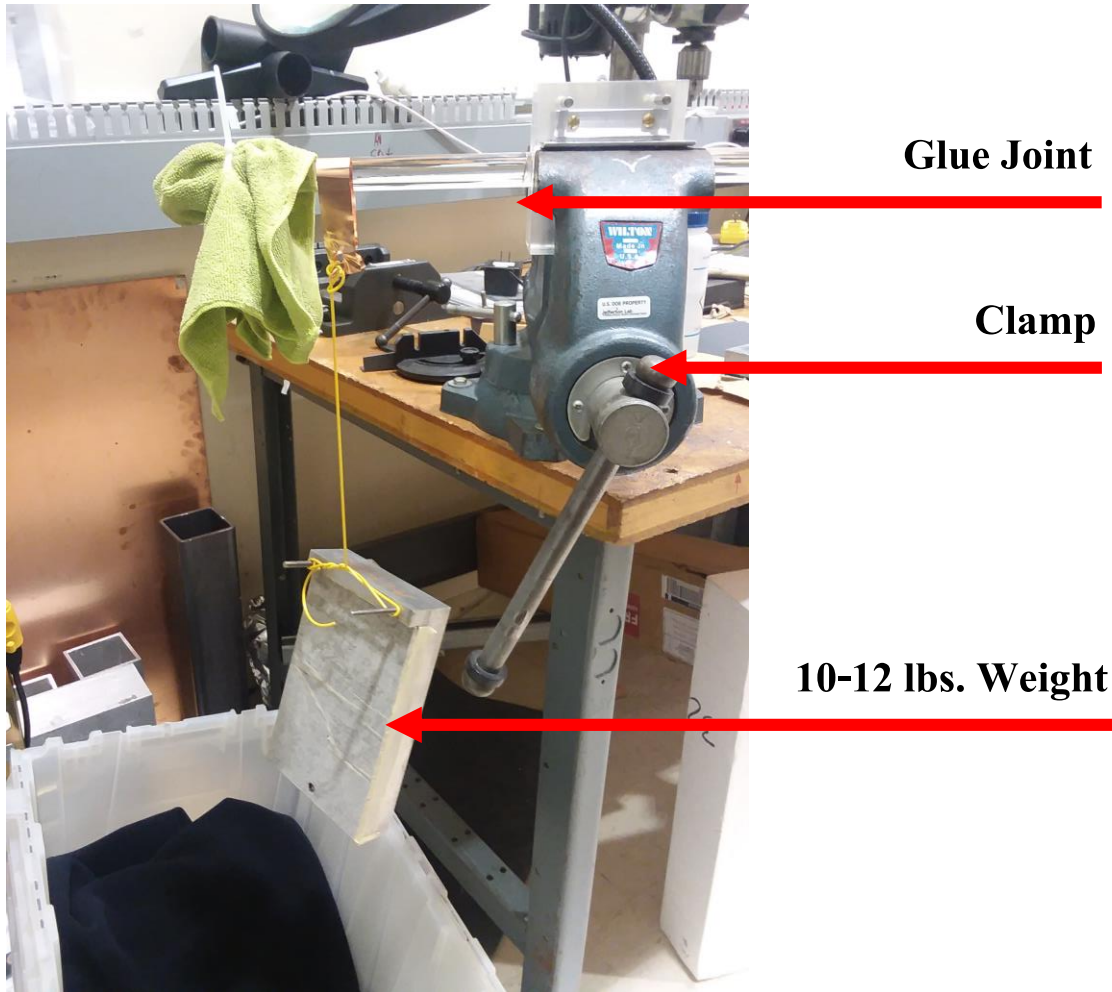
Stress Test

- Setup comprised of two light guides with roughened surfaces glued together, glue joint positioned directly on edge of clamp
- 10 and 12 lbs. weights were tested after varying 1-inch interval distances from joint
- Found that neither 10 lbs. nor 12 lbs. weights could break glue joint with 400 grade roughness
- Joint had to be weakened with alcohol bath, finally broke using 18 lbs. weight
- Proof that new method of roughening light guide surface combined with optical glue is sufficiently strong
- Lower grades of roughness available for testing, but 400 grade is best for strongest glue joint
