**INVESTIGATION REPORT
OF THE
FIRE IN THE
WIDE BAND LABORATORY
AT
FERMI NATIONAL ACCELERATOR
LABORATORY
BATAVIA, ILLINOIS
OCTOBER 3, 1987**

**U.S. DEPARTMENT OF ENERGY
Chicago Operations Office**

FIRE IN THE WIDE BAND LABORATORY

OCTOBER 3, 1987

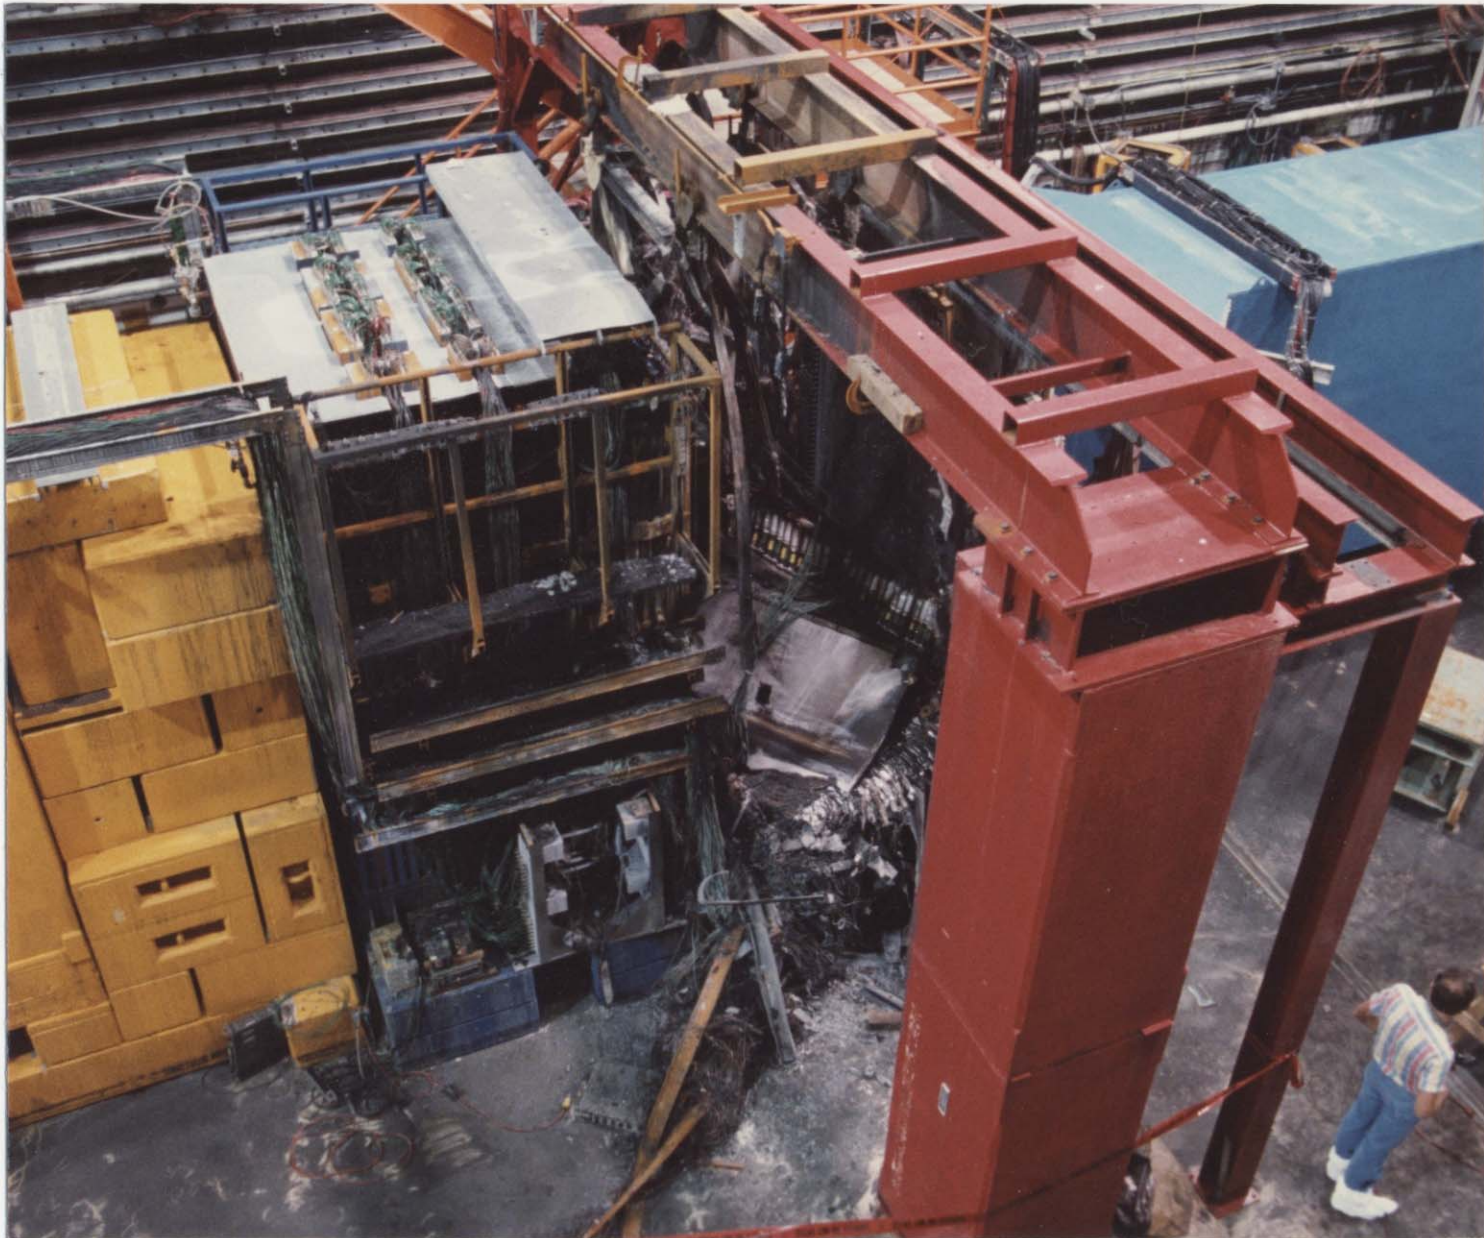
After the fire was extinguished and the situation stabilized, the first assessment of the damage was made. (See Figures 7-13.)

Figure 7. West side of beam line after fire.

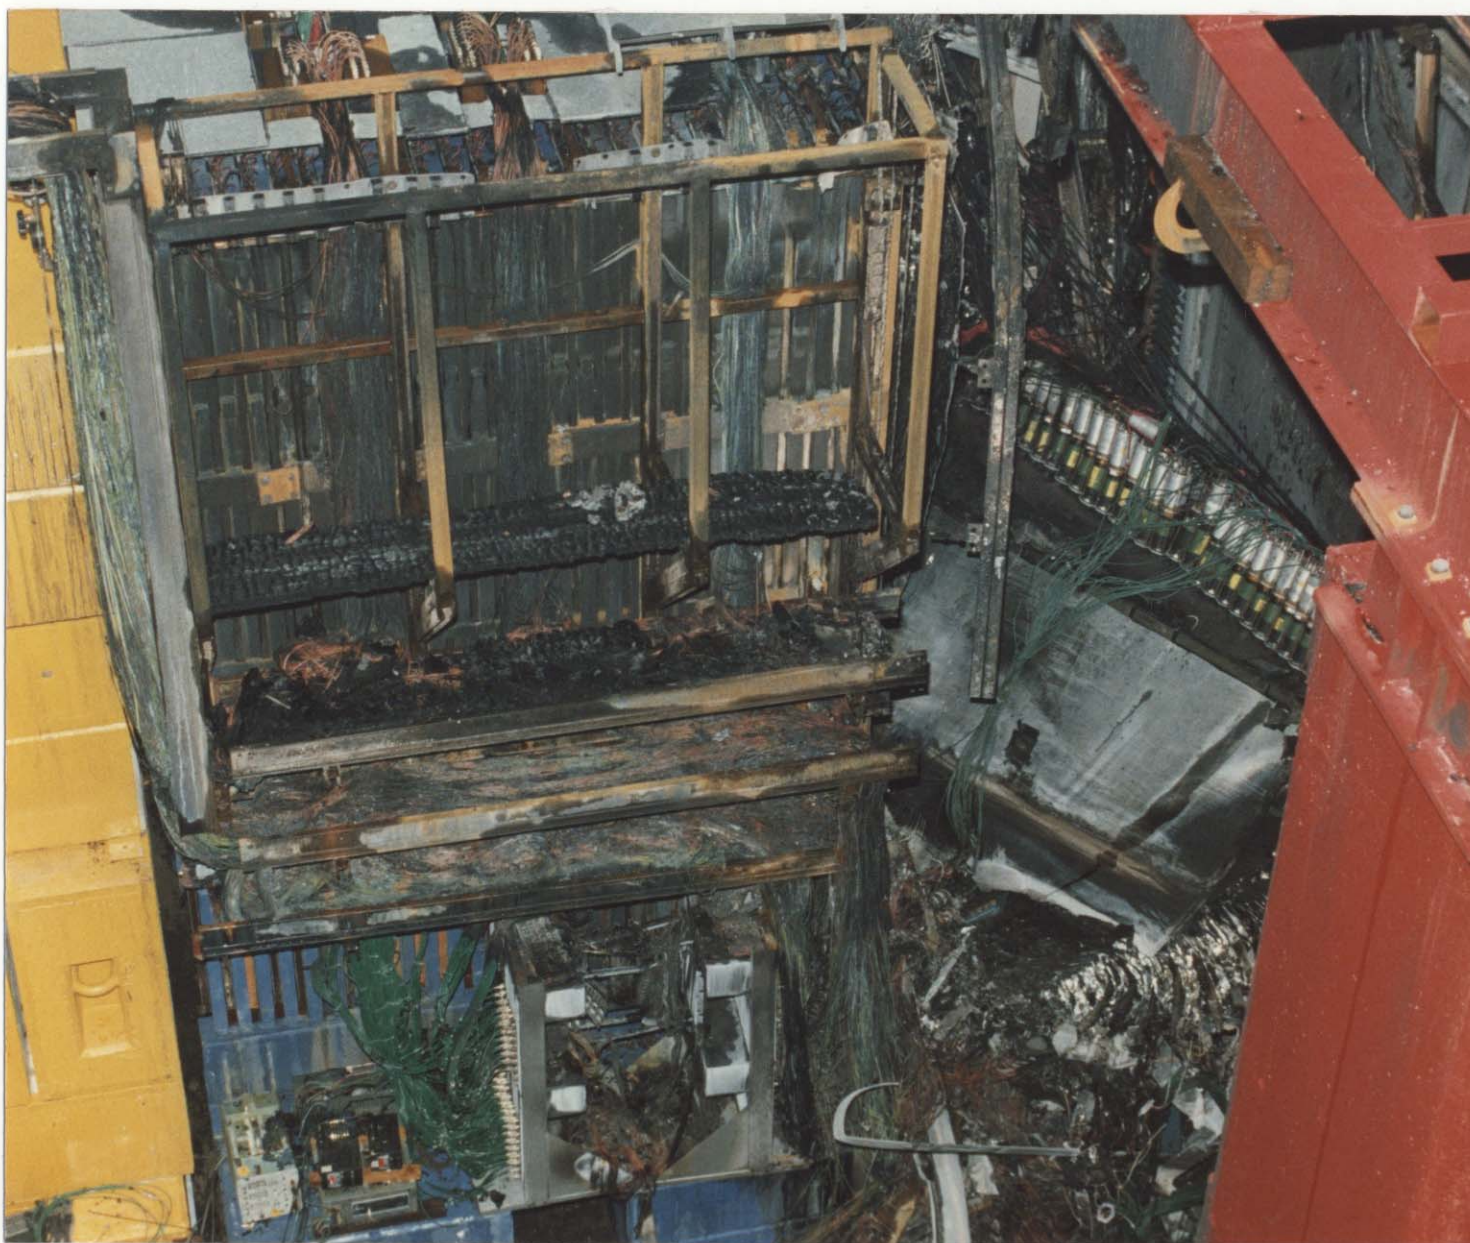
Figure 8. West side of beam line after fire. Note damage to HC, IEC, and dynode sum box.

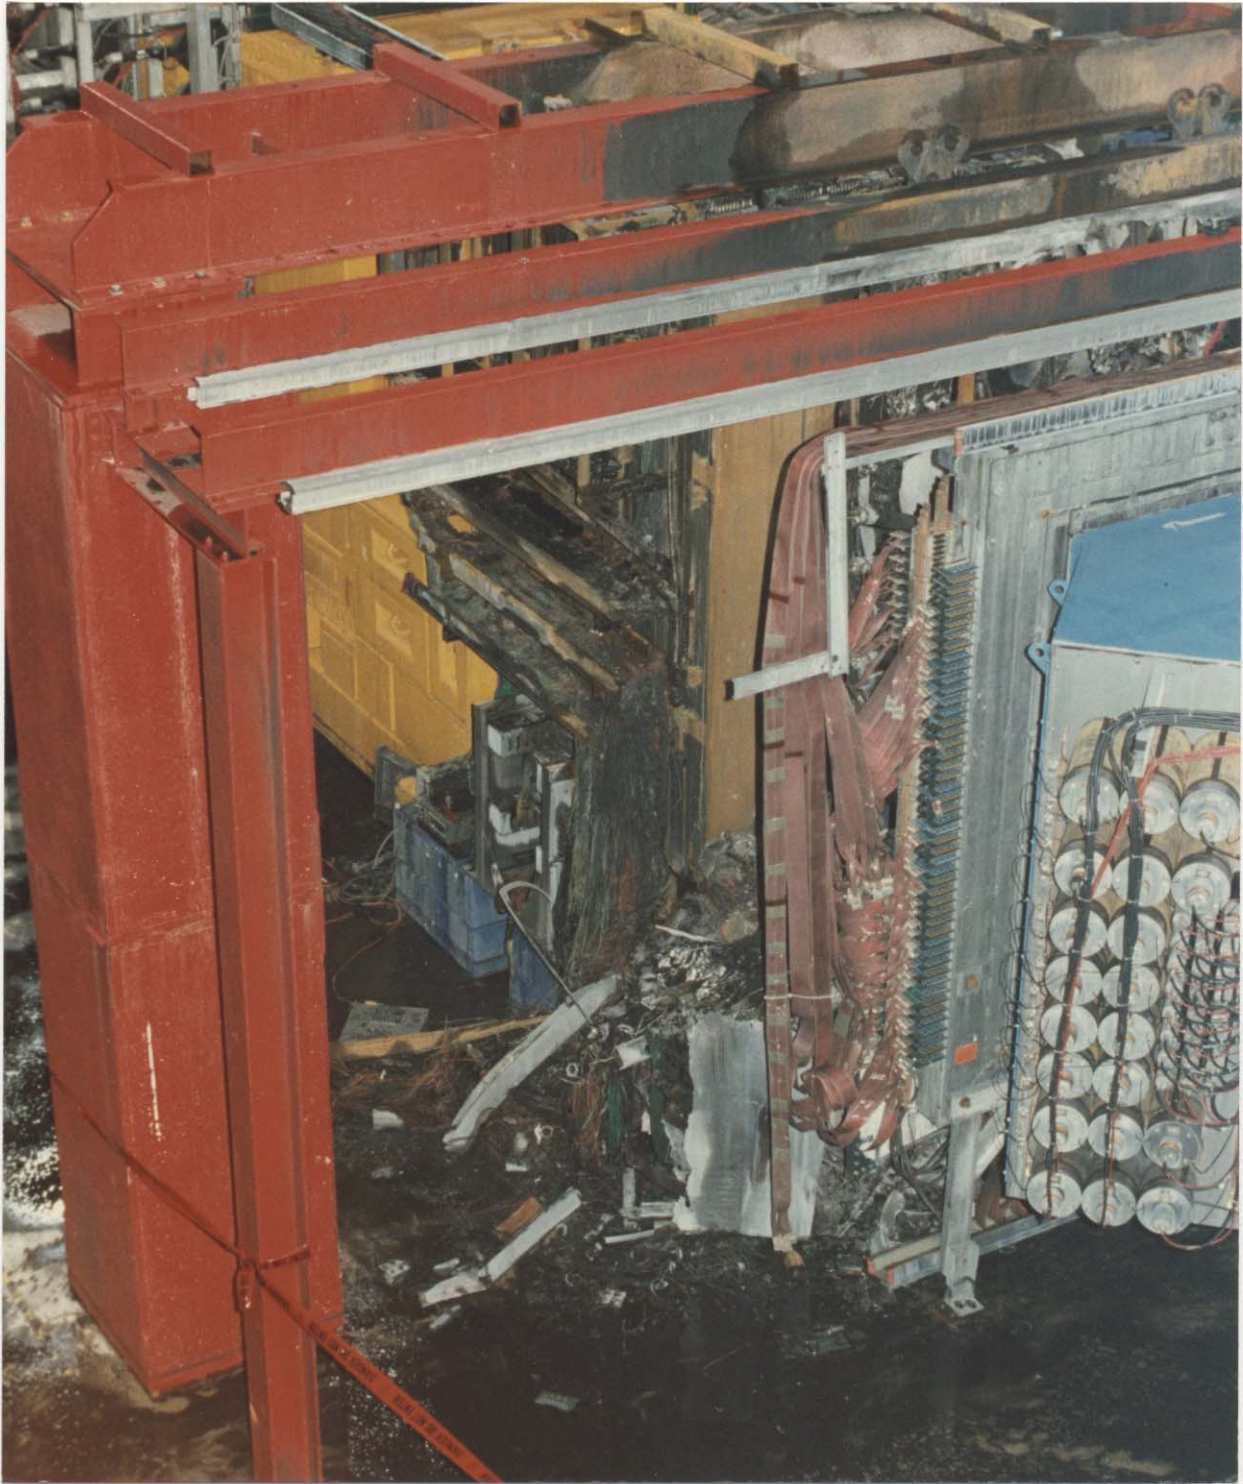
Figure 9. West side of beam line after fire. Note damage to HC, IEC, and support structure, and undamaged ribbon cable on P4.

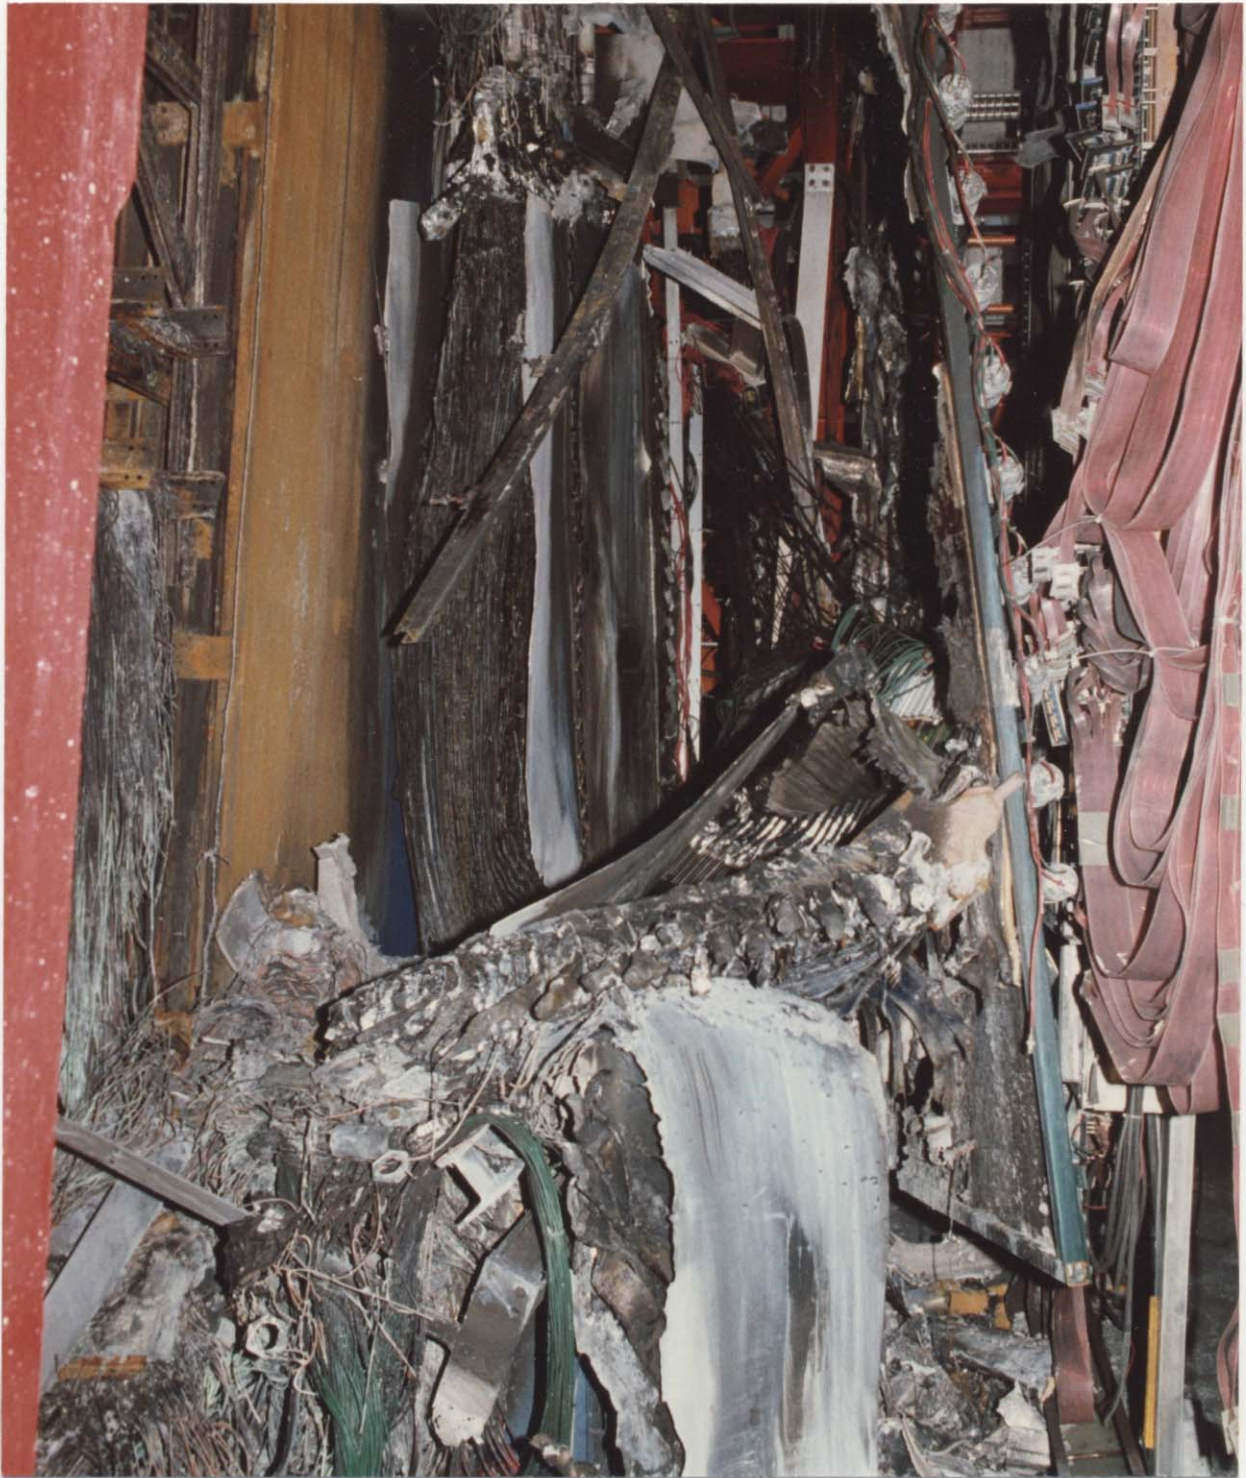
The front module of the IEC was totally destroyed. Most of the PMTs from the second module were burned off the top, bottom, and west sides and had fallen into the debris. The third module was damaged similarly to the second one (with some top PMTs remaining), but was still hanging, supported by its east hanger and by aluminum framework on the bottom. The upstream section of the aluminum framework was nearly totally destroyed. The downstream section had its west beams burned off, with some distortion to the remainder. There was also some distortion of the steel support structure.

Figure 10. Damage to IEC and HxV. IEC third module and downstream tiebreaker are visible hanging from aluminum framework.

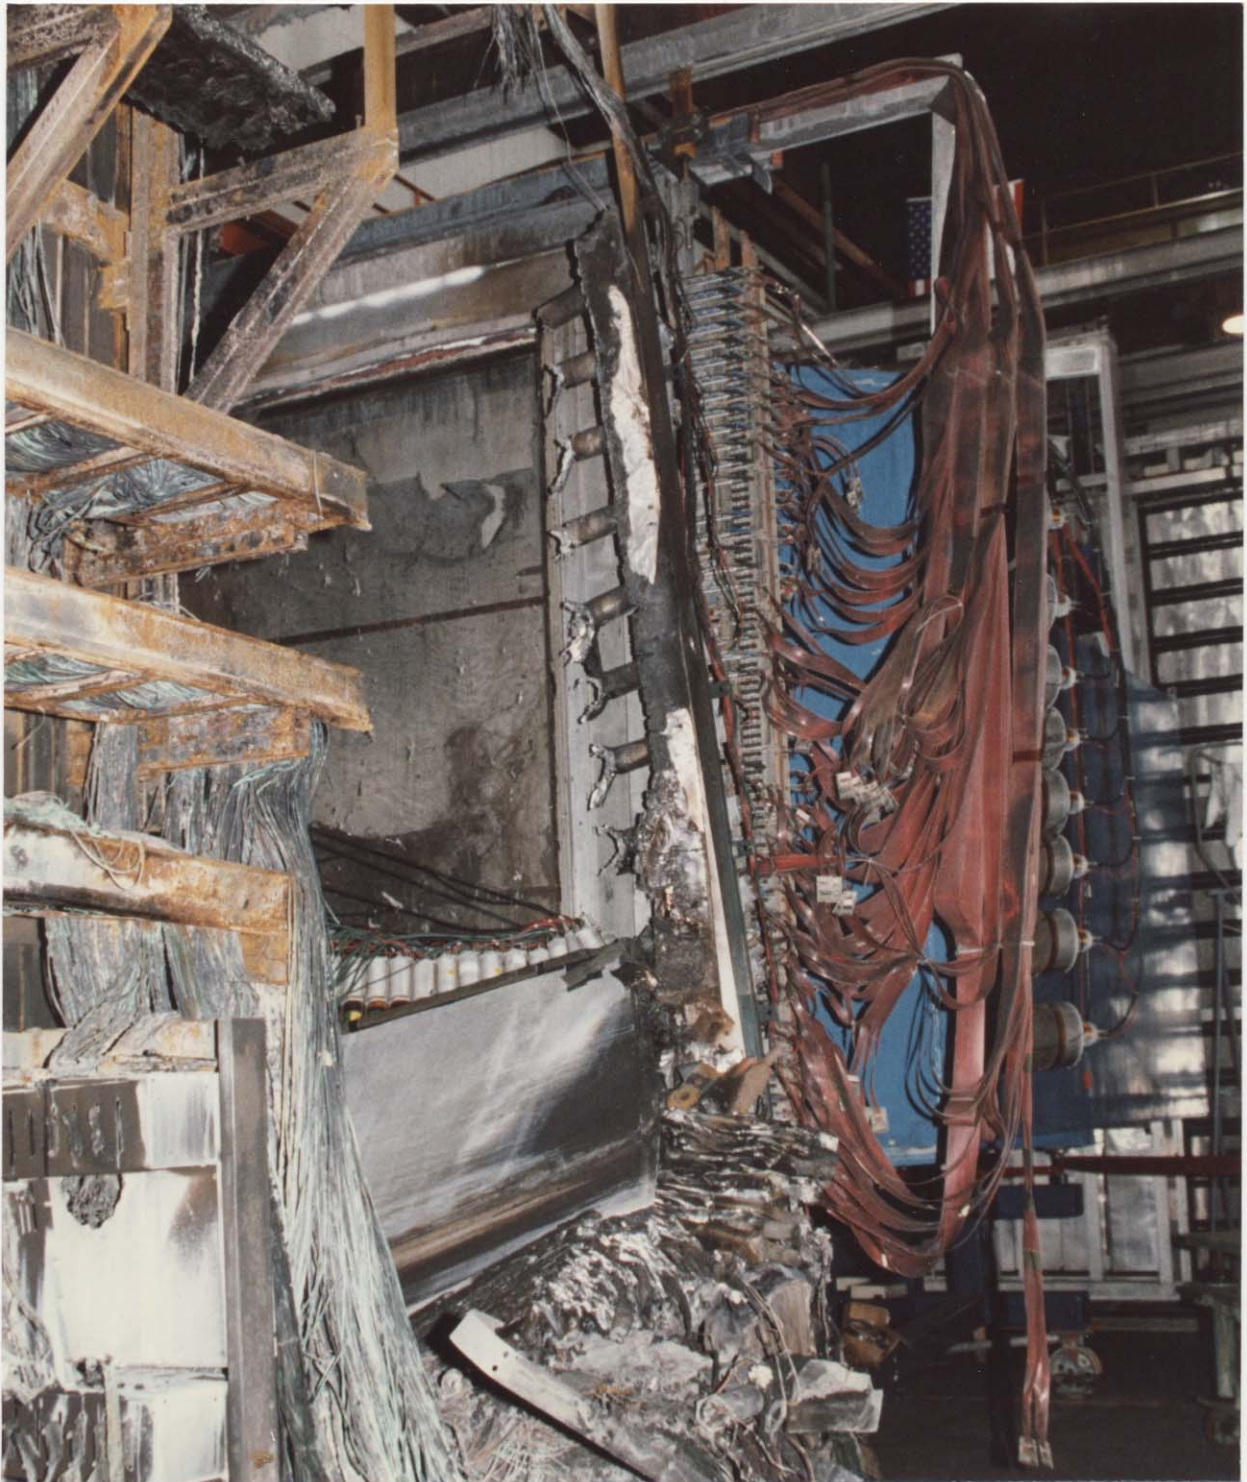
Figure 12. Damage to dynode sum box (with hole burnt through south panel) and IEC second module, remnants of west side of HxV, and damage to P4. Note minor damage to P4 ribbon cables.

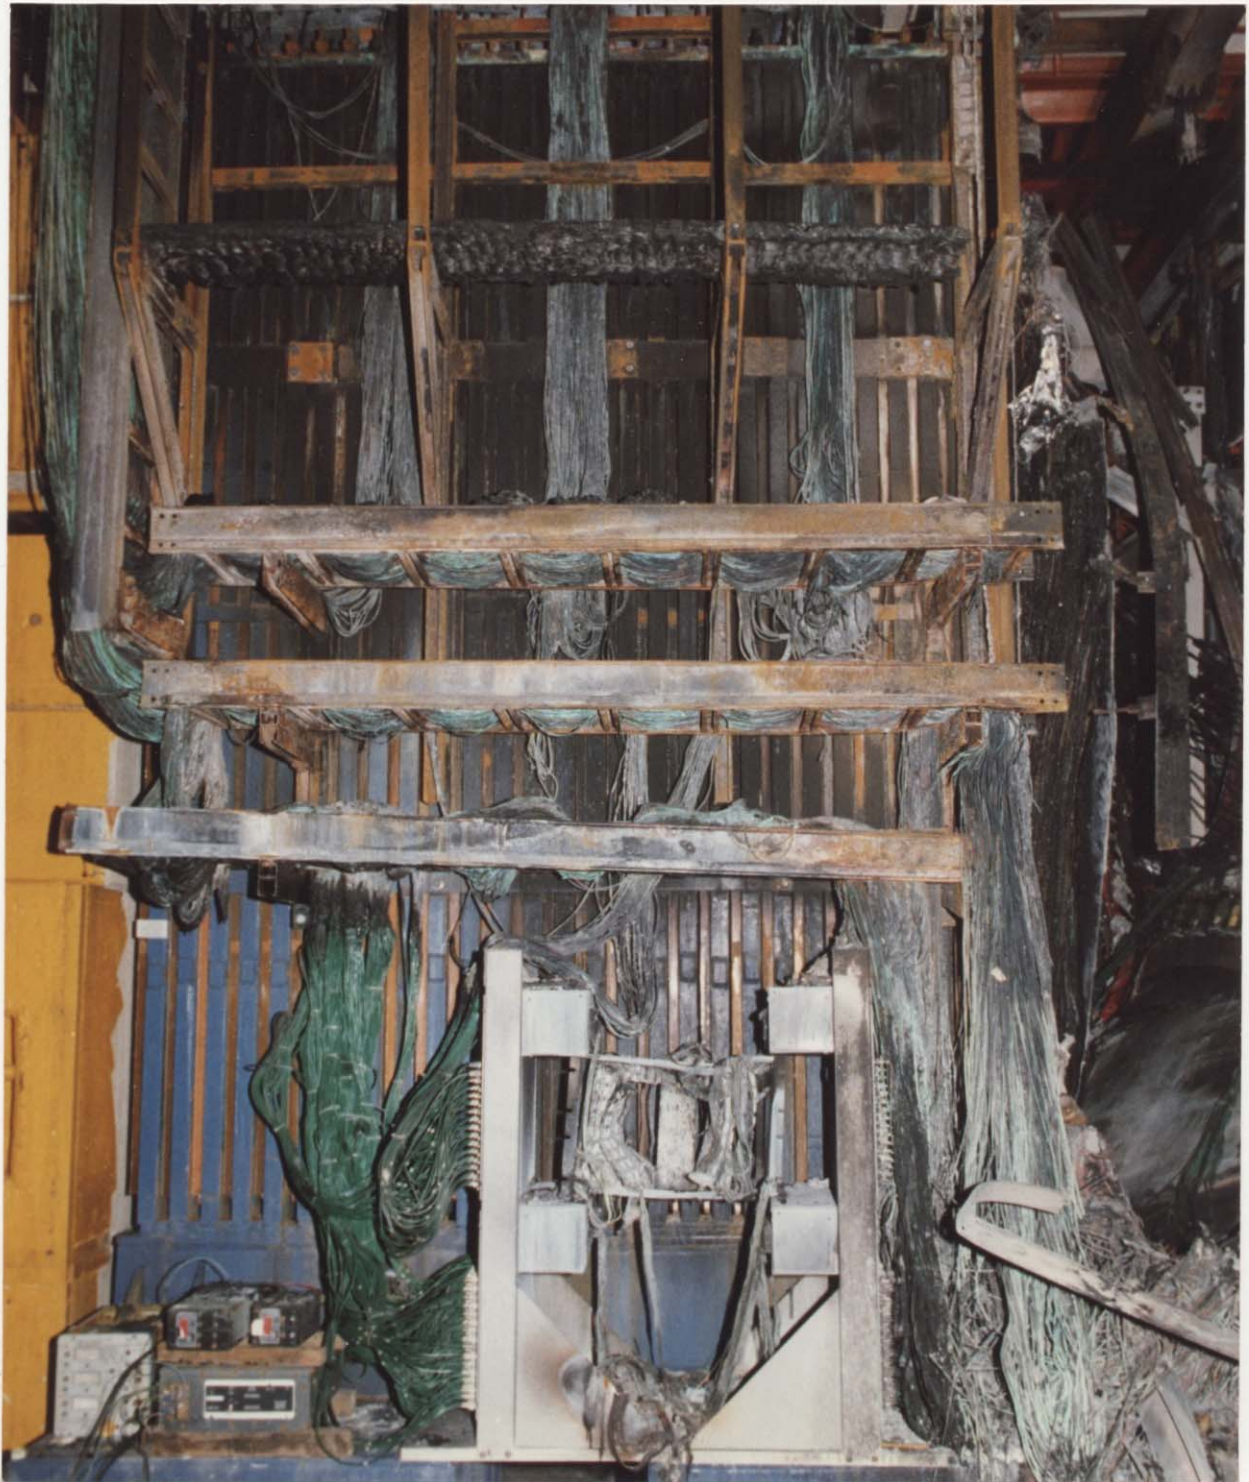
Figure 13. Damage to west side of HC and dynode sum box. Note almost complete destruction of cables on right side of sum box and mostly intact cables on the left.

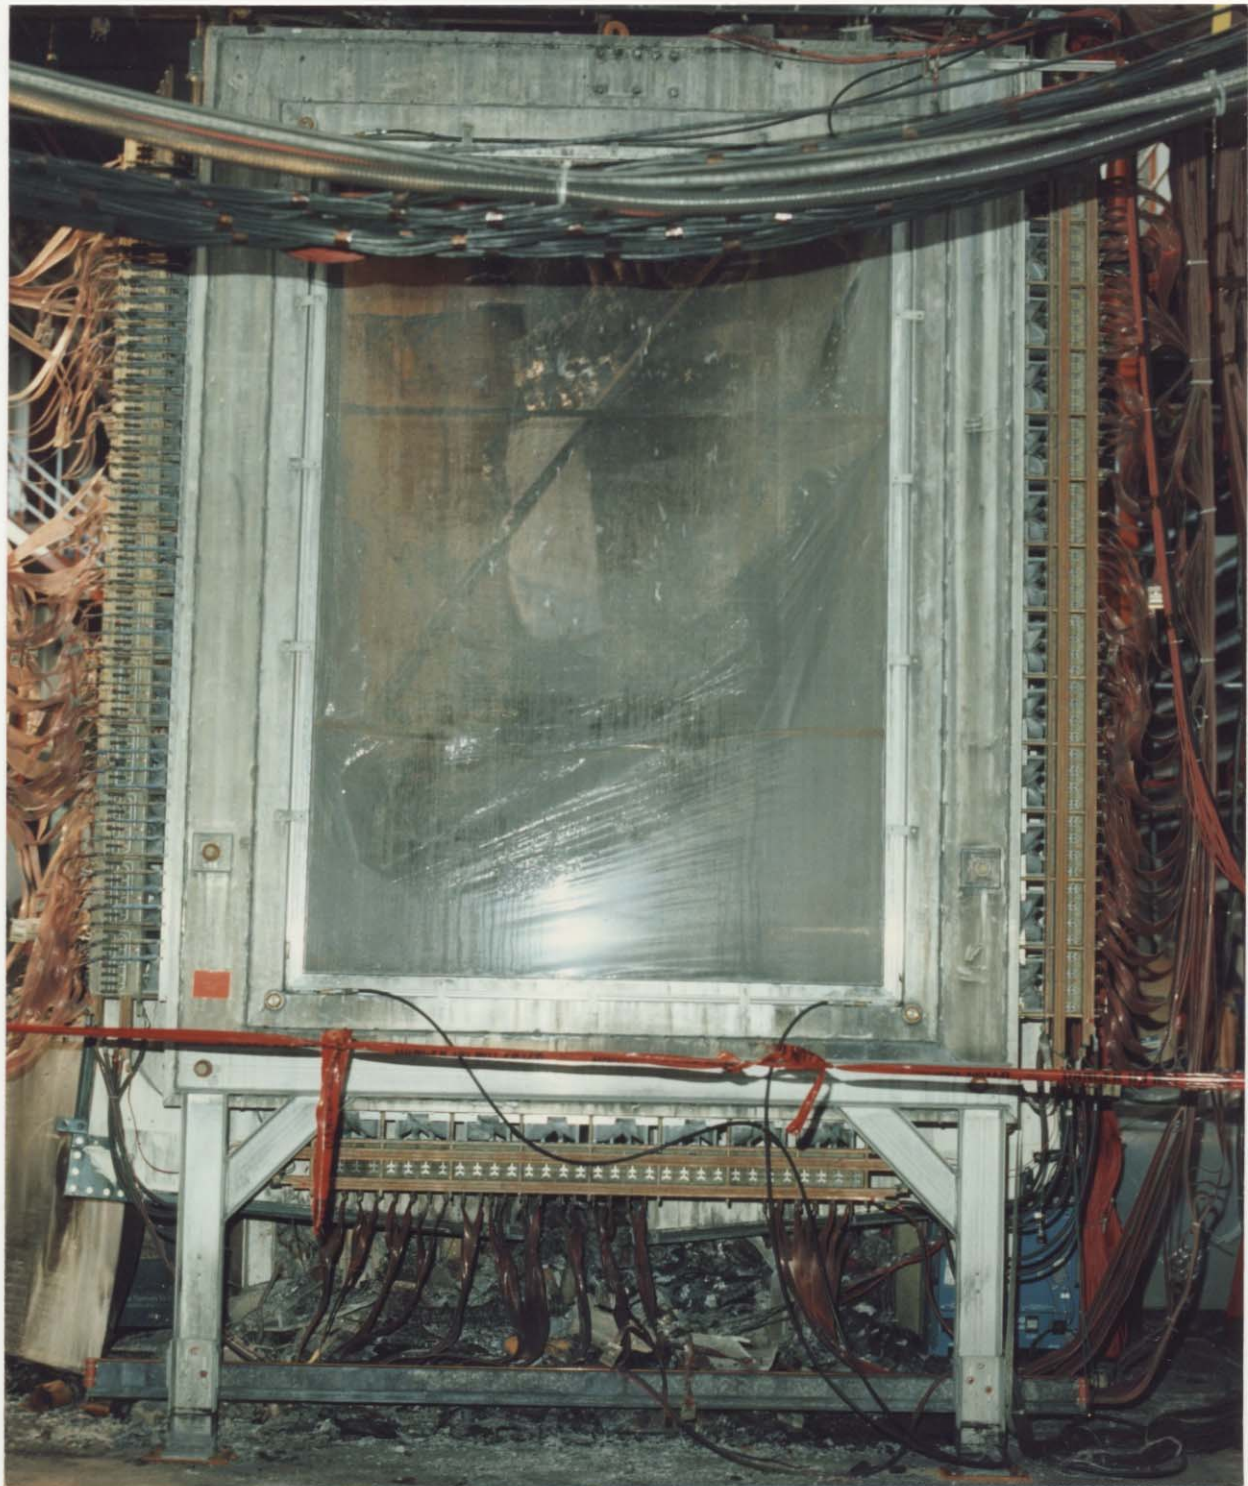
this detector. It had been originally thought that the damage to P4 could easily be repaired by rewiring and installing new mylar windows and gaskets. However, after removal and disassembly, the main circuit boards were observed to be extensively damaged, which will necessitate a major refabrication effort. An interesting observation was that in spite of the damage to HxV (immediately downstream of P4) the ribbon cables from the P4 preamplifier boards were hardly damaged (see Figure 14).

Figure 14. Upstream view of P4 after C3 was rolled aside. Note extensive damage to ribbon cable on bottom, but only minor damage to cables on west (left) and east sides.

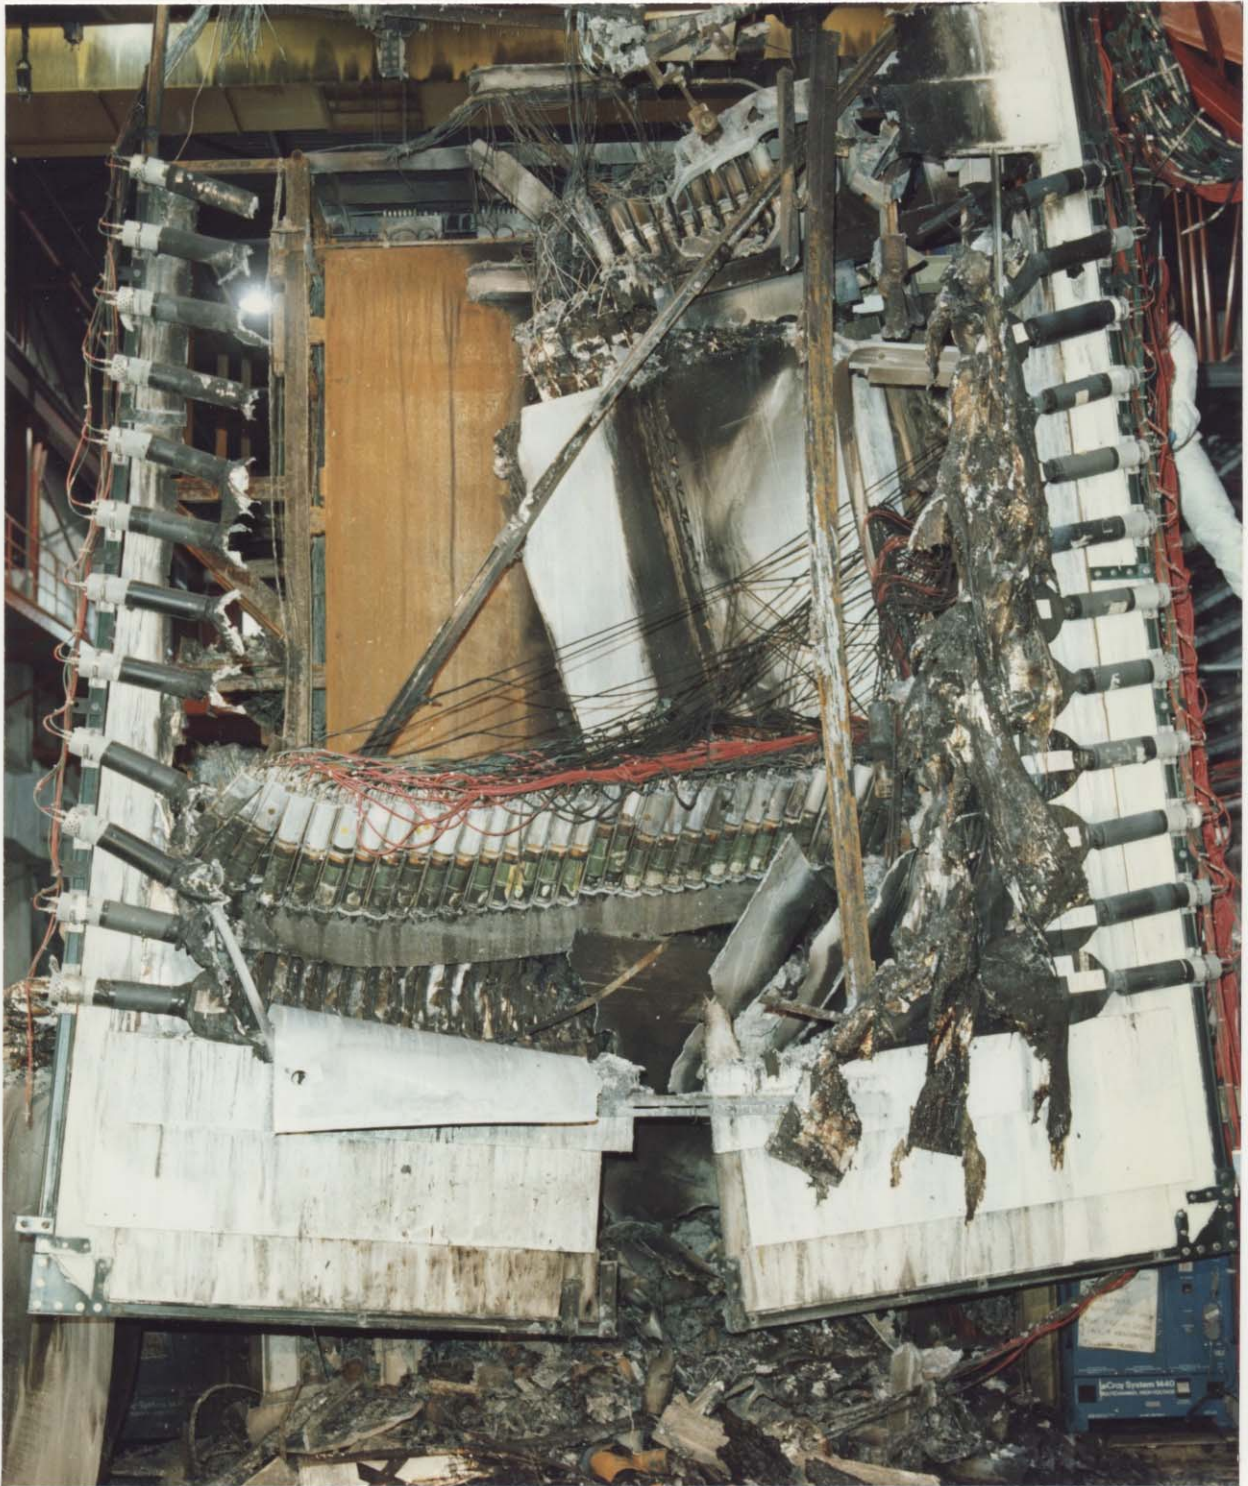
The HxV detector was nearly totally destroyed. Almost all of the plastic scintillator material was consumed. The burn pattern was "U" shaped with slightly more damage on the west side than the east (see Figure 15). The downstream side was completely charred while the upstream side still had some intumescent paint undamaged. This reinforced the theory that the fire and source were further downstream. The remnants of HxV were removed in two pieces to gain access to the IEC, which suffered the bulk of the fire damage.

Figure 15. Upstream view of HxV with P4 removed. Damage on west side is only slightly more severe than on east side.

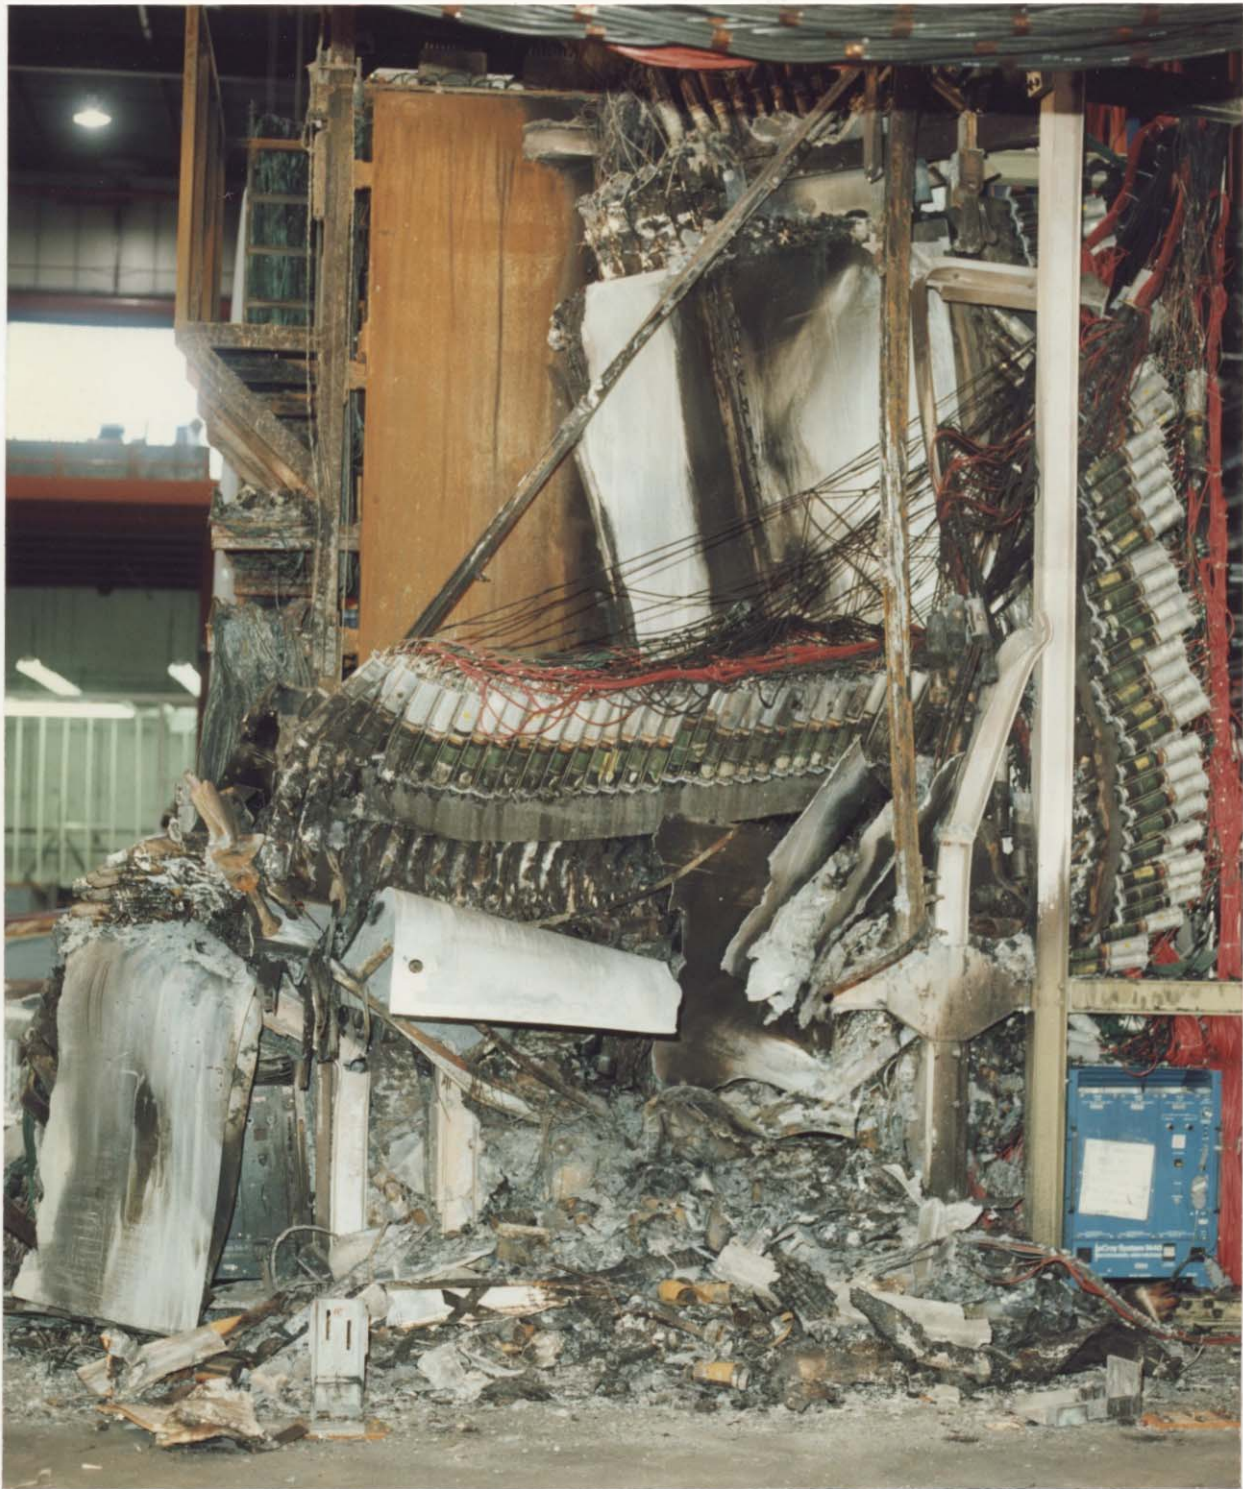
The third module of the IEC was partially resting on a downstream aluminum frame member and hanging from its east hanger (see Figures 16 and 17). Since it was estimated to weigh about 2 tons, great care was taken not to disturb it without adequate preparation. It was lifted out using the overhead crane and innovative rigging. The damage was found to be

Figure 16. Upstream view of IEC with HxV removed. MF6 is clearly visible on lower right while MF7 is buried under rubble at lower left. Note undamaged cables along east side.

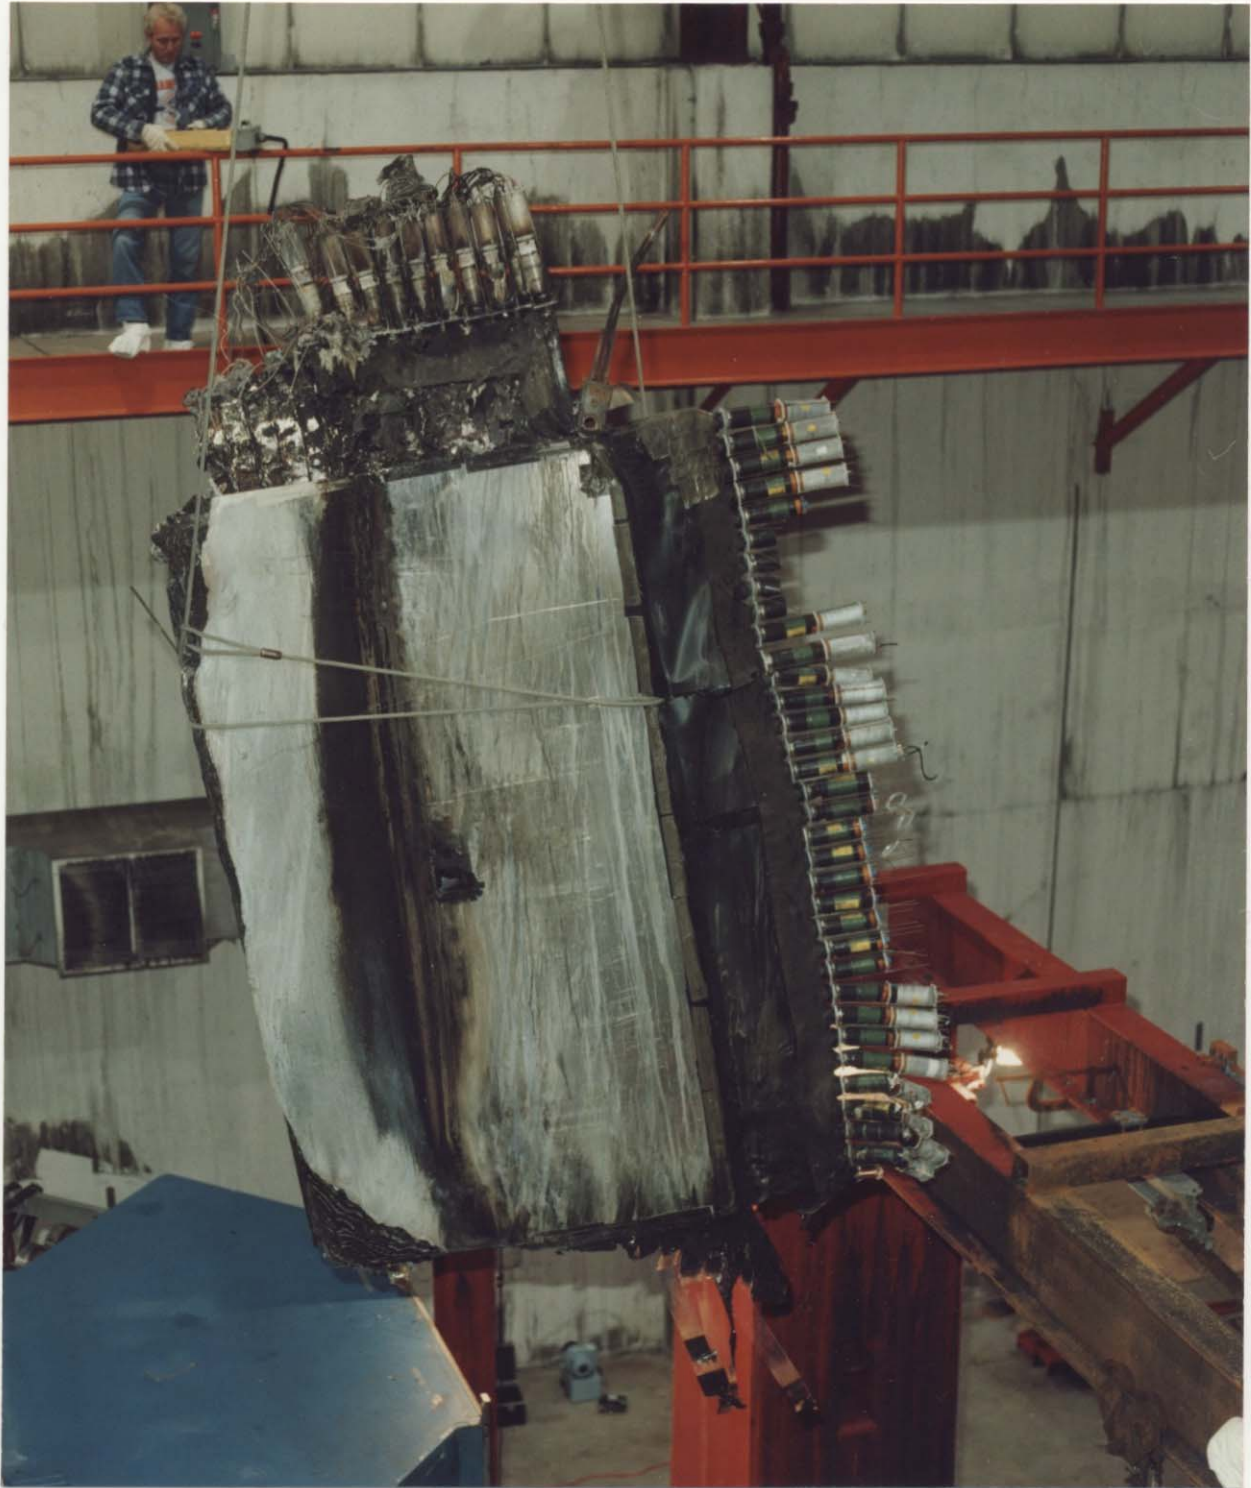
extensive on the west and bottom sides, with most of the PMTs and scintillator light guides burned off. The top received somewhat less severe damage. The east side of this module was undamaged and still had most of its PMTs and cables intact. (See Figure 18.) Thus, there was comparatively little fire on the east side of this module. A partial disassembly indicated that the majority of the internal scintillator material had remained unburned, apparently protected from heat by the lead sheets.

Figure 18. Upstream view of IEC third module after removal from fire scene. Note damage is greater on left (west) and bottom.

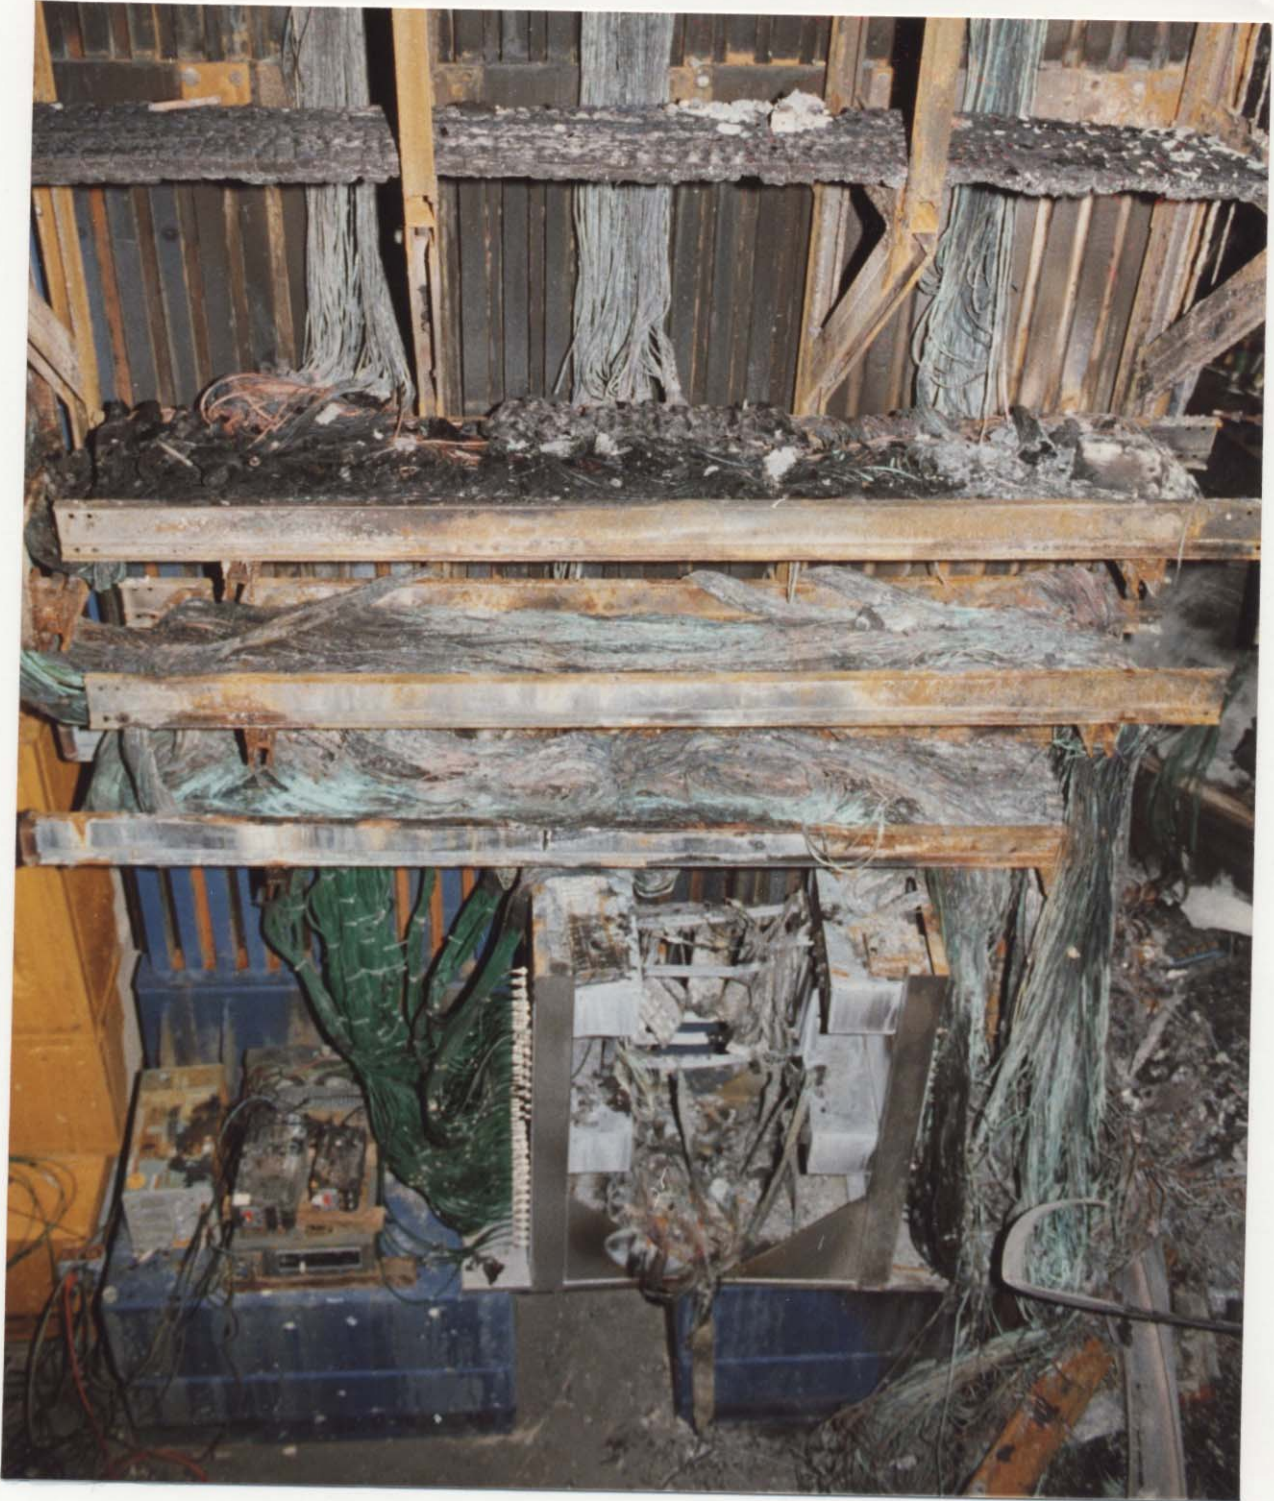
The examination then focused on the cable trays attached to the west side of the HC, as well as the dynode sum box and its associated cables. The cables in the horizontal trays were extensively damaged (see Figures 21 and 22), but for the most part, not as severely as the vertical runs. The dynode sum box was also badly damaged and was removed for further examination (see IV.B.5.). Most of the cables on the north side of the sum box were undamaged, while most of those on the south side were burned. This also suggested a fire origin near MF7.

Figure 21. Fire damage to west side of HC.

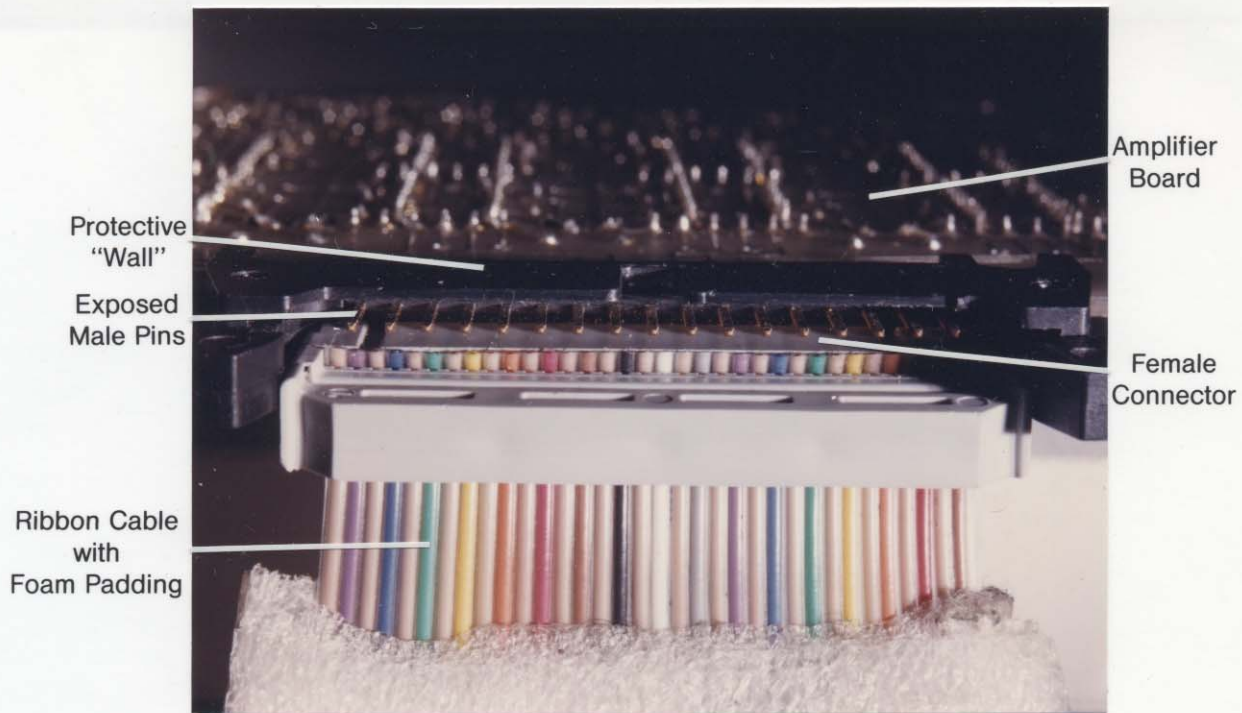
Figure 26a. Misregistered 34-pin connectors. Note row of exposed male pins. Cable and connectors are same type as those in dynode sum box.
