**INVESTIGATION REPORT
OF THE
FIRE IN THE
WIDE BAND LABORATORY
AT
FERMI NATIONAL ACCELERATOR
LABORATORY
BATAVIA, ILLINOIS
OCTOBER 3, 1987**

**U.S. DEPARTMENT OF ENERGY
Chicago Operations Office**

FIRE IN THE WIDE BAND LABORATORY

OCTOBER 3, 1987

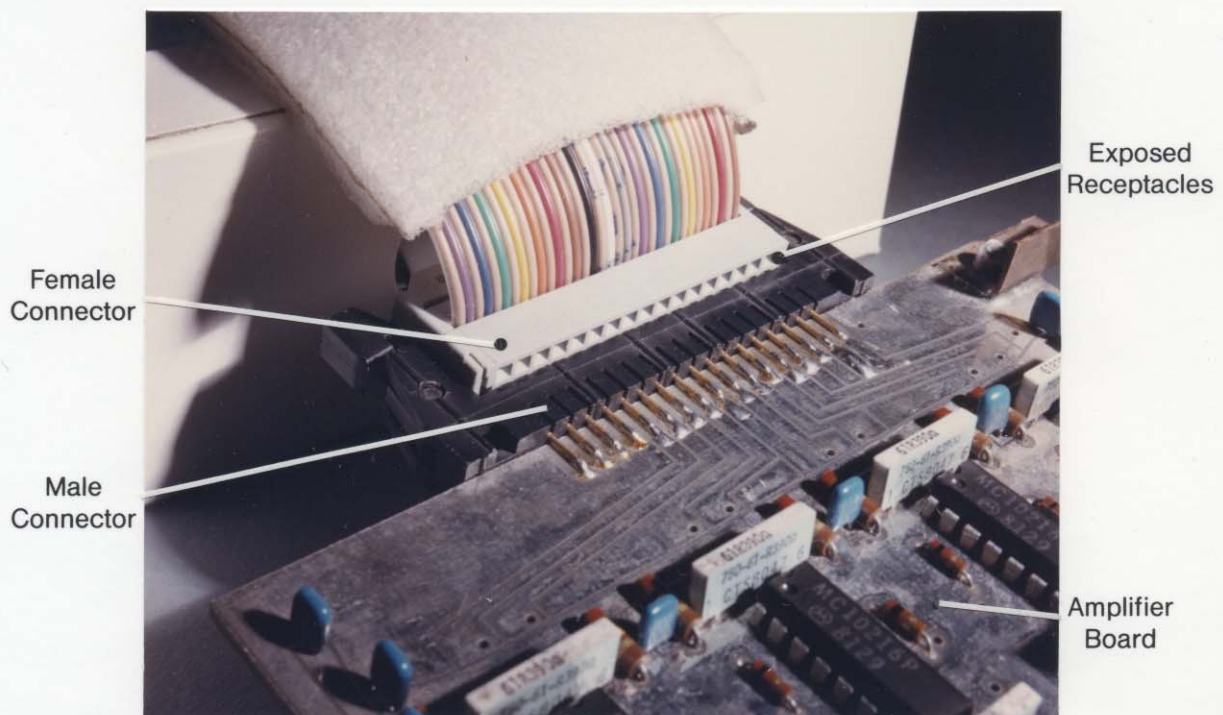
Fig. 26b. Misregistered 34-pin connectors. Note exposed female receptacles and absence of protective "wall" on male connector.

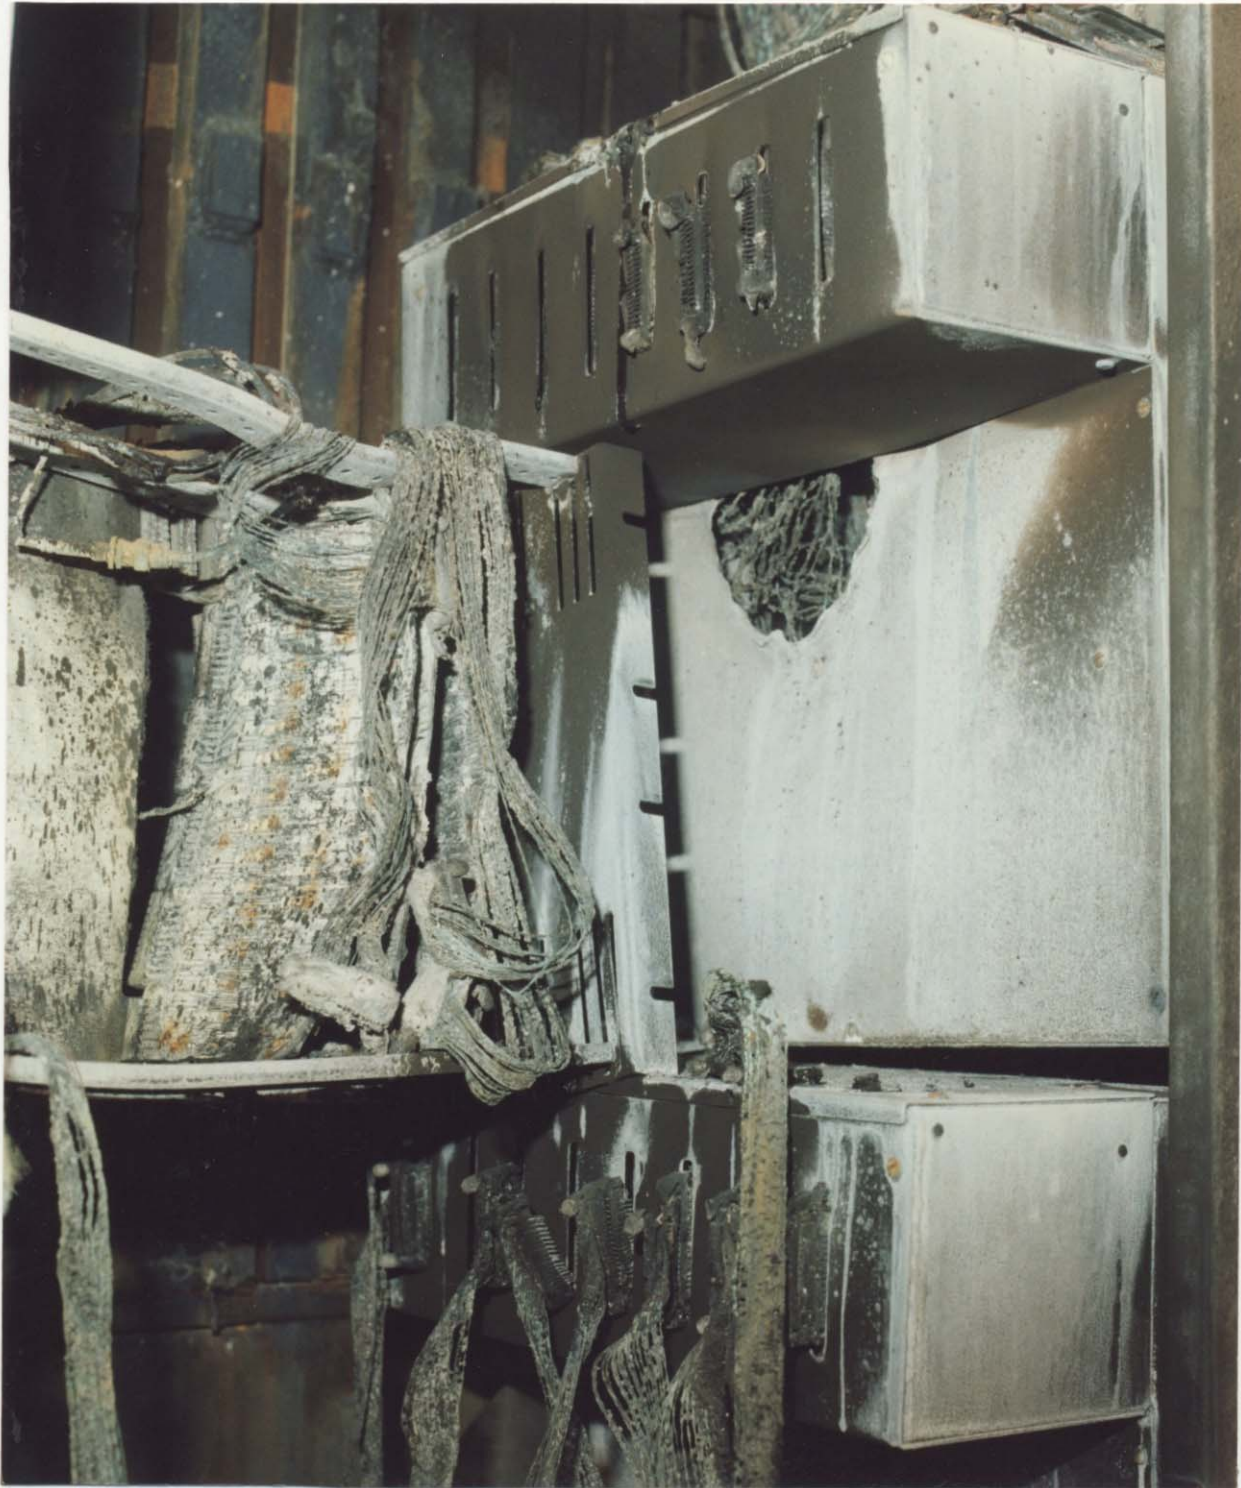
Figure 27. Interior of upstream side of dynode sum box. Connectors handled immediately prior to fire are on lower chassis box. Suspect connector is third from outside.

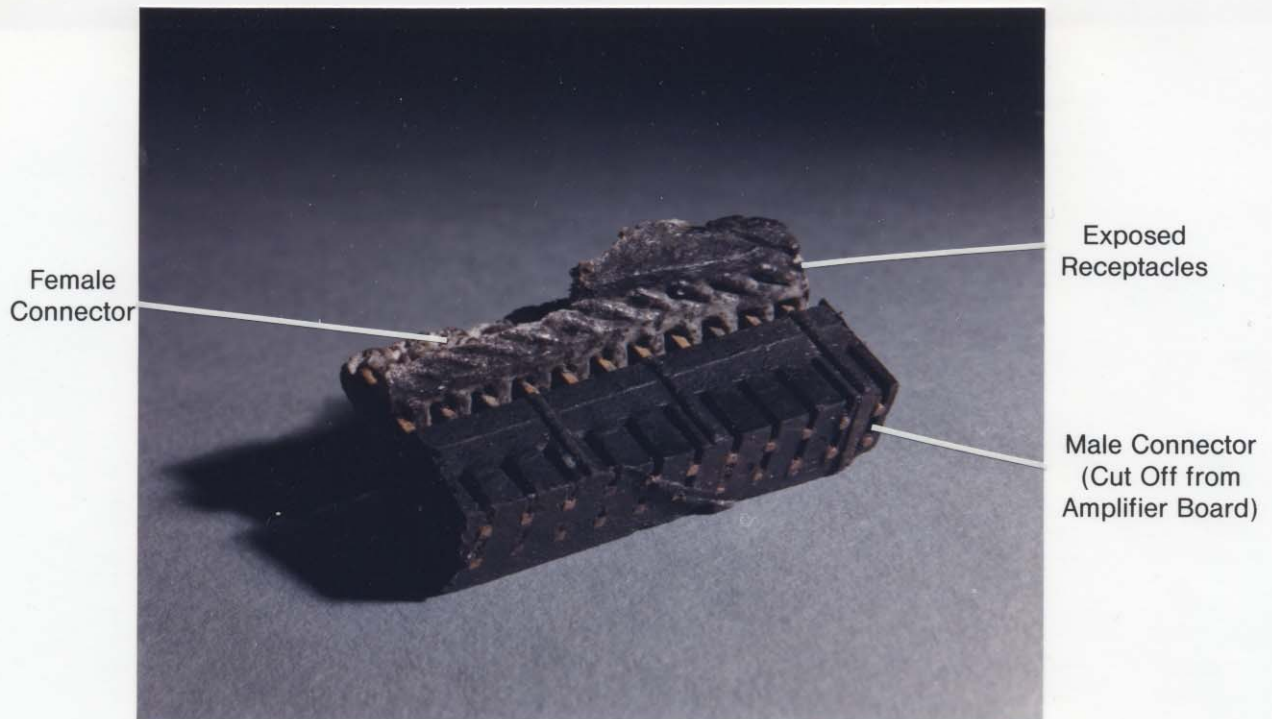
Figure 29a. External view, section of suspect 34-pin connectors. Note exposed row of female receptacles; deformed by partial melting of female connector.

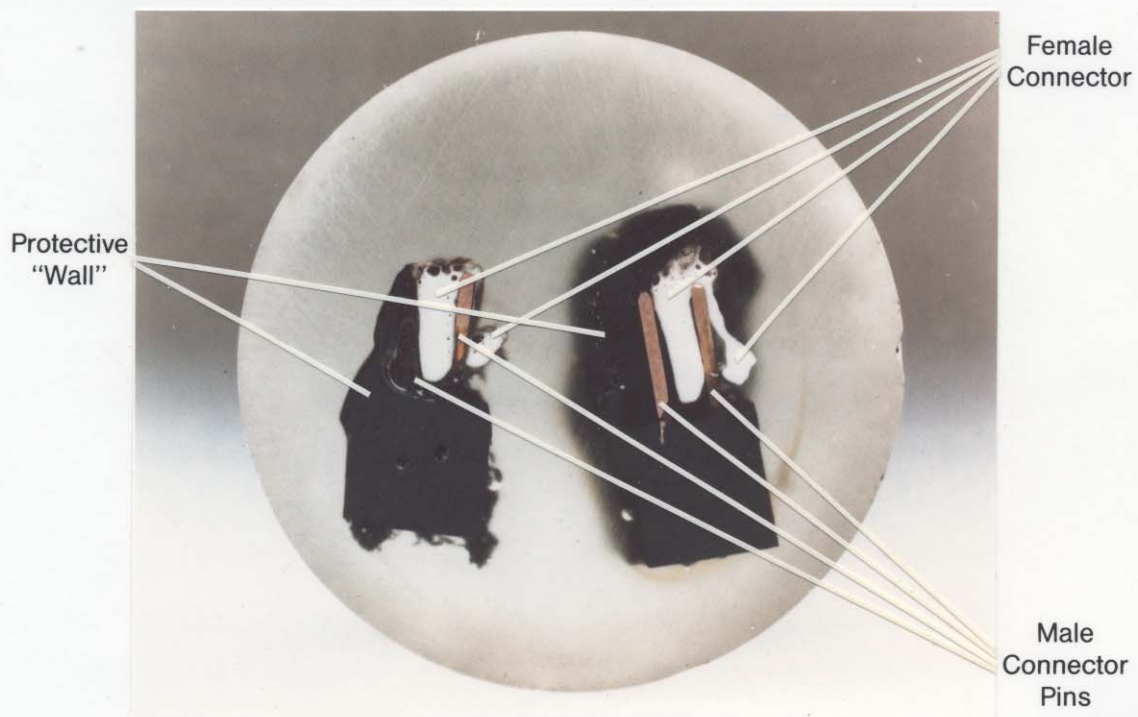
Fig. 29b. Cross-sectional views of suspect connectors. Note absence of gray plastic (female connector) on left side of pins.

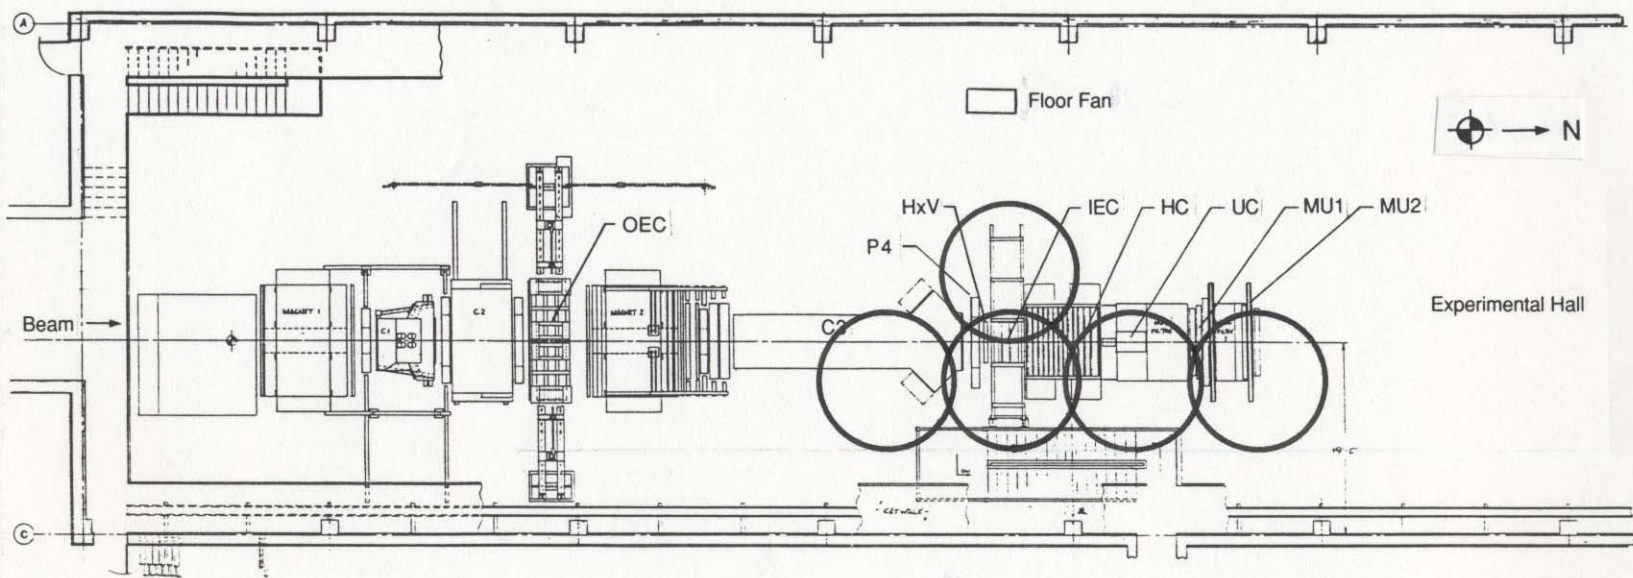
Figure 30. Discharge pattern for the five operated sprinklers in the experimental hall.
