Facilities

Earth Shielding Surveys

June 2019

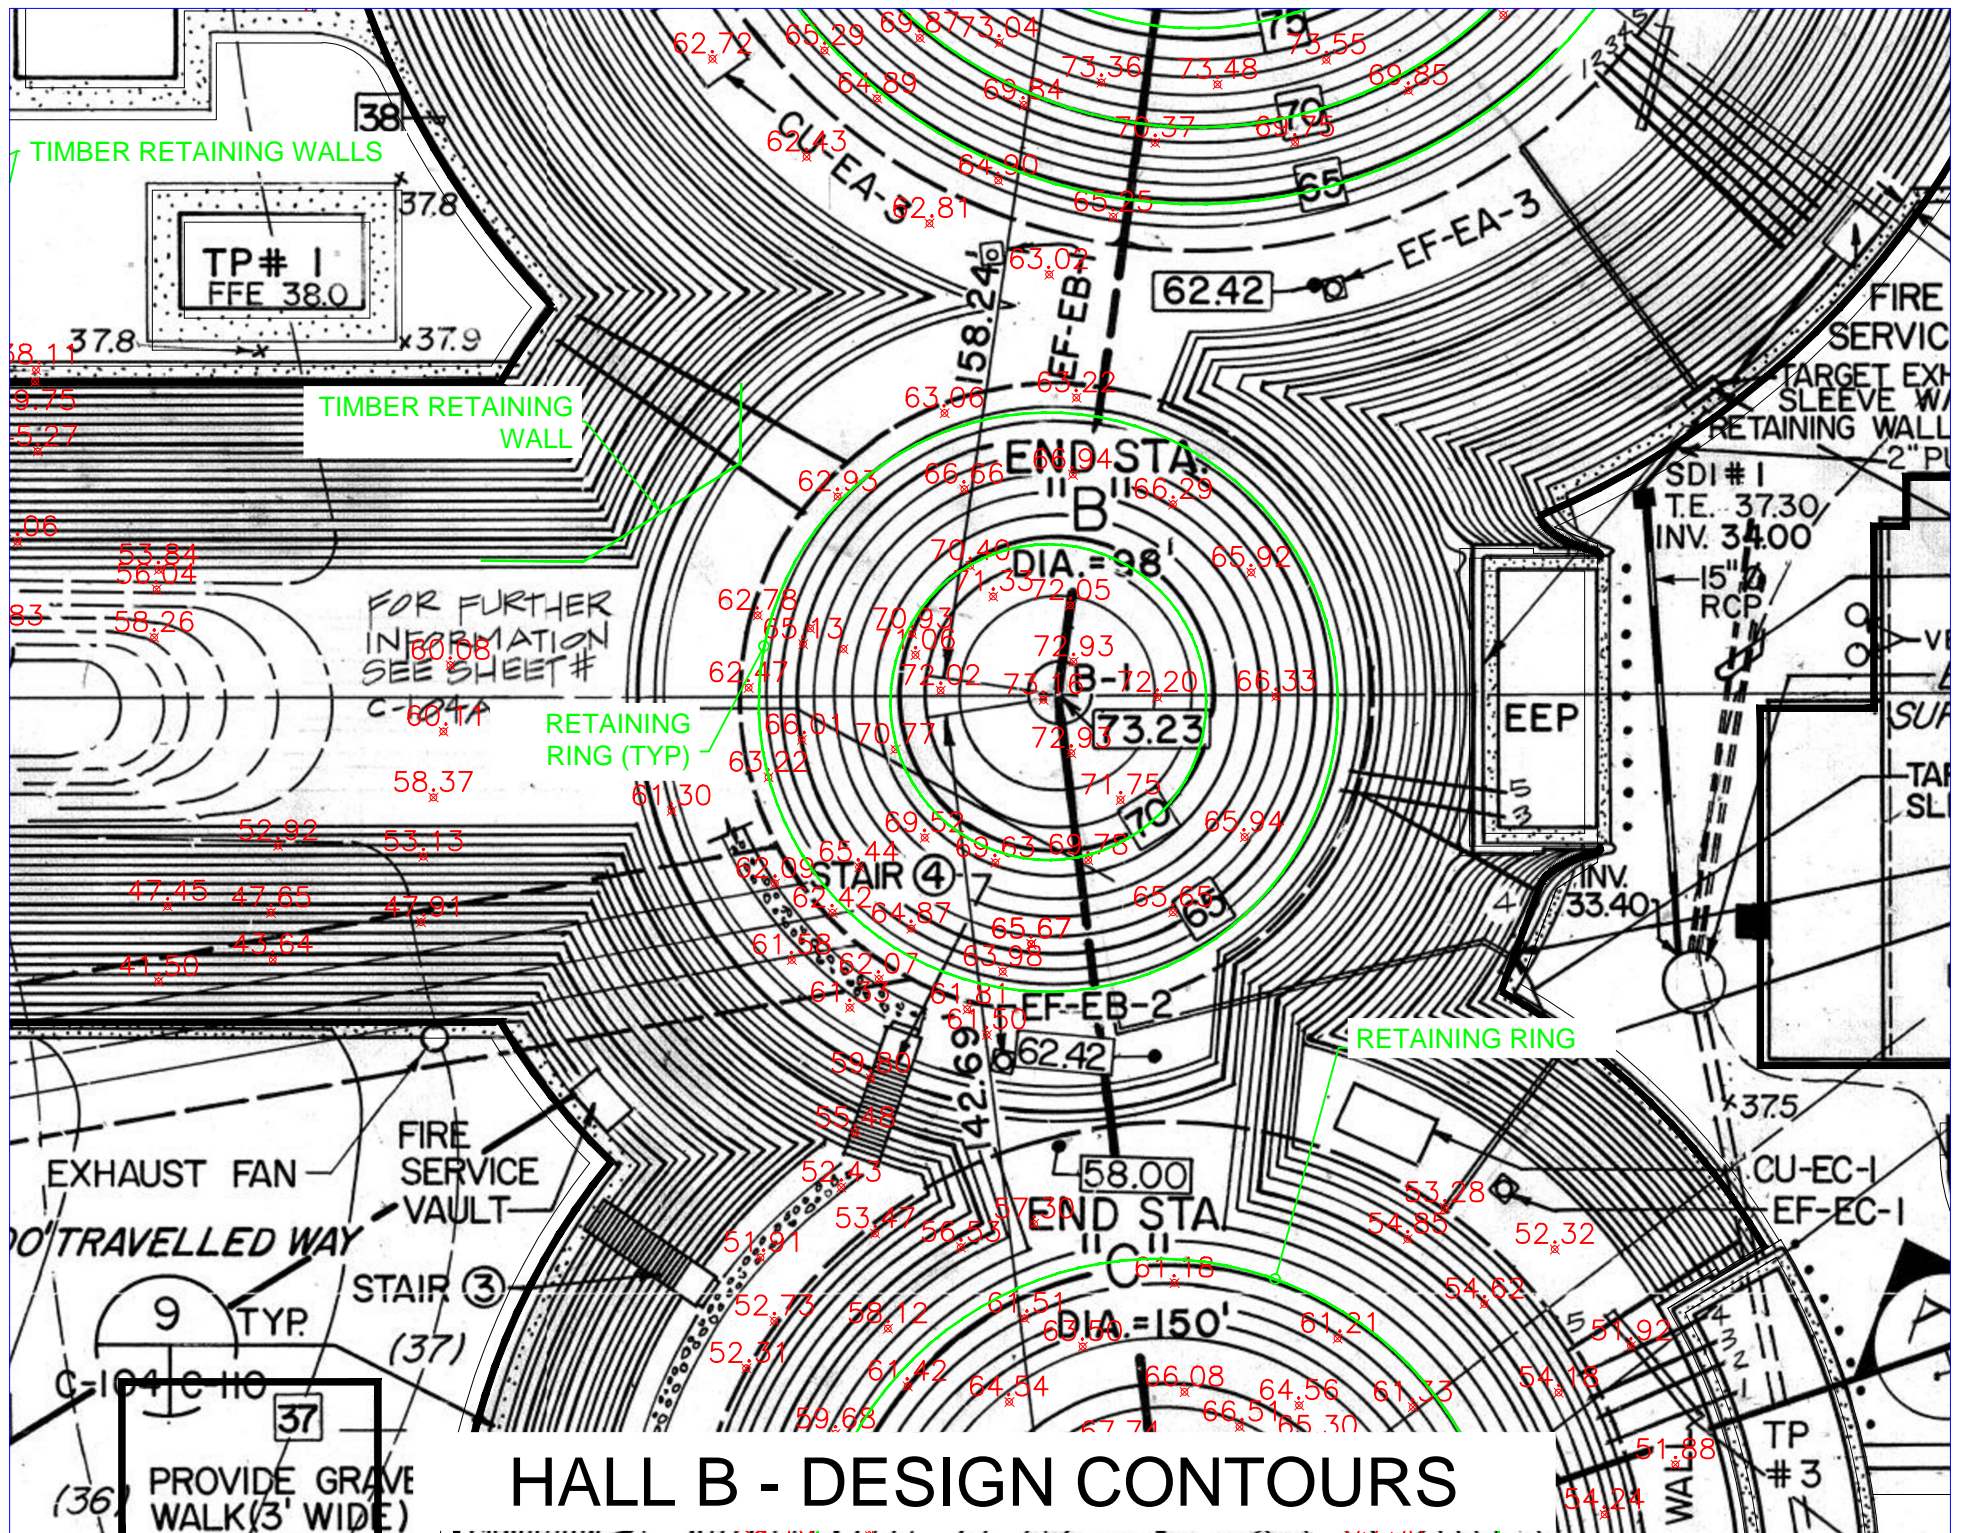
HALL B - DESIGN CONTOURS

End Station B: The entire dome is covered in heavy vegetation and there is no evidence in the observed elevations of any notable soil movement. Both soil retention rings appeared to be in good condition with little observed soil movement adjacent to either ring.

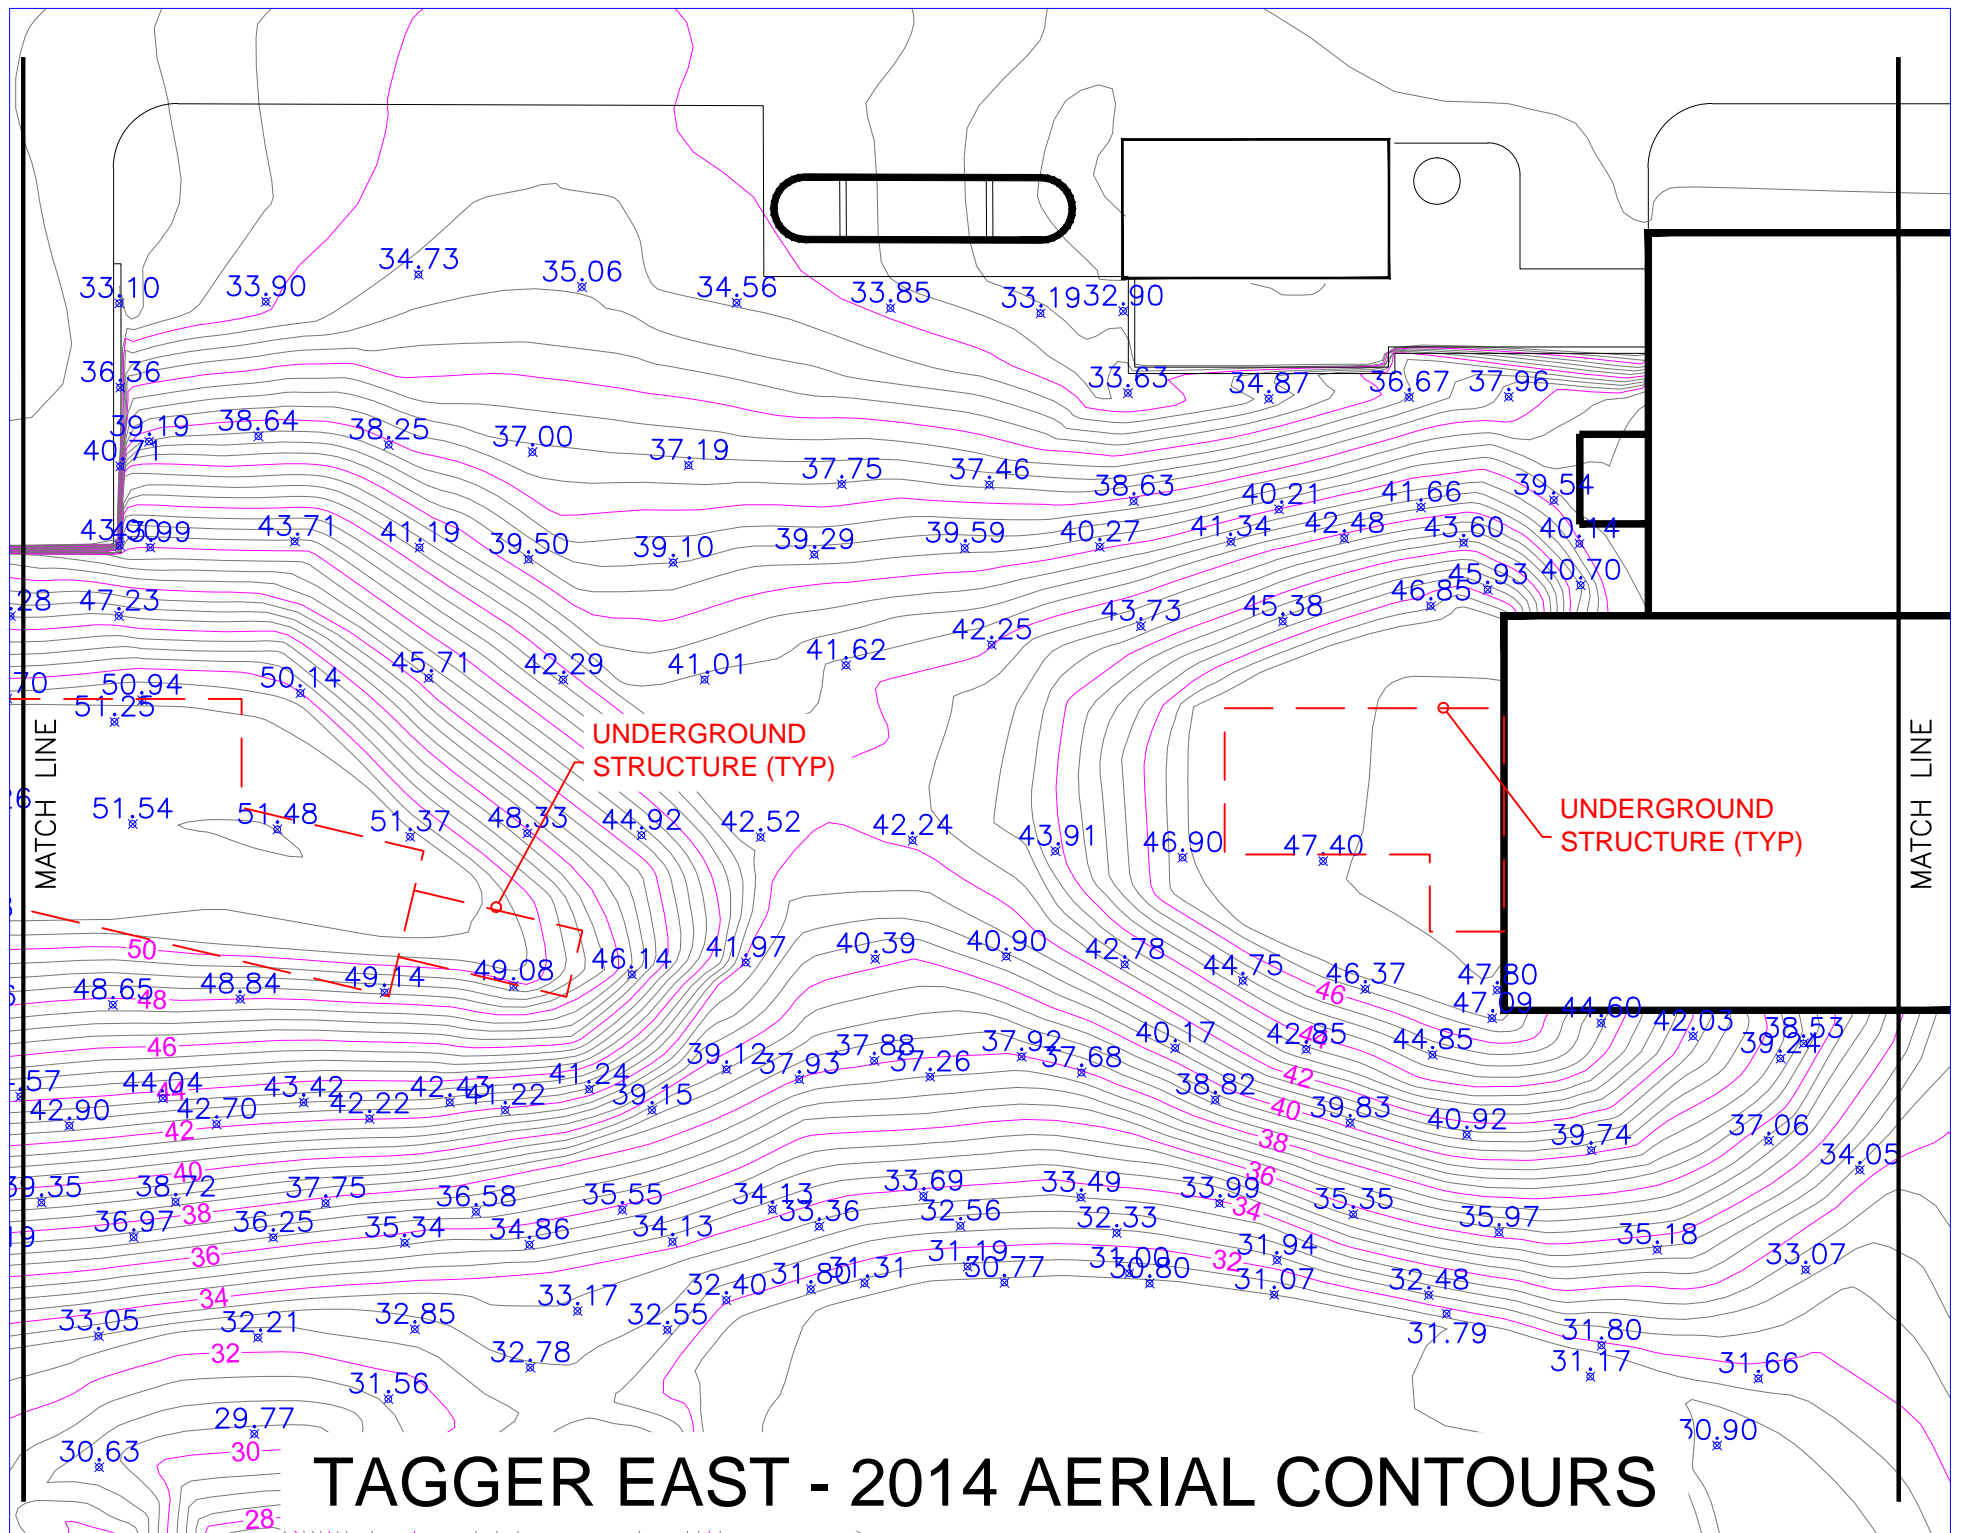
TAGGER EAST - 2014 AERIAL CONTOURS

Hall D Tagger Berm: The entire tagger berm is heavily vegetated and there was no evidence in the observed elevations of any soil movement. Retaining walls on the south side of buildings 200 and 201 were inspected and found to be in sound condition.

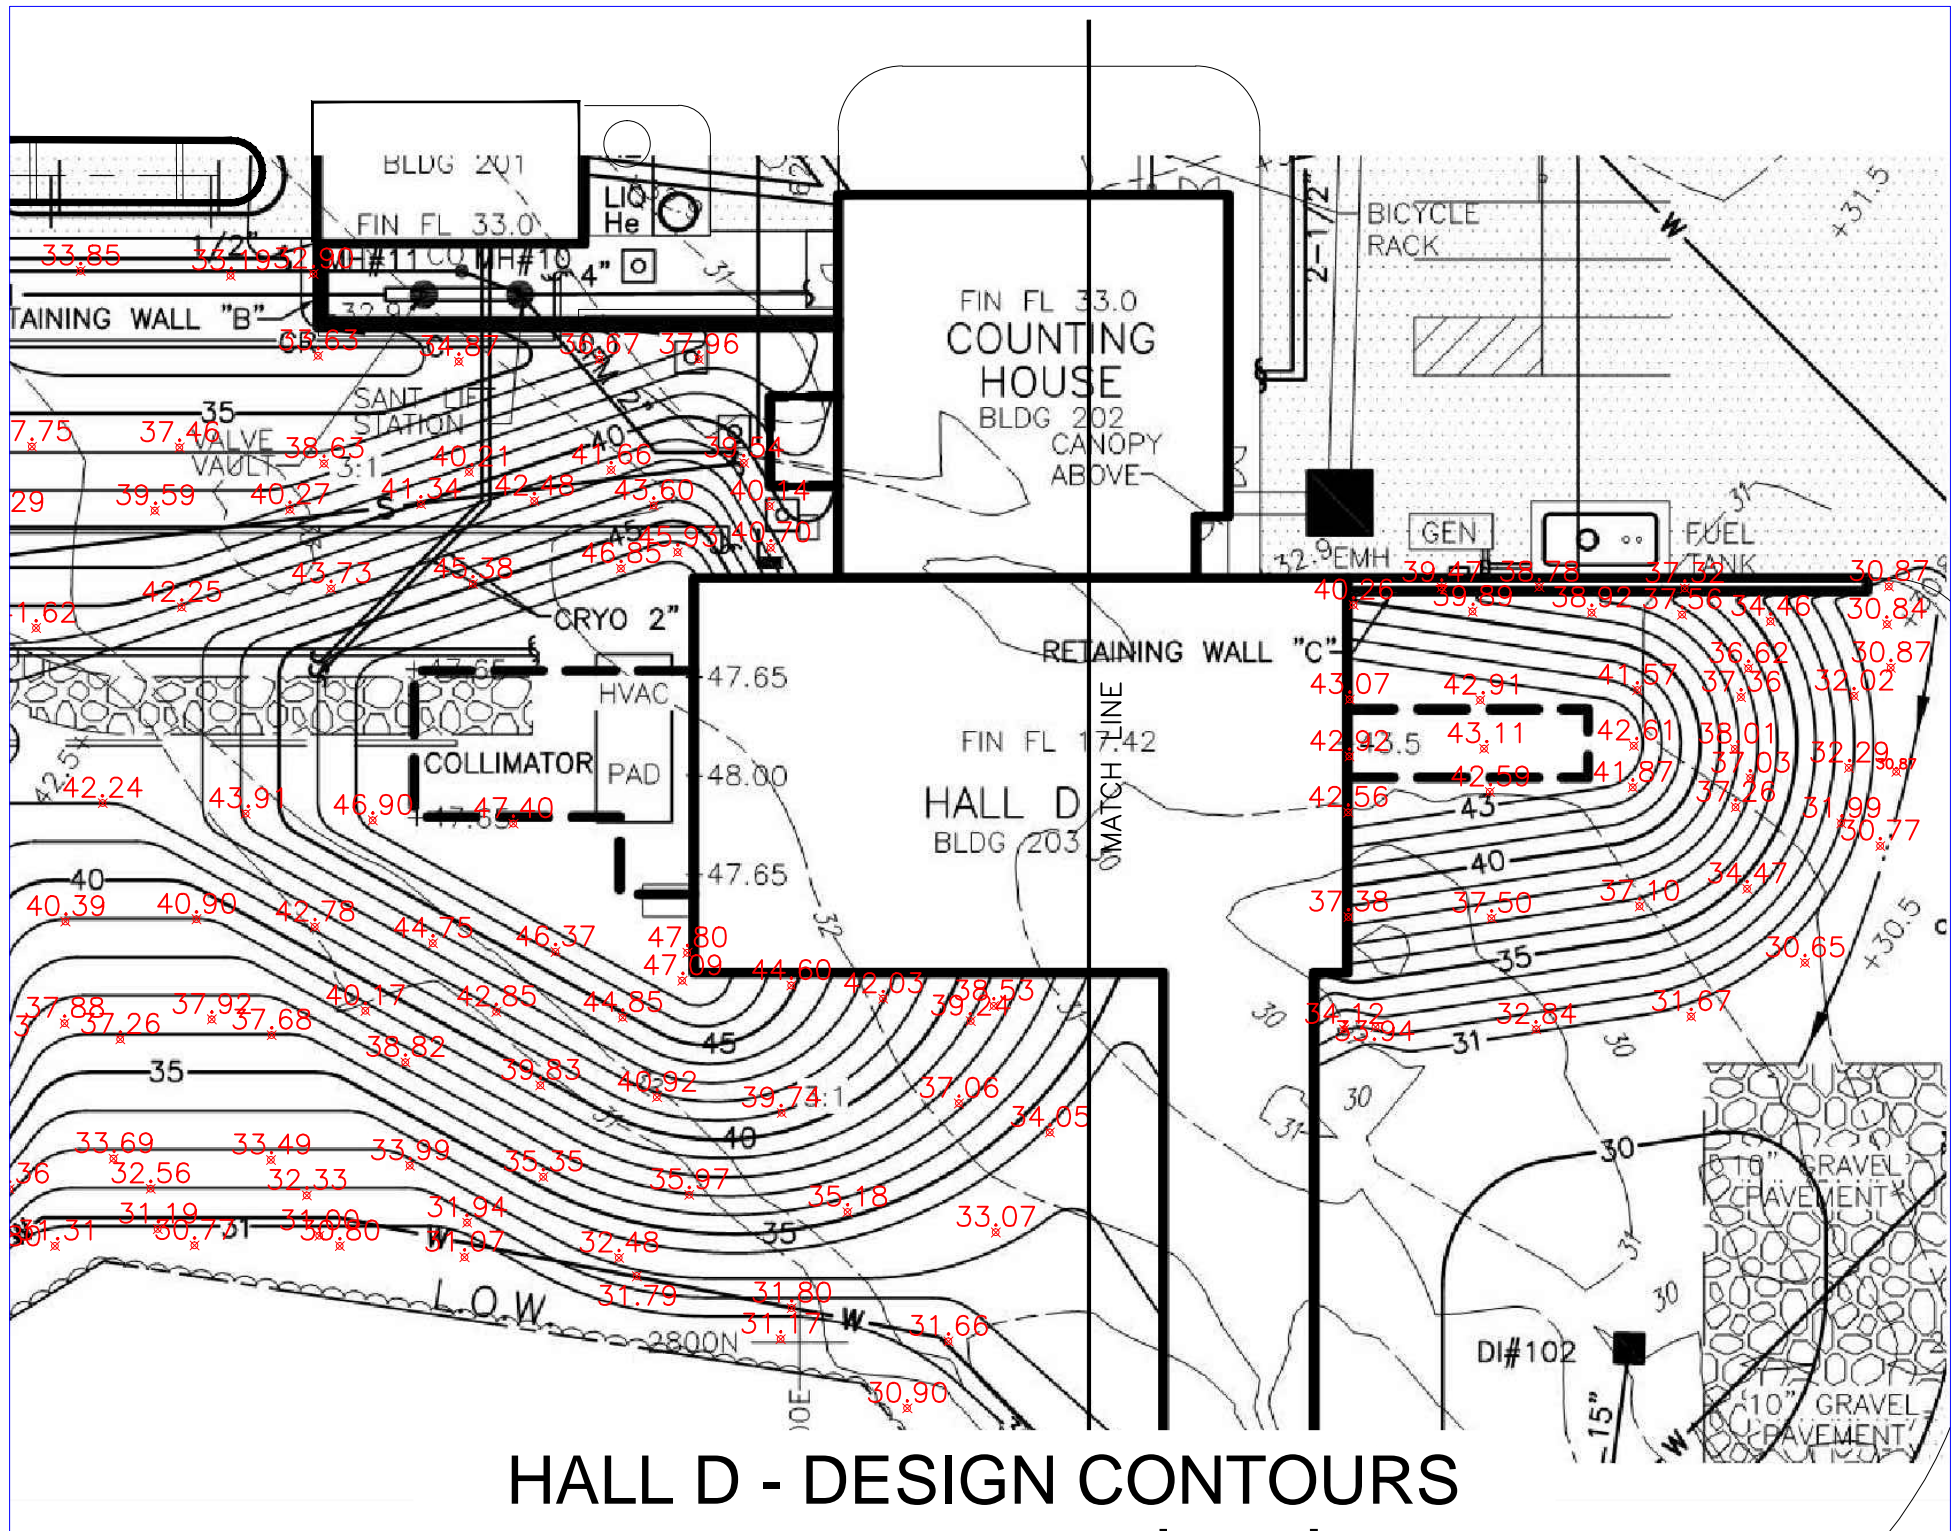
HALL D - DESIGN CONTOURS

Hall D Berm: The berm is heavily vegetated and there was no evidence in the observed elevations of any soil movement.
