## MSP430F2013 Device Erratasheet

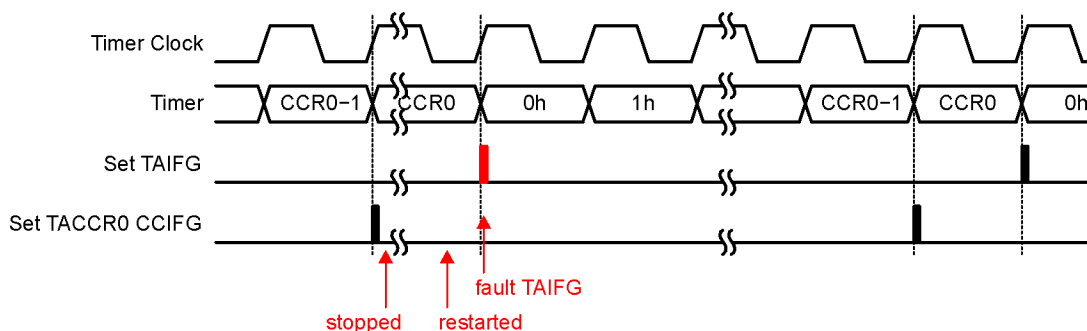
## TA21 *TIMER\_A Module*

<b>Function</b>	TAIFG Flag is erroneously set after Timer A restarts in Up Mode
<b>Description</b>	In Up Mode, the TAIFG flag should only be set when the timer counts from TACCR0 to zero. However, if the Timer A is stopped at TAR = TACCR0, then cleared (TAR=0) by setting the TACLR bit, and finally restarted in Up Mode, the next rising edge of the TACLK will erroneously set the TAIFG flag.

<b>Workaround</b>	None.
-------------------	-------
