INFN GEM Update:

5/12/21-5/18/21

TEDF Activities (May 12-18)

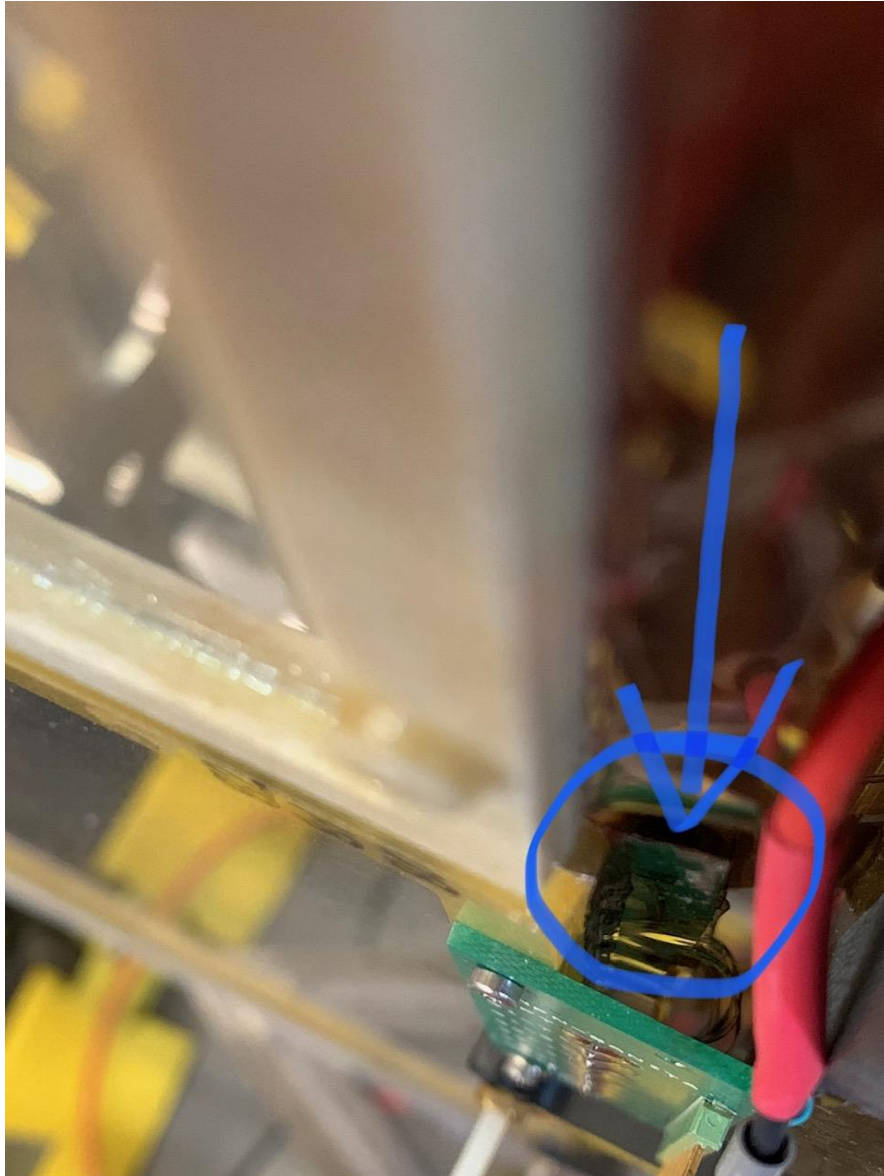
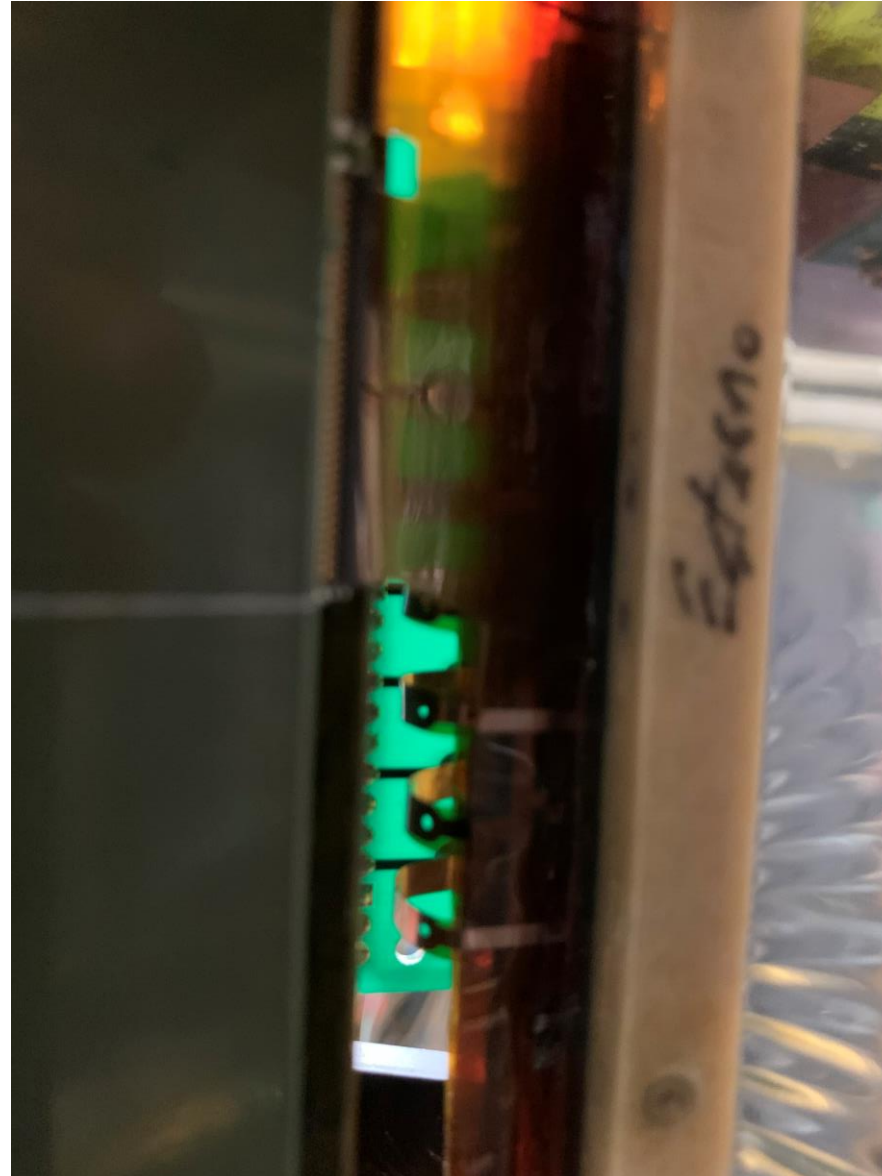
Build-up or Corrosion on HV Divider?: TEDF May 13-17

- HV board on lowest module of layer J0.
- On the Kapton flaps, looks like there may be some sort of build-up of material. Not sure what it is.
- From the other side it is kind of difficult to see.
- Could there be corrosion or material build-up affecting this arcing problem.

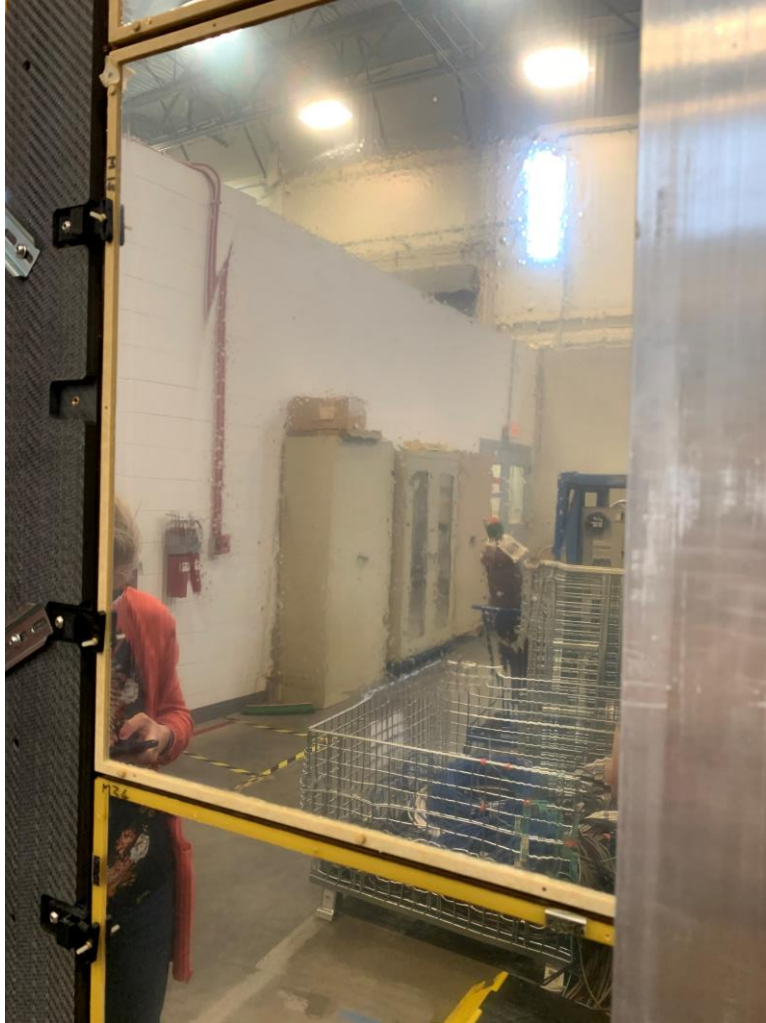
Middle Module J0

Also occurring on bottom module of layer J2. Texture pattern is more towards the center of GEM modules. As if goose-bumps have formed throughout the region. Only happened after turning HV on for a few days. Believed gas pressure was not strong enough to keep these apart.

What's going on: After turning on HV over the weekend electrostatic forces are present that have caused the exterior aluminized mylar to be attracted or connect to the drift foil. **This is not a good thing! Causes changes in data.**

Possible solution: Since the two foils are disconnected. Connect a 1 GigaOhm resistor between the top exterior aluminized mylar and the drift foil, in essence creating a small Faraday cage effect and then the two foils will not connect again. This exterior mylar is then at the same HV as the drift foil. This solution has already been implemented by UVa. This problem is not thought to appear for INFN modules when horizontal. Working with Jack to do this modification.

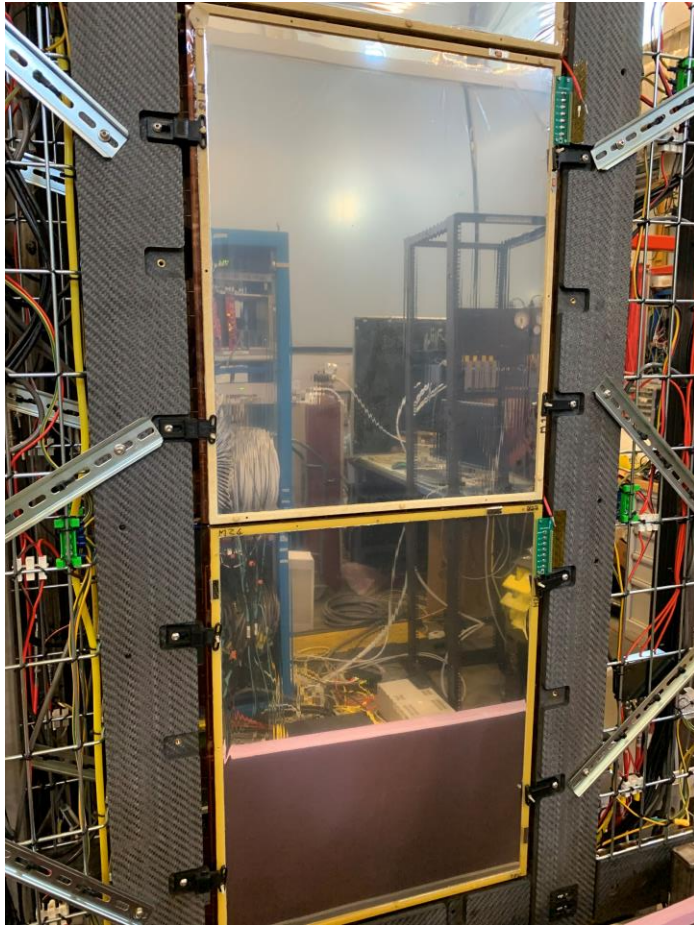
Bottom & Middle Module J0

Exterior Aluminized Mylar of GEM Windows Good: TEDF May 17

What Changed?: Measured the resistance between the exterior mylar and the drift foil. Based on how the multimeter works to measure resistance, by sending a small amount of current to determine an impedance. This effectively discharged the two foils and removed any electrostatic forces that influenced the shape of the external aluminized mylar.
