INFN GEM Update:

Hardware Update

11/18/20-11/23/20

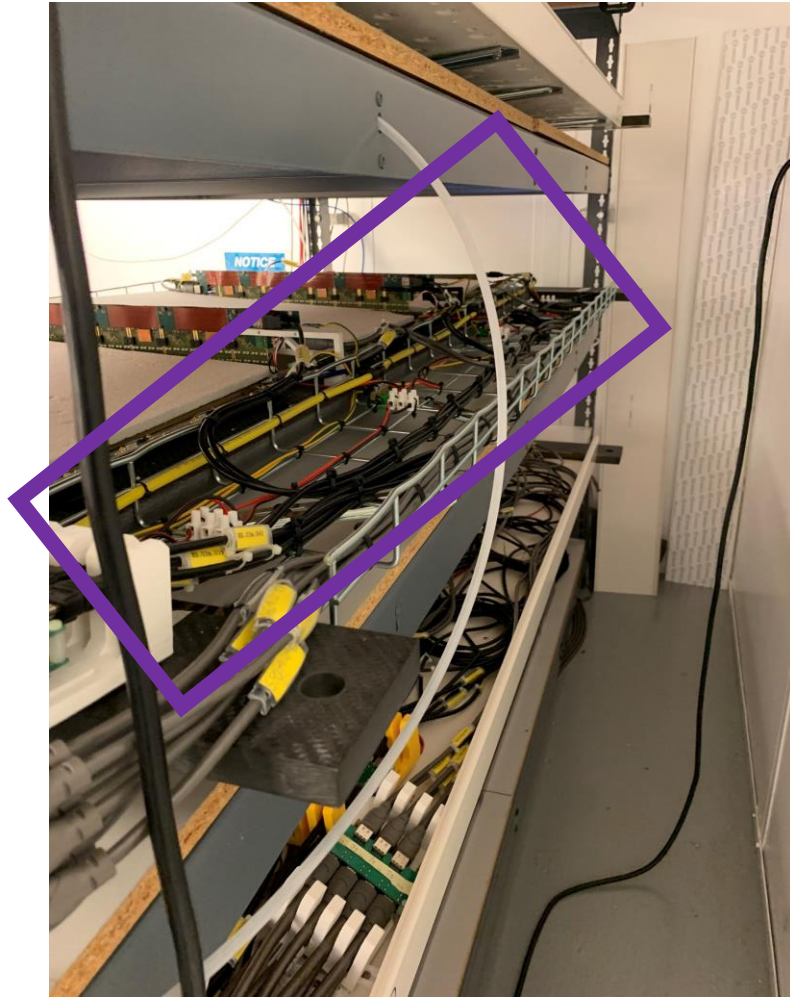
Cable Trays Replacement Progress (Nov. 19)

- There are a few noisier cards on each MPD for MPDs 3-6. These are actually due to a problem with the connection between Kapton Fingers and the APV card. I looked at a few of the connections.

From top to bottom door side: J4 (metal and not pictured), J3 (plastic), J0 (metal), J2 (plastic).
Priority is J0 and J2, since best chambers

- Conclusion, this cable tray replacement was successful. But we need to fix these Finger-Card disconnection which occurred during the replacement.
- Serves as a learning experience for me in replacing cable trays.

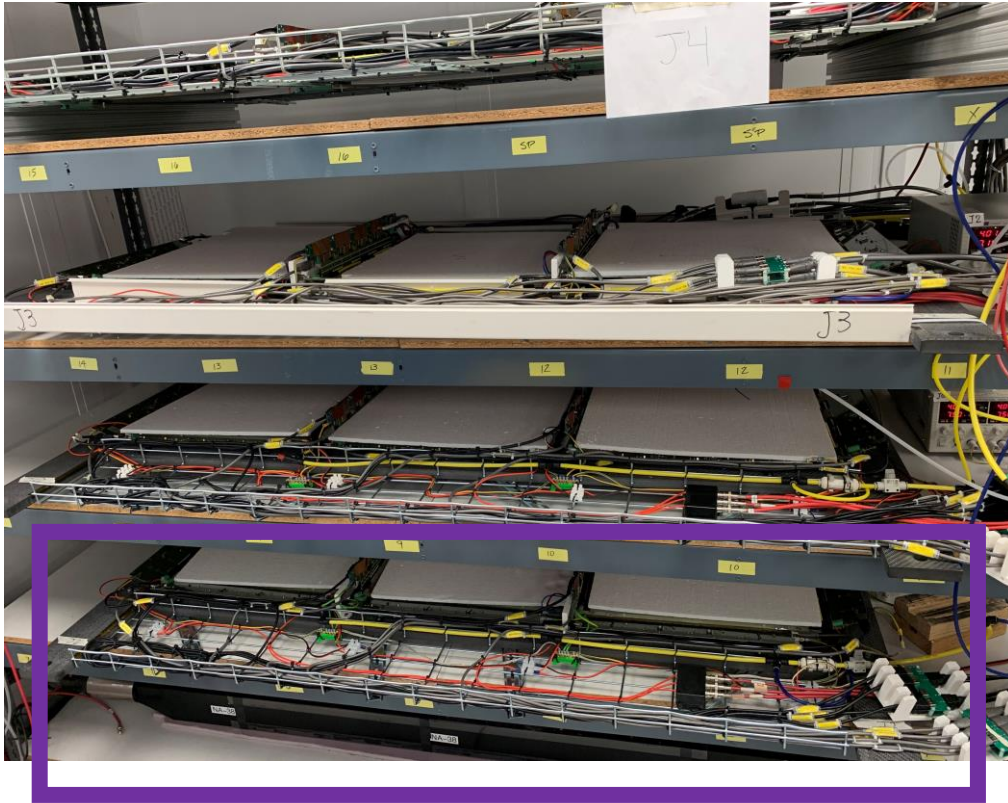
Cable Trays Replacement Progress (Nov. 23)

From top to bottom DAQ side: J4 (metal), J3 (plastic), J0 (metal), J2 (metal). Priority is J0 and J2, since best chambers

- Replaced DAQ side cable tray for chamber J2, plastic to metal.
- Reconnected all cables and tied cables in place with cable ties.
- This cable tray contains cables for electronics connected to MPDs 11-14.
- Checked multiple iterations of Low Level Histo Plots (Amplitude vs ADC value) and unplug/replug cables until plots show nominal behavior.
- Investigating Pedestal plots (Run 189-193), most individual plots looked similar to previous pedestals under similar conditions. Conditions: HV= 0 V, N2 flushing, ~3000 events.
- There are a few noisier cards on each MPD for MPDs 11-14. These are most likely a connection issue between Kapton Fingers and the APV card.
- Conclusion, this cable tray replacement was successful. But we need to fix any Finger-Card disconnection which occurred during the replacement.
