Department **PHYSICS**  
Subject **WANG DIPOLE**  
Name **SCOT L. SPIEGEL**  
Address **CEBAF / HALL A**

# WANG CIRCUIT CARD VOLTAGE CONDITIONER

# WANG QUENCH PROTECTION

WANG  
INTERLOCKS  
CHASSIS

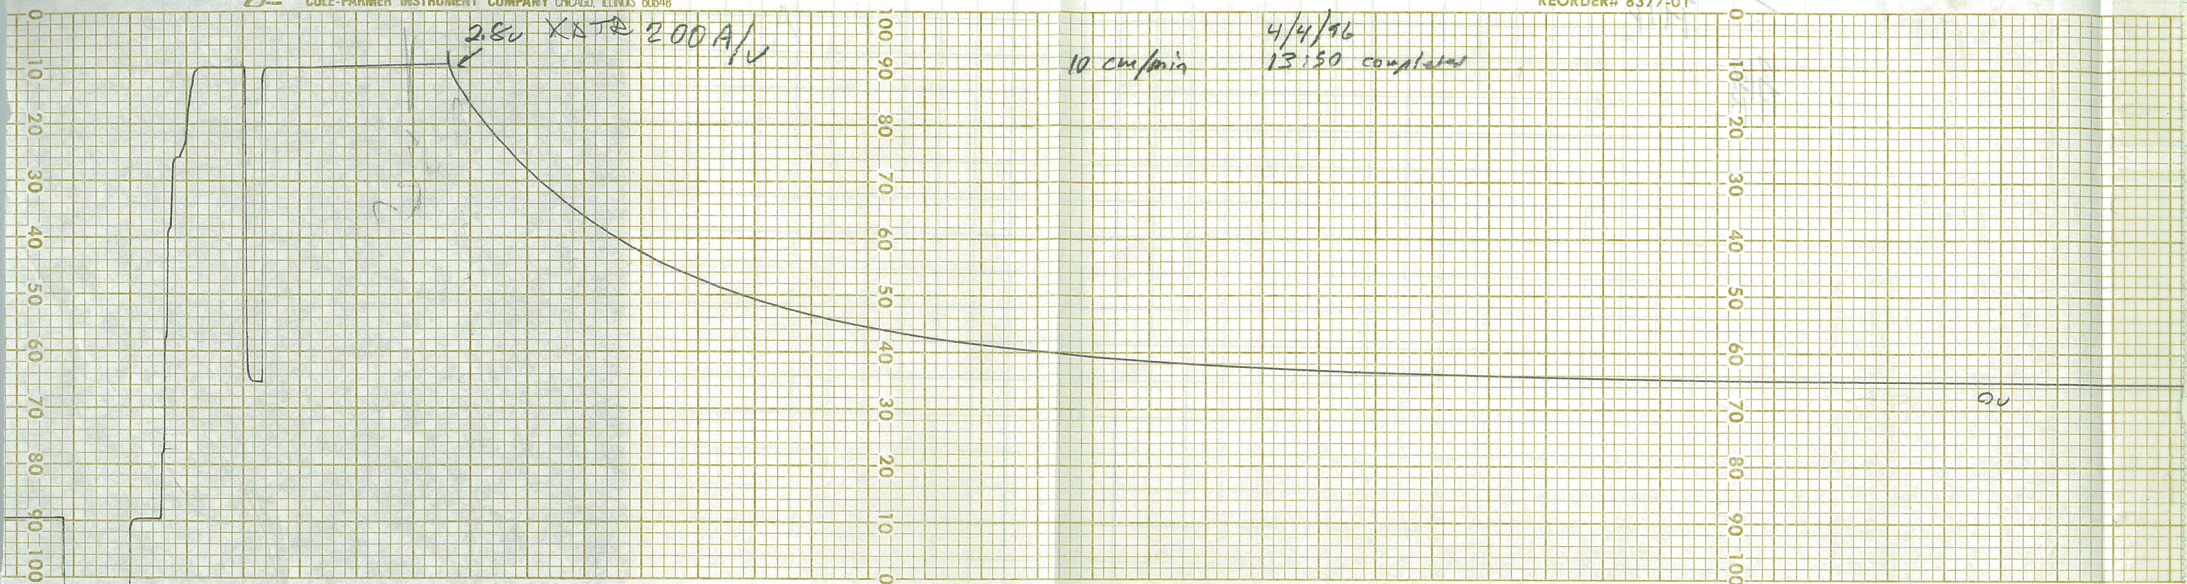
1430 A-lead flow trip  $\rightarrow$  fast dump full 1K  
reset and start again to 600 A

1550 made artificial fast dump by  
removing interlock connection  
on power supply.

max voltage ~ 6V.? @ 562 A.

Lead A fault noted - probably  
due to fast dump.

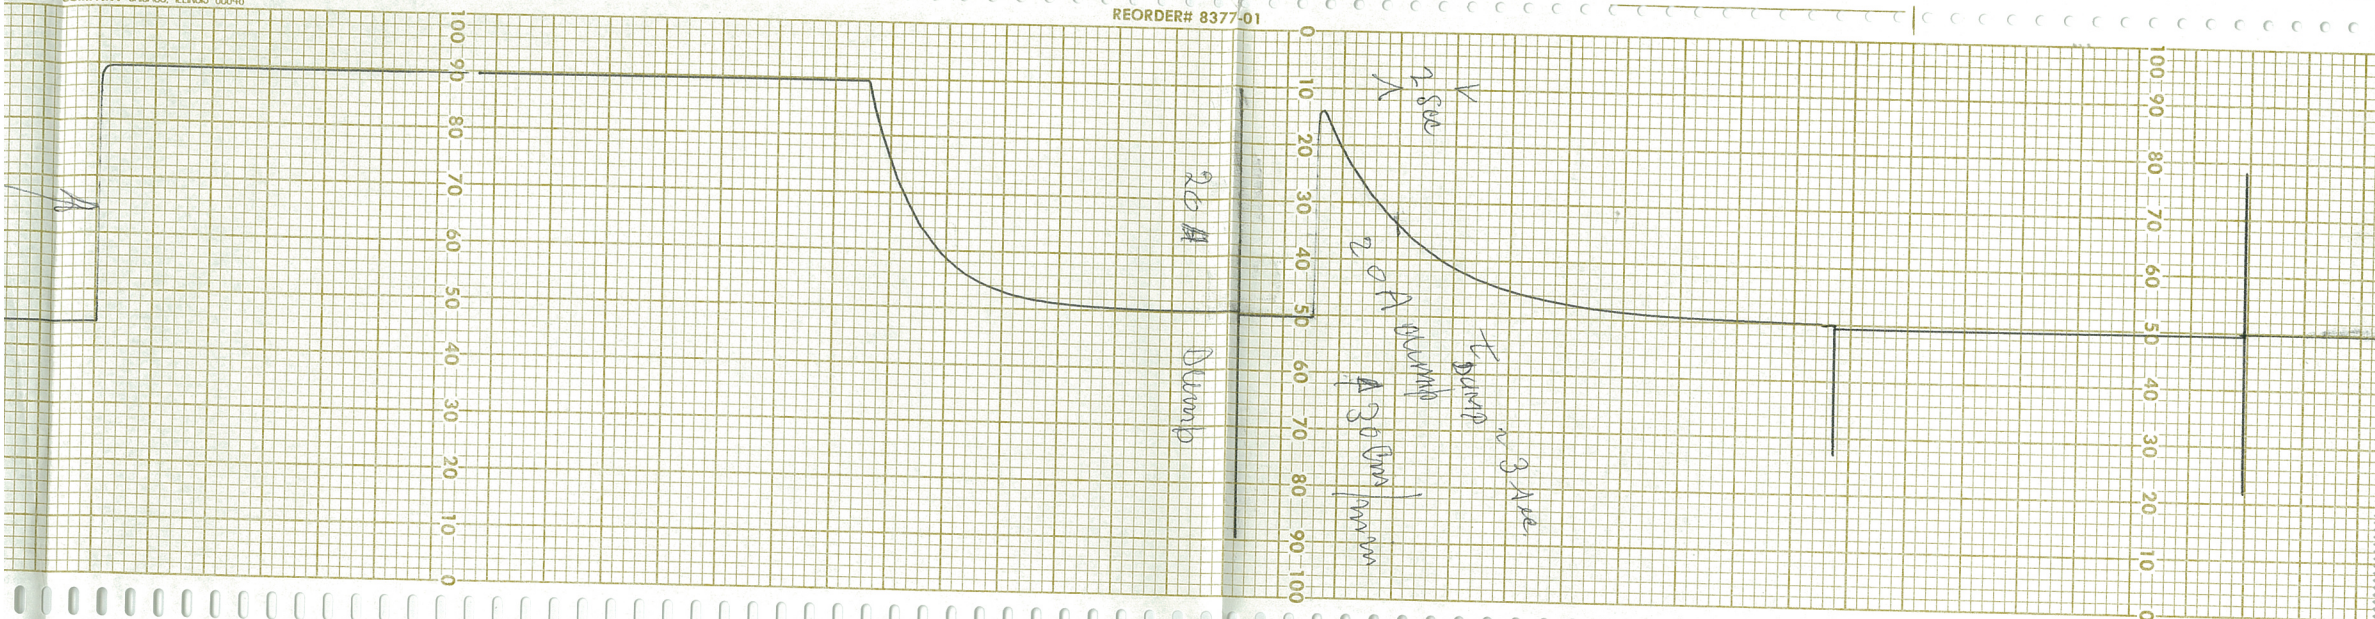
1200 Ran at 400 A

Did dump at 20A + other test

T<sub>1</sub>  $\sim$  3 sec

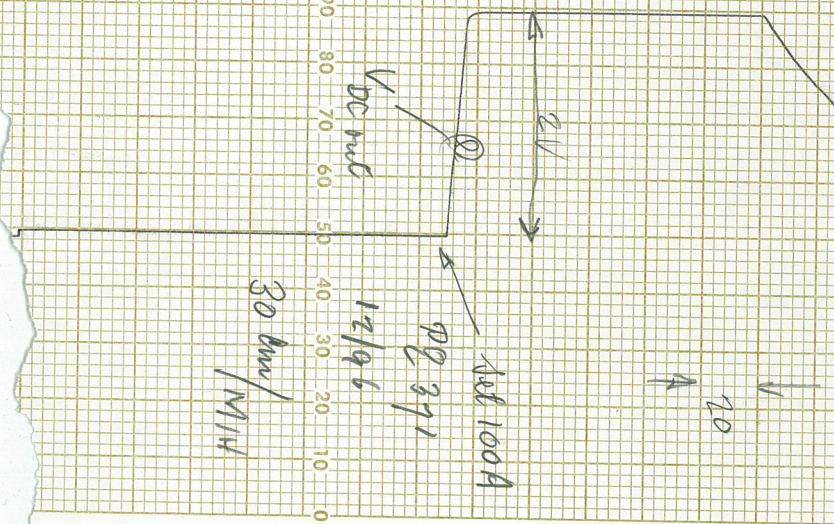
Set 100A

30 mm/MIN

1/DC out

(No dump)  
from  $I_{DC} = 100$   
to  $I_{DC} = 0$

20 A  
fast response  
manually damped

1/8  
damp  
3 sec
