# Progress in lead glass cleaning with UV

# GOAL (reminder)

We need to prove that periodic UV irradiation of more than 1744 lead glass bars is a viable option to maintain a given level of transparency during the 150x8h shifts of GEp(5)

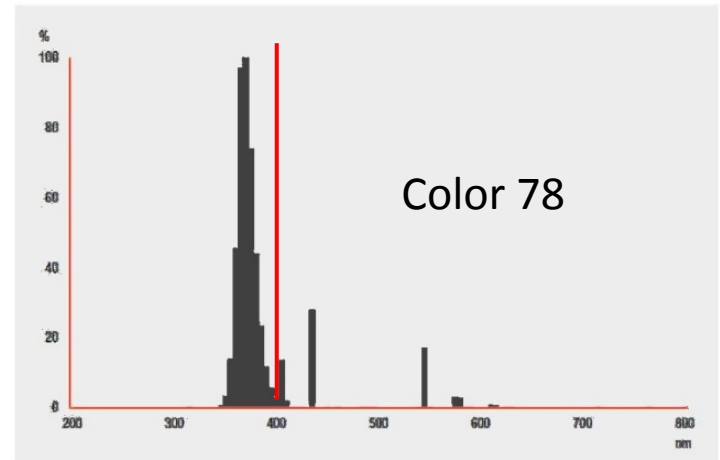
### DULUX L 18W/78

Power = 18W

UVA (315-400 nm) = 3 W

Length = 225 mm (without ballast)

Radiation Intensity = 1.5 W/m<sup>2</sup>

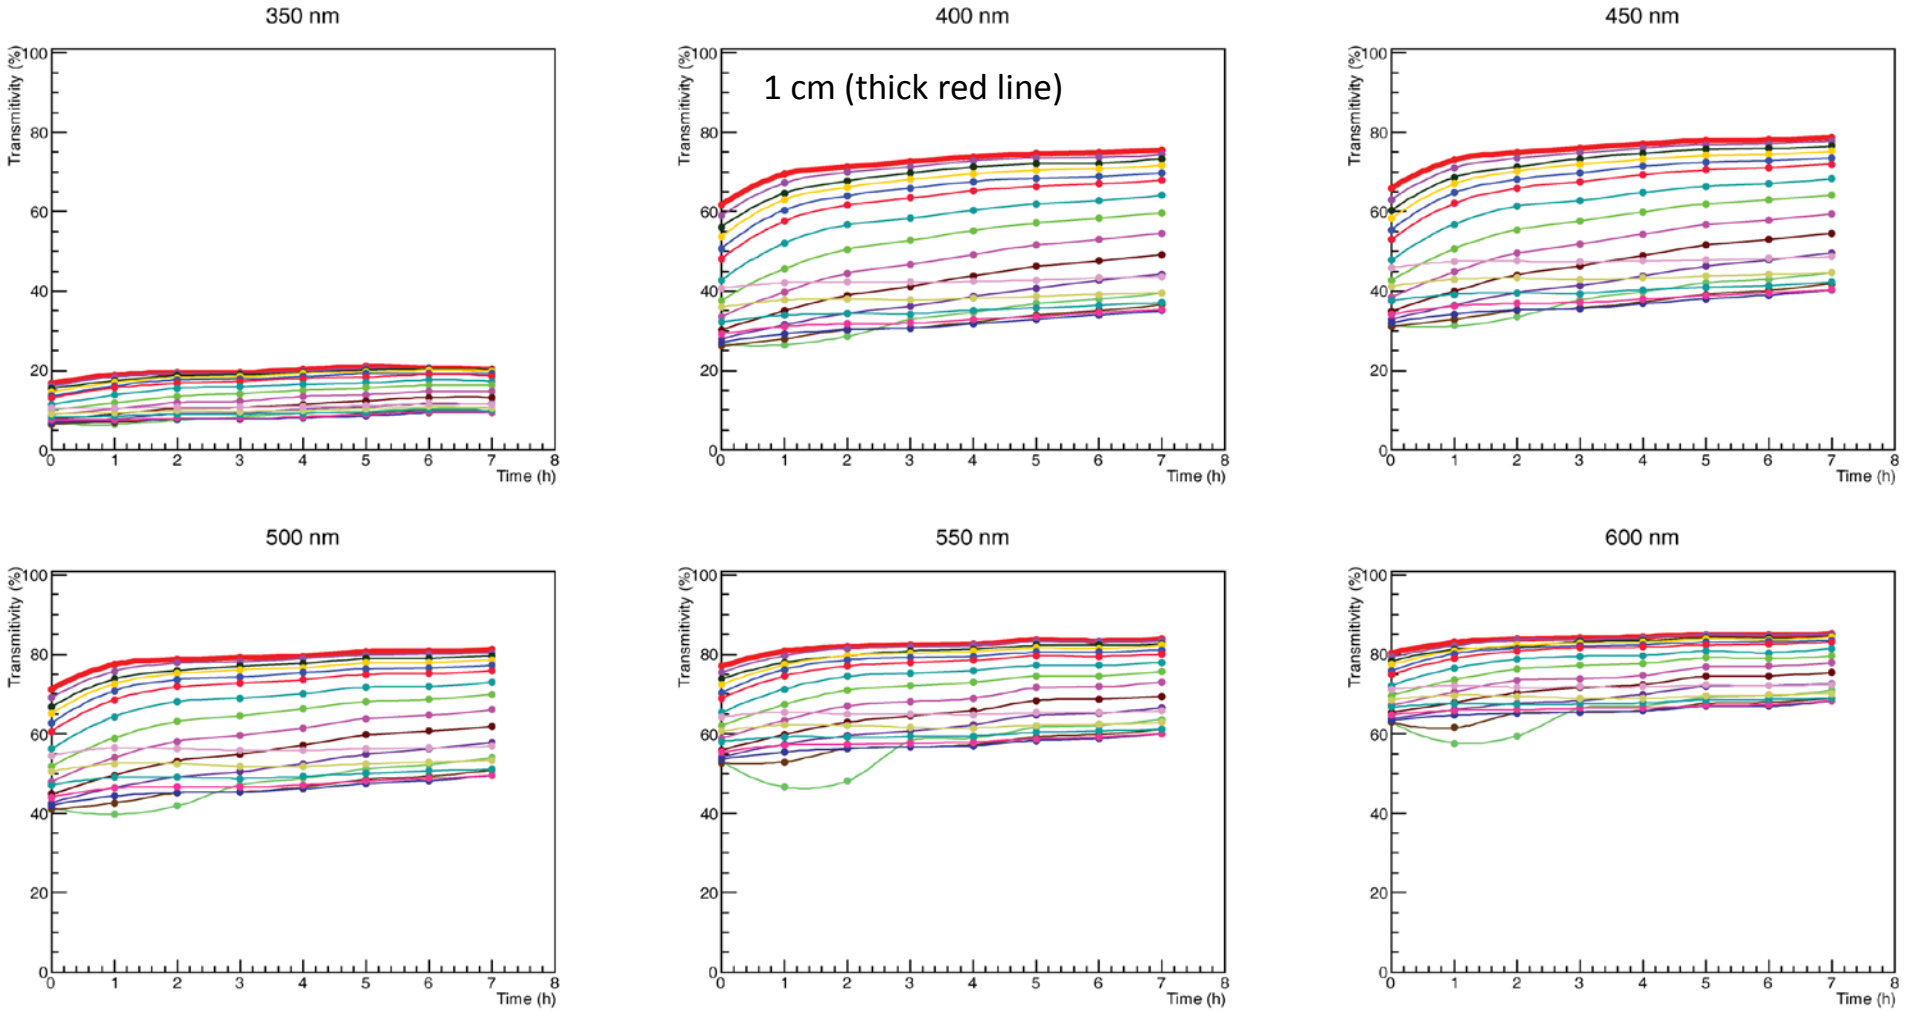
Transmittance vs time (session) (6 wavelengths, each line 1 position)

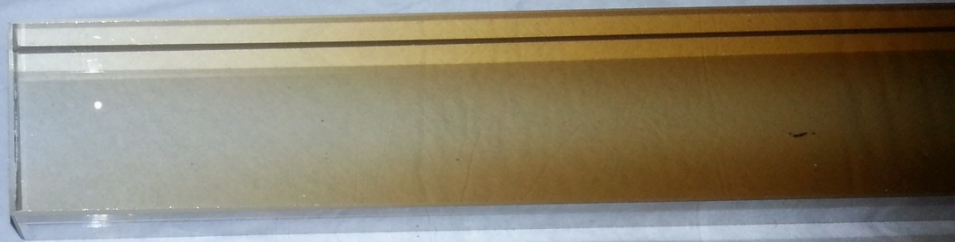
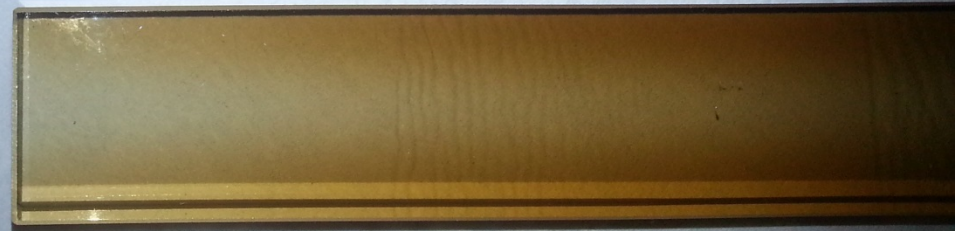
IDAHO 06

After 1 hour with UV light

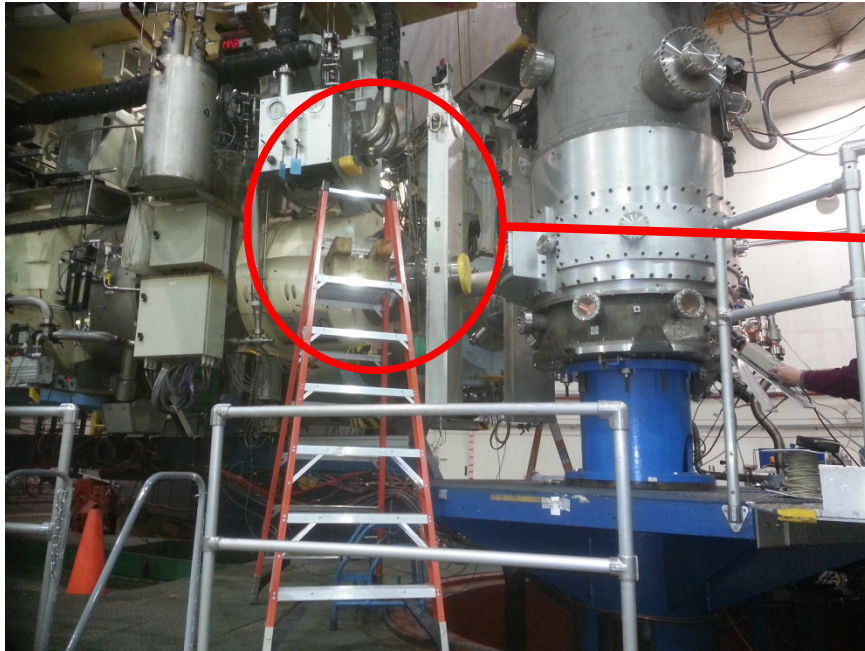
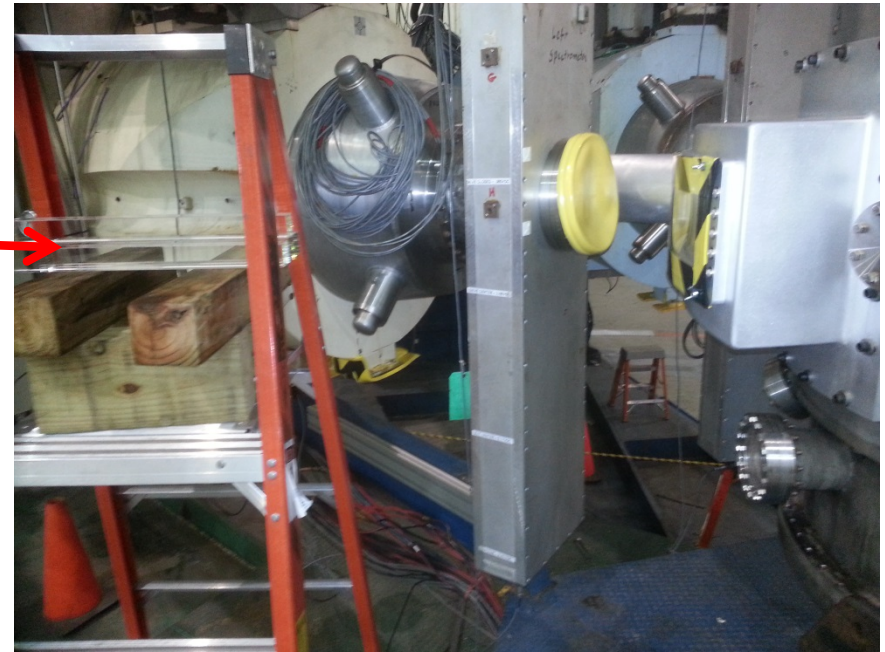
4 bars were placed close to the scattering chamber in Hall A, in order to exploit the radiation from target to damage the bars
