INFN, silicon tracker status

Silicon microstrip detector design

The SBS silicon tracker X and Y planes

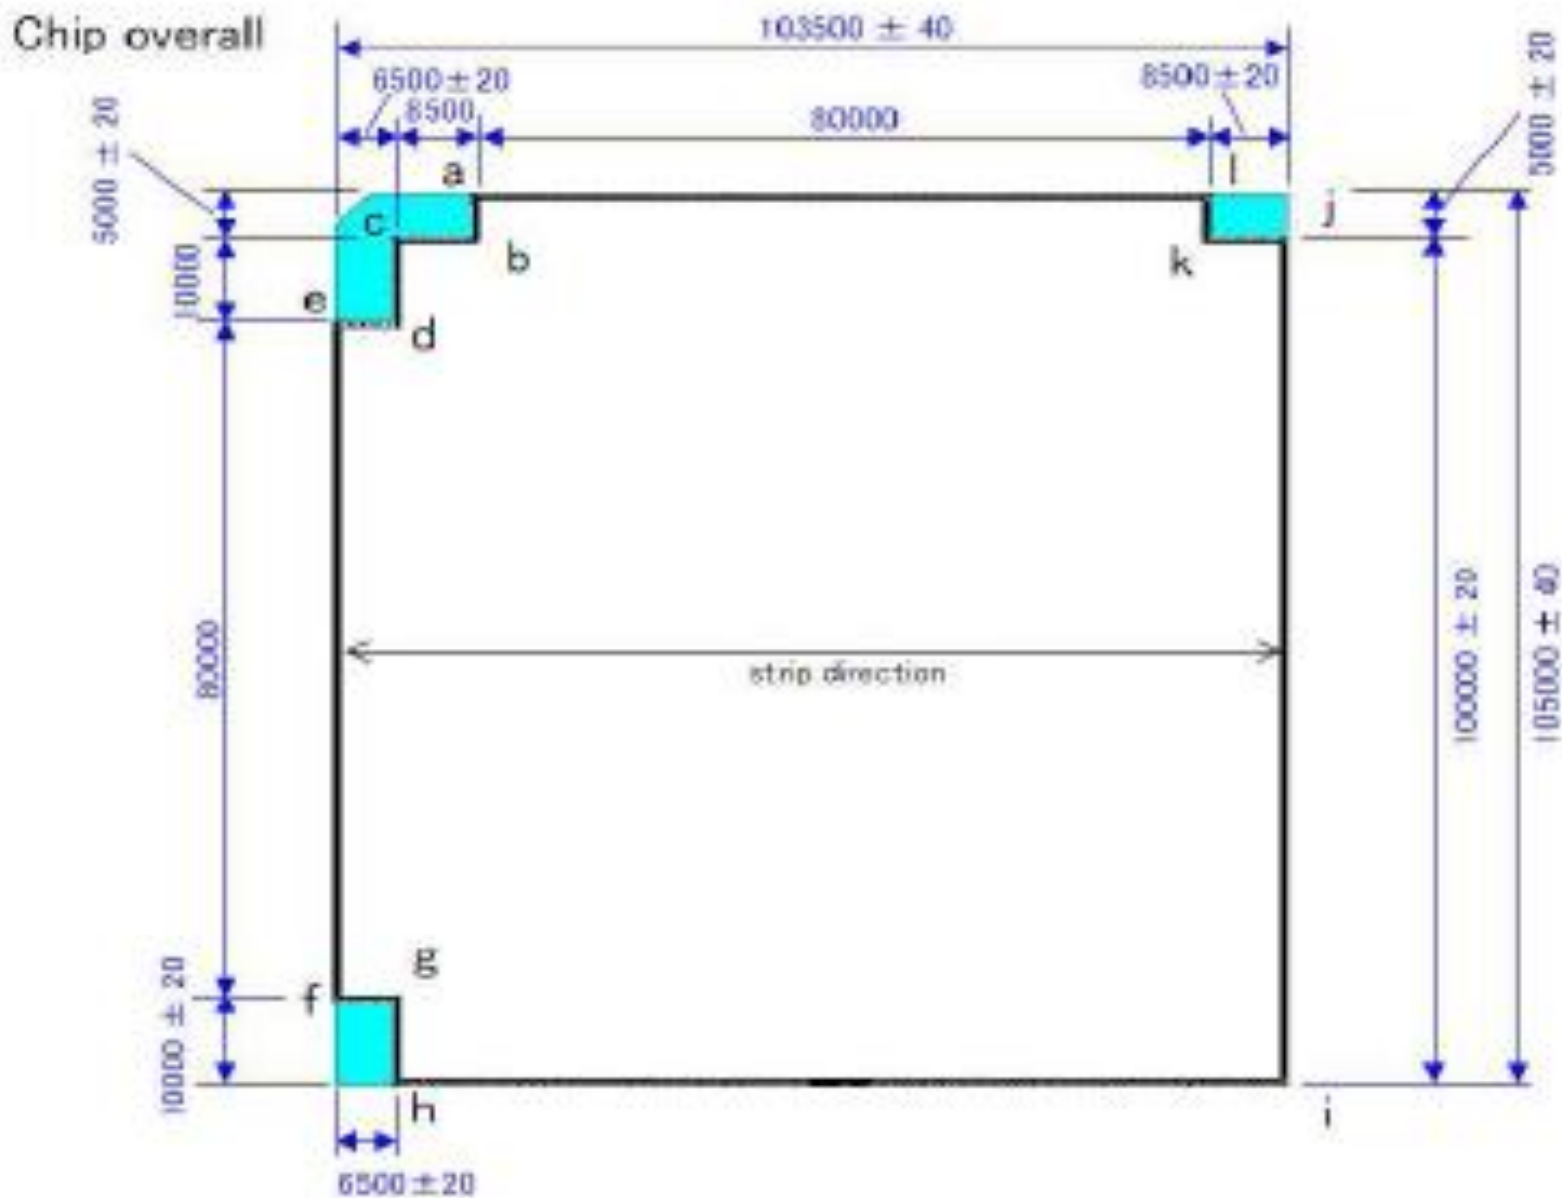
number of strips : 2070
strip length : 78500 (No. 1-100)
strip length : 95500 (No. 101-300)
(No. 1871-2070)
strip length : 102000 (No. 301-1870)

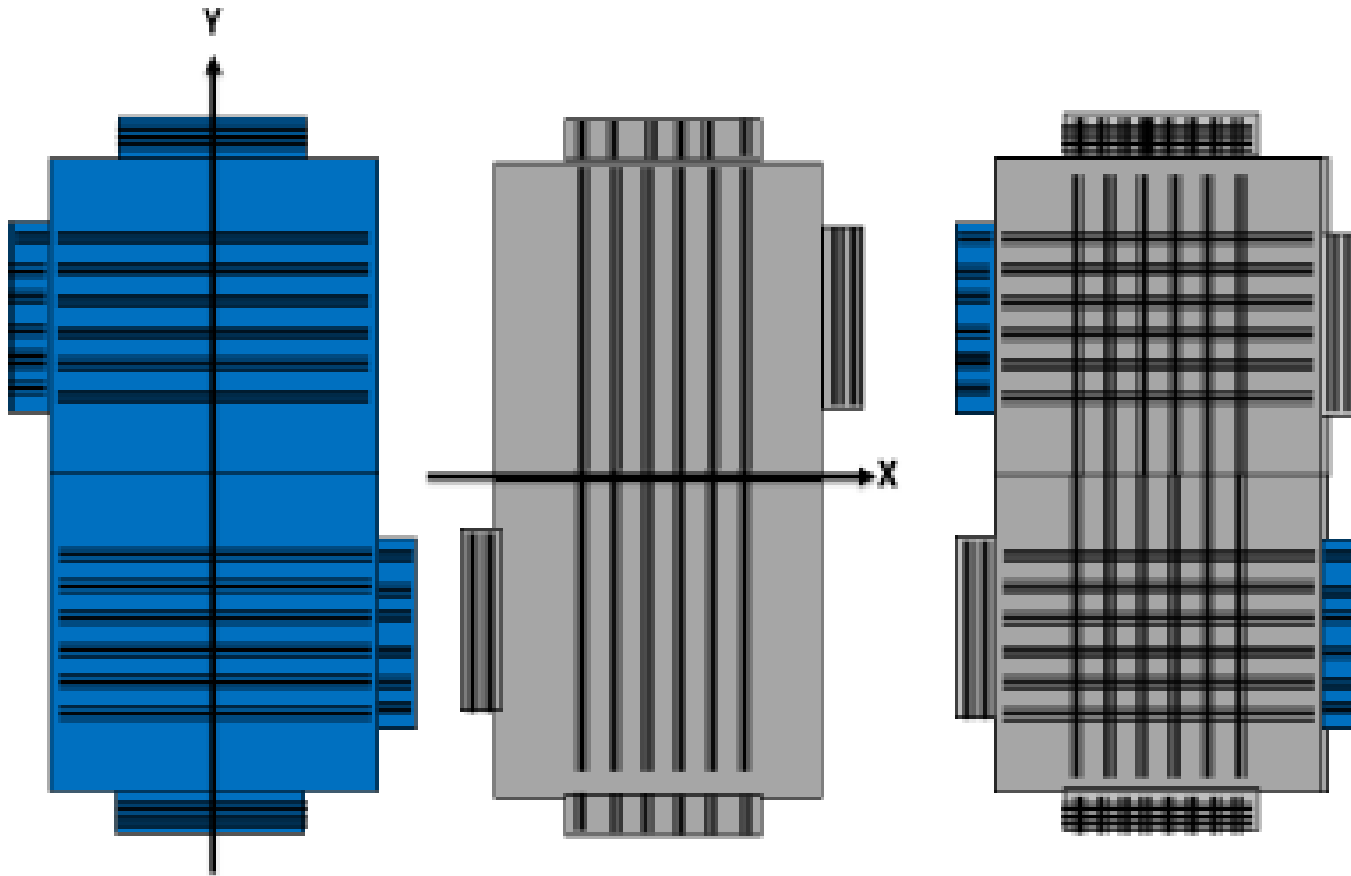
Four identical silicon microstrip detectors build up the SBS silicon tracker X and Y planes. Each plane is build up by two silicon microstrip detectors properly rotated and constituting each half a plane.

Two different kind of PCBs for the X and Y half planes respectively.

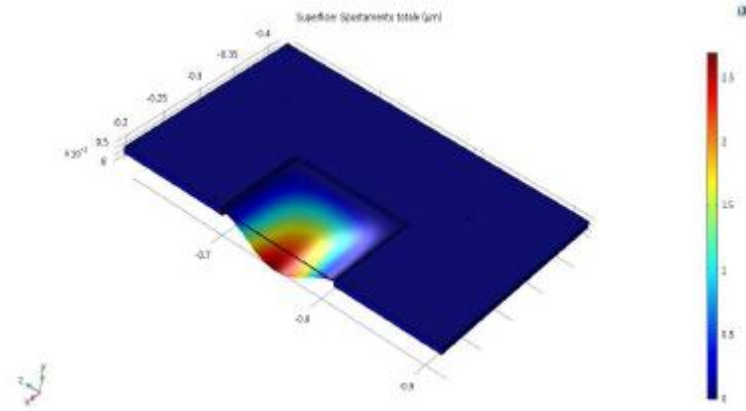
Computer simulations of **detector + PCB assembly deformations during wirebondings**

No effects of bad handling and/or wirebonding stresses on our PCB + detector assemblies resulted by computer simulations.

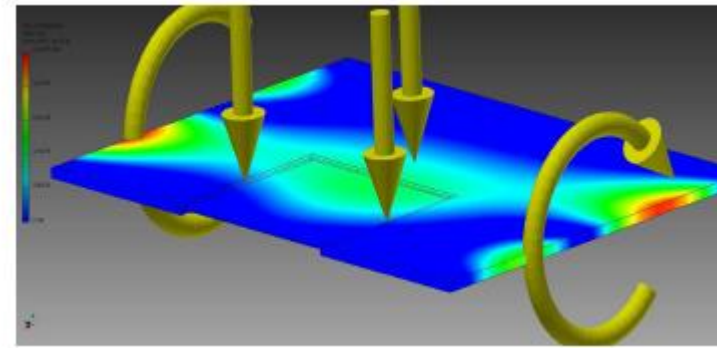
Computer simulations of **detector + PCB assembly deformations caused by handlings**.

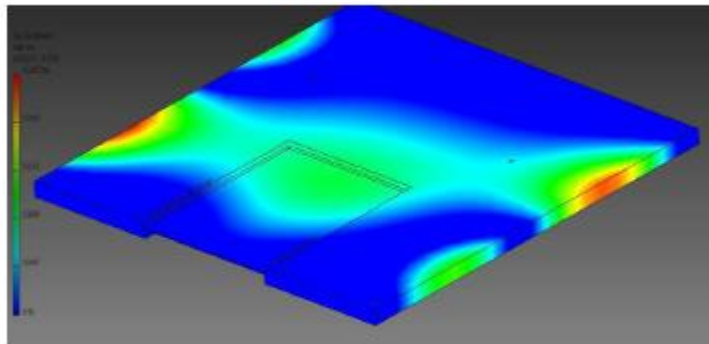
Cumulative effects of wirebondings and handlings.

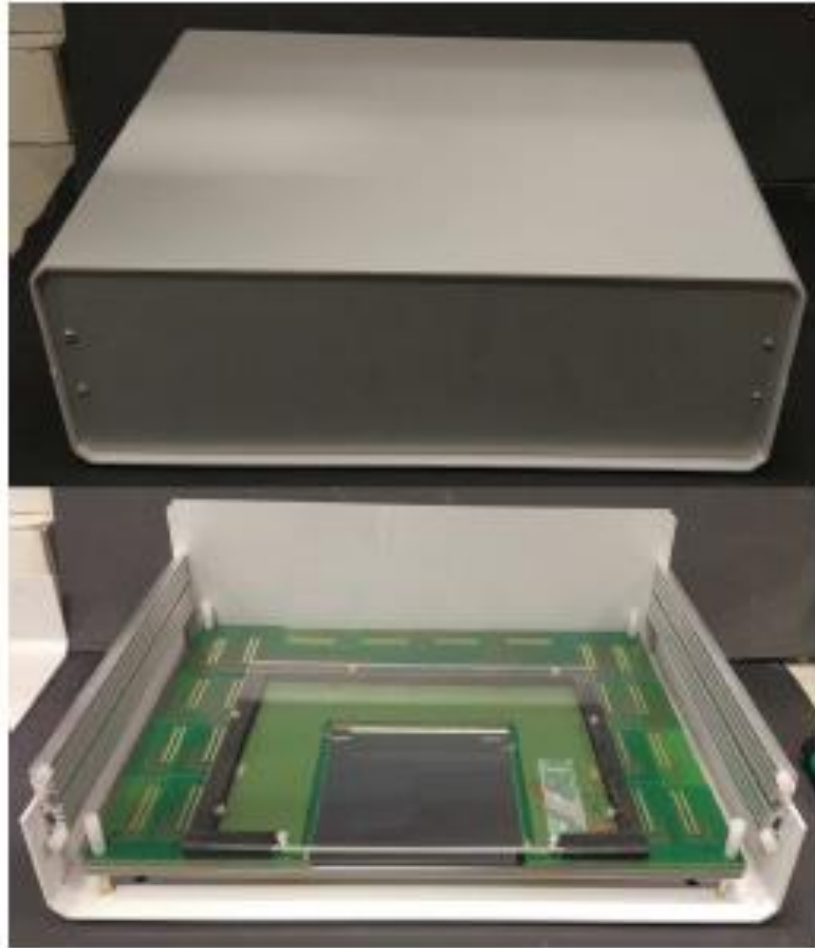
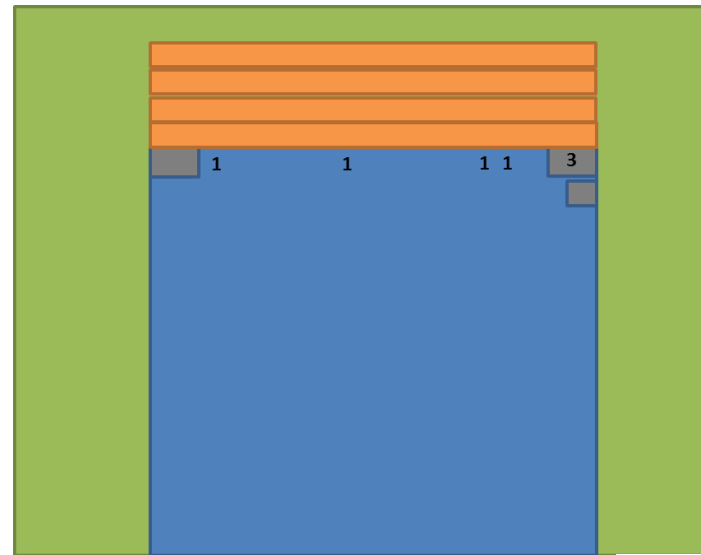
New Transport system successfully tested for transportation from Bari to Rome (≈ 430 km)

Broken wirebondings: (out of 5500)
patch = 3
Silicon = 4
PCB = 0

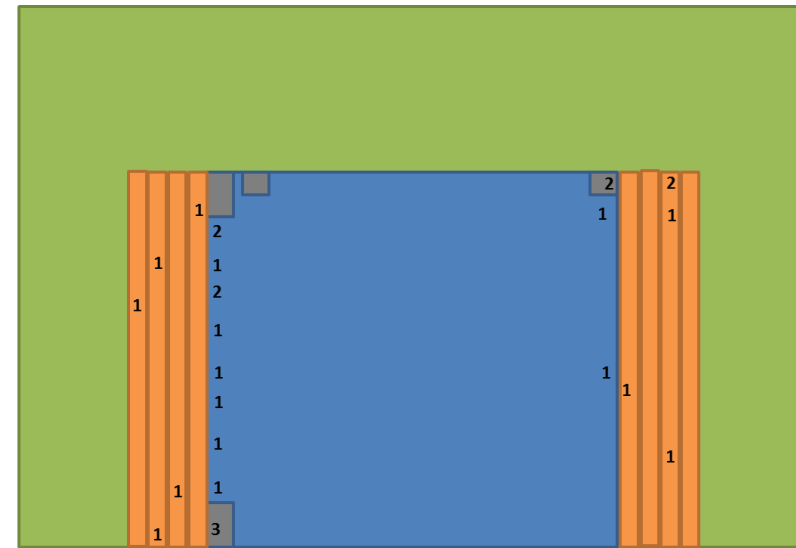
X Plane Detector

Broken wirebondings: (out of 5500)
patch = 3
Silicon = 4
PCB = 0

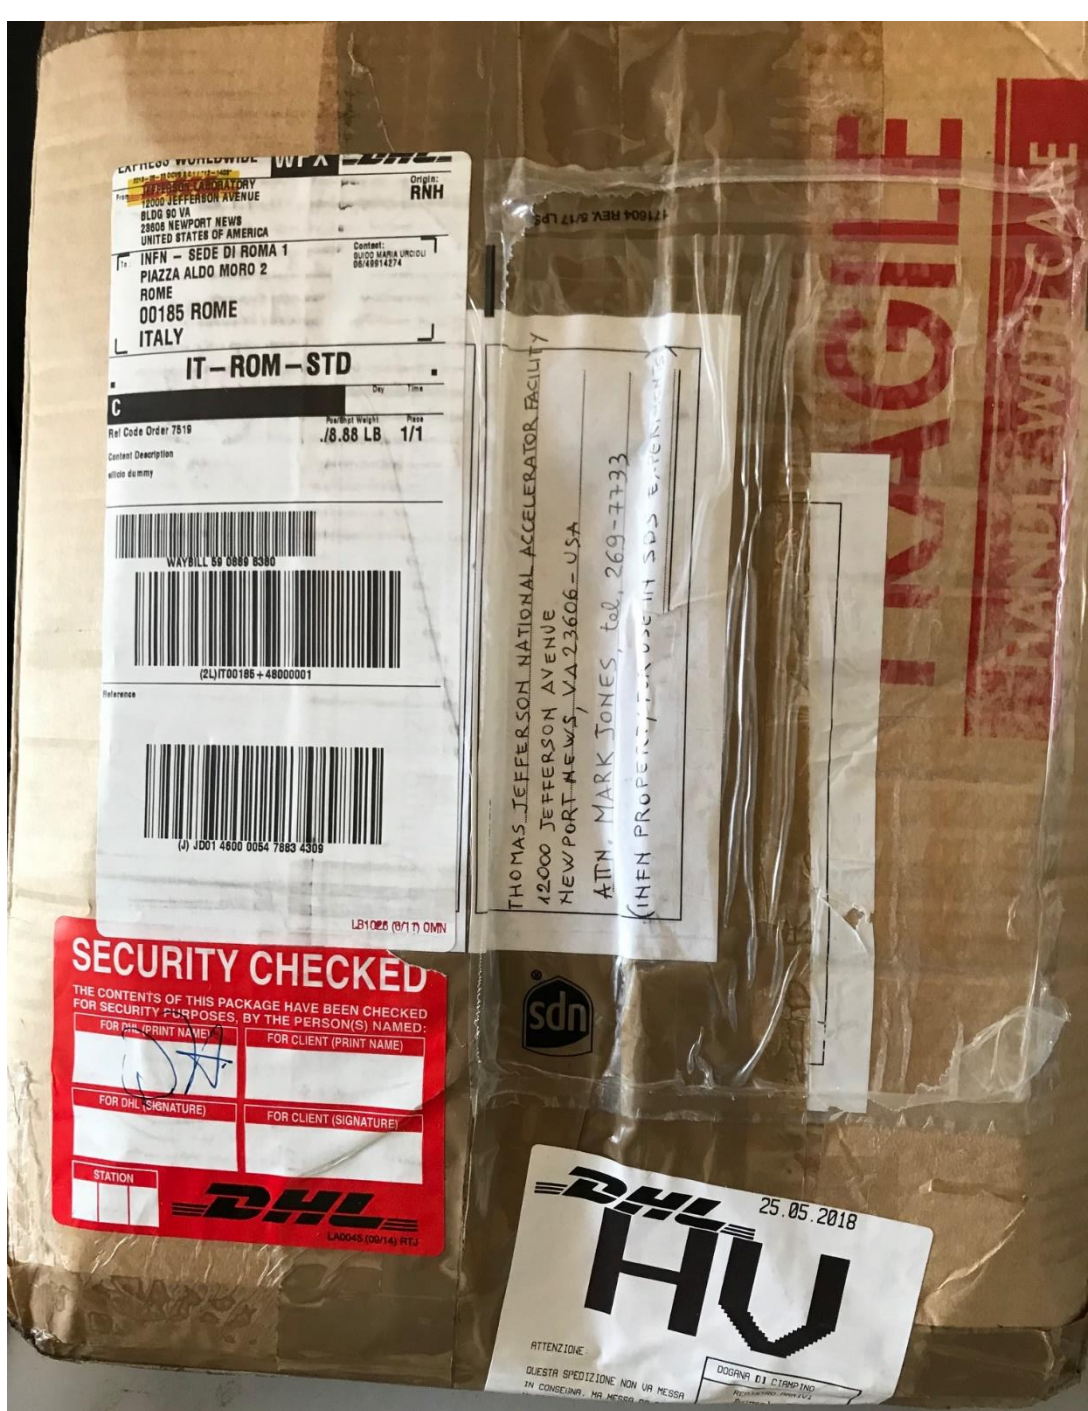
Test Robustness of Packing and Shipping
of one wire bonded dummy silicon detector
sent to JLAB and returned to Rome, **via airplane**

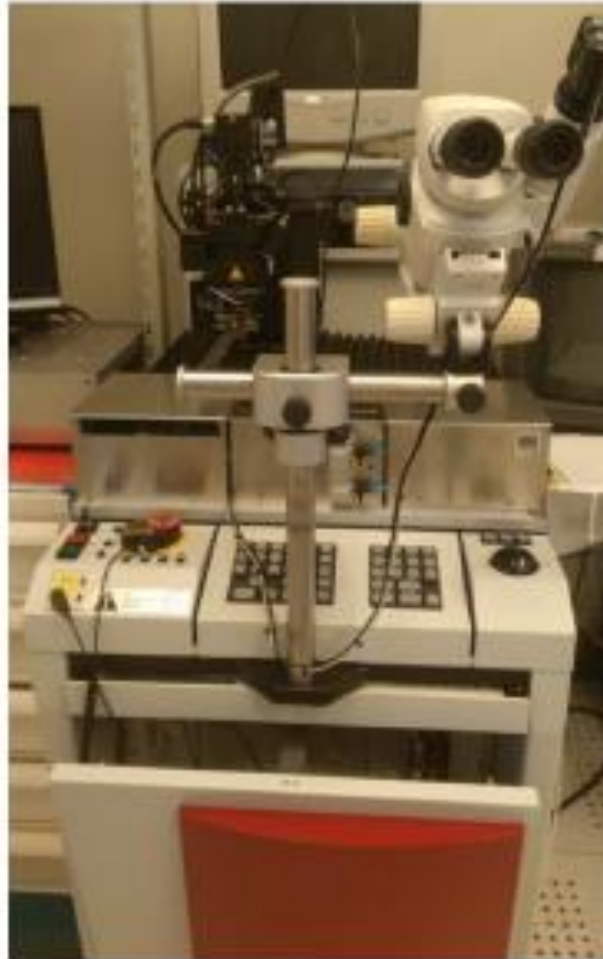
Silicon microstrip detector production started at INFN-Bari with an **automatic bonding machine** Devoltec 6400, G4 type: **one** half plane **X** with a standard PCB design, and **one** half plane **Y** with a reduced GND plane PCB **already produced**

**Just
arrived!!
To be
checked
soon by
Probe
Station
visual
inspection**

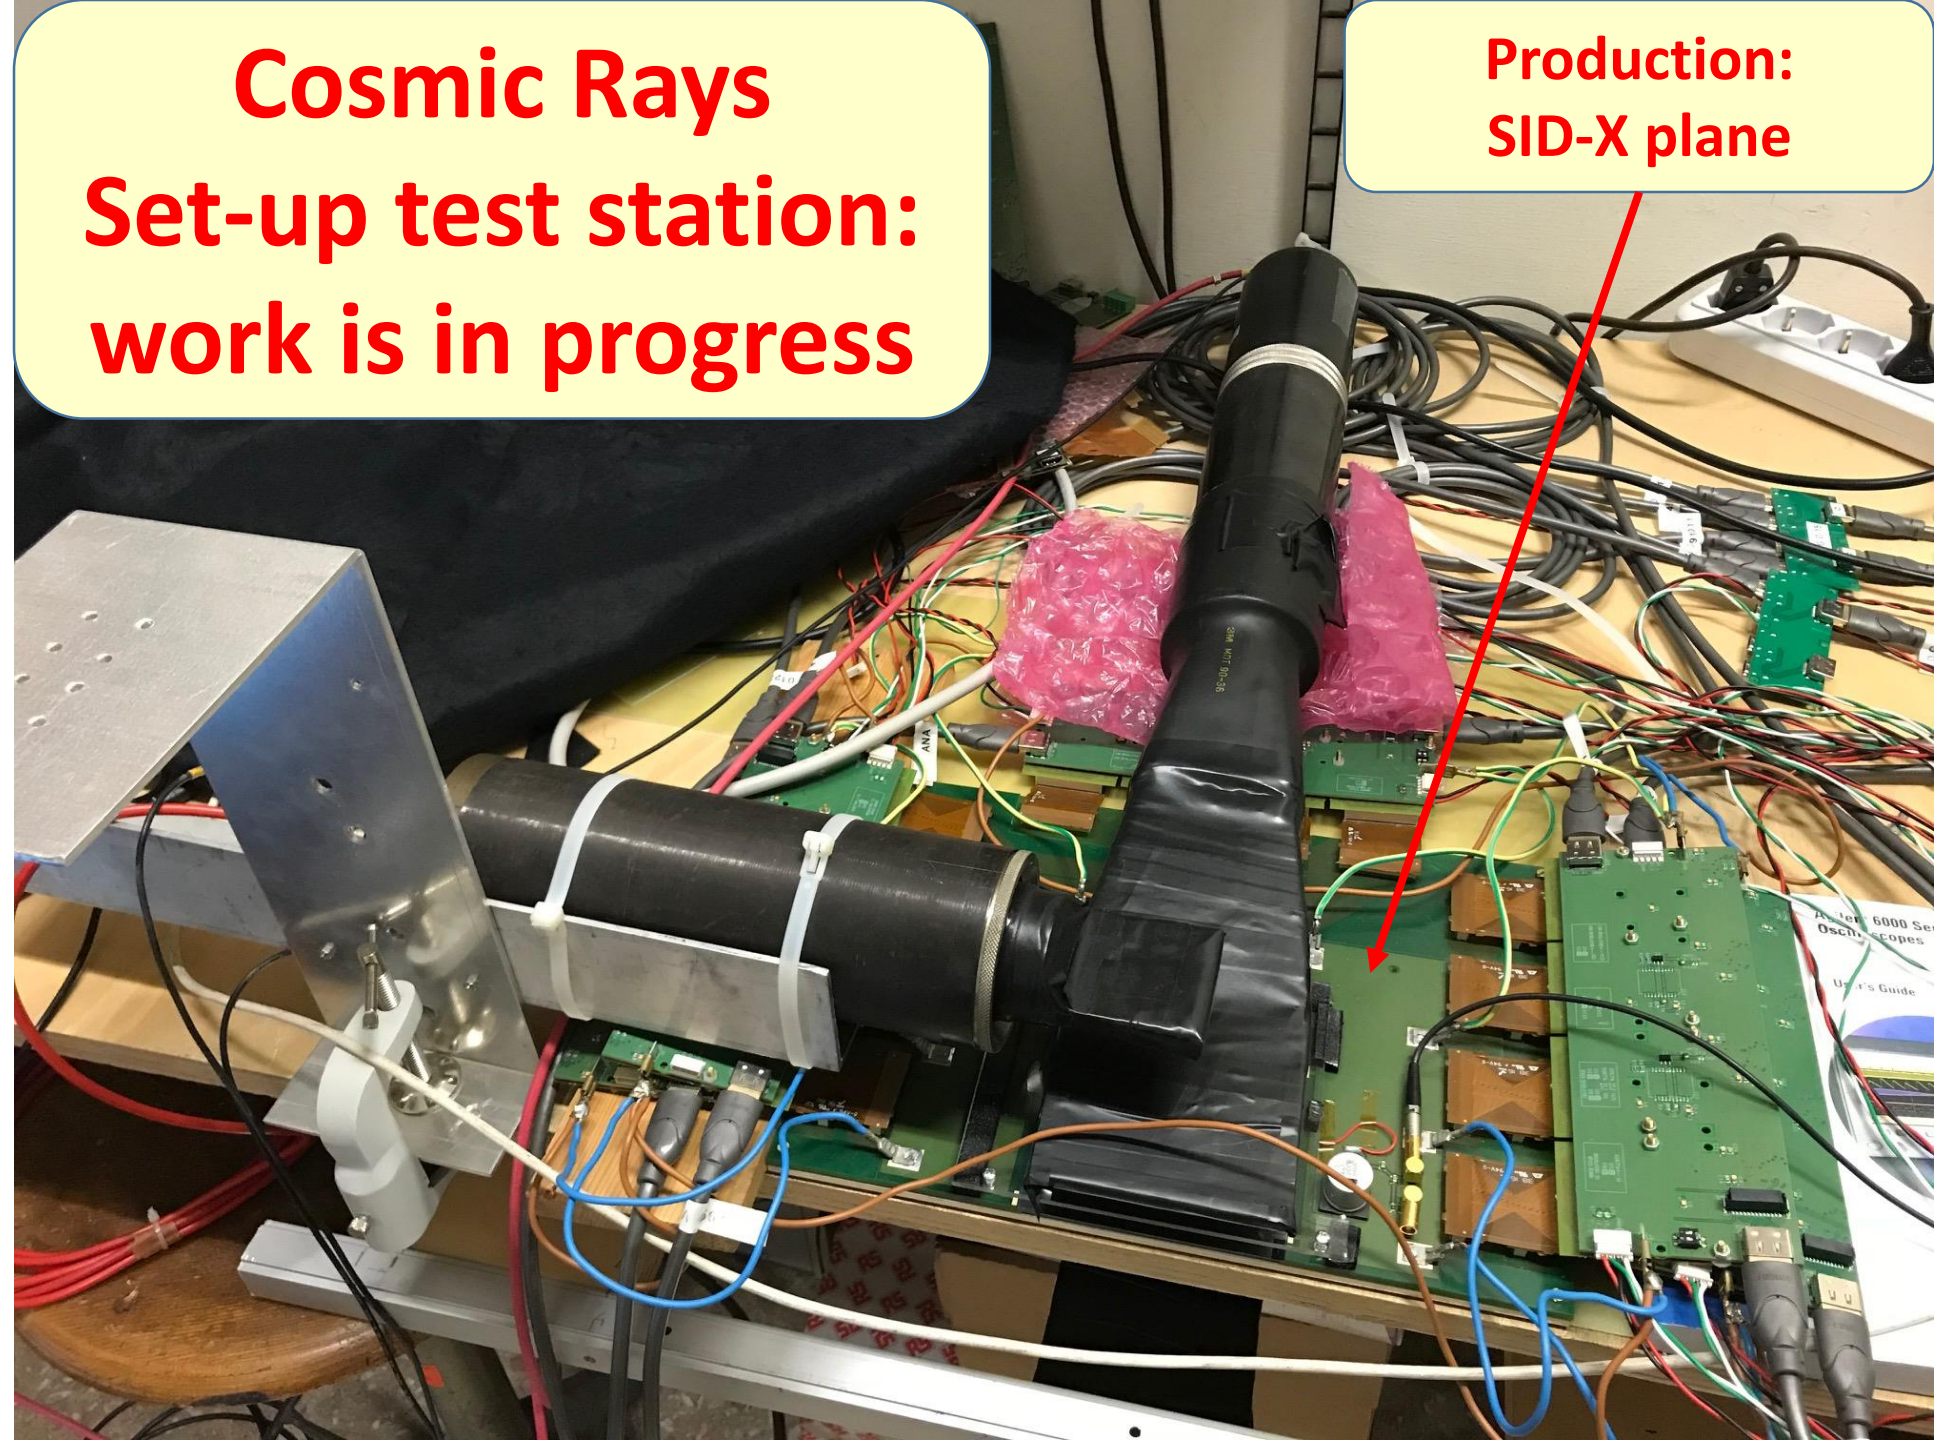
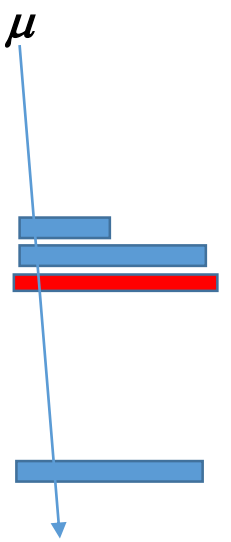
Production:
SID-X plane

**VME RACK for
DAQ
Low and High
Voltages**

**Cosmic Rays
Set-up test station**

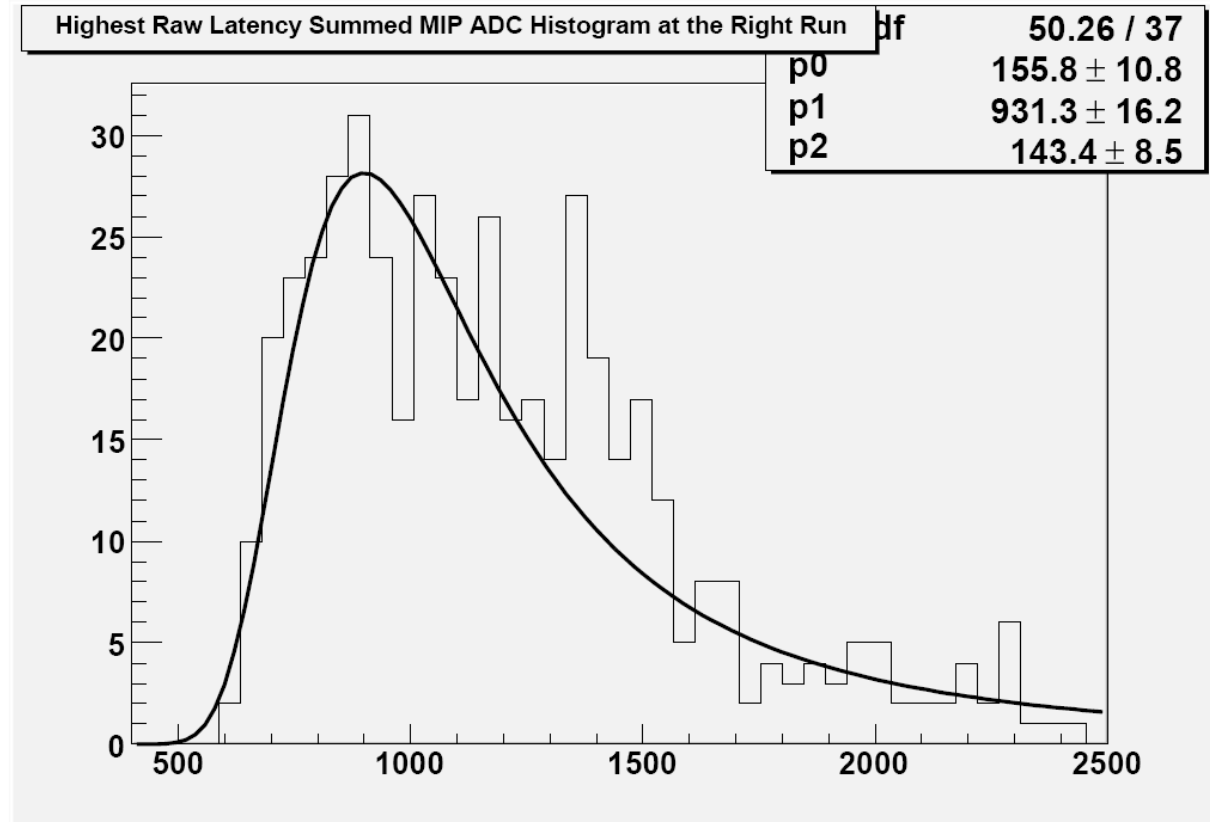
MIP distribution along the detector

- For each cosmic ray run, the average of each single strip ADC counts and the relative standard deviation are calculated.
- A MIP is considered «crossing» a strip when, for the event concerned, the ADC relative value exceeds the average of a predetermined number of standard deviations.

Prototype signal good results confirmed

Hole generated
by geometric
causes
