Preshower Tile Radiation Hardness

Irradiative Preshower Results

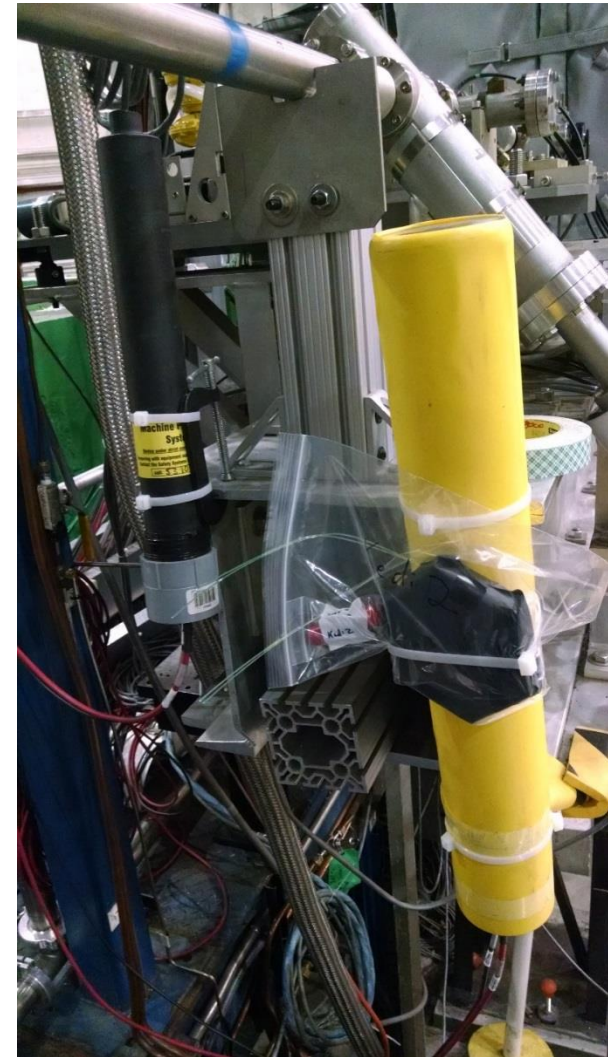
- 8 preshower tiles were placed around Hall A, generally near ion chambers (yellow tube).
- Preshower tiles are from CNCS and Kedi, and previously tested in 2015.
- Each tile was wrapped in tyvek and black tedlar and contained two fibers with 2.5 turns each.
- [Radiation hardness website](#)
