Subject Lab Techniques IV

Name Jack Segal

## Initial Operation of Gas Test Chamber

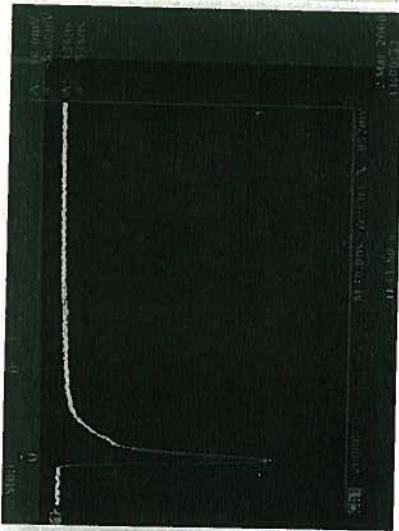
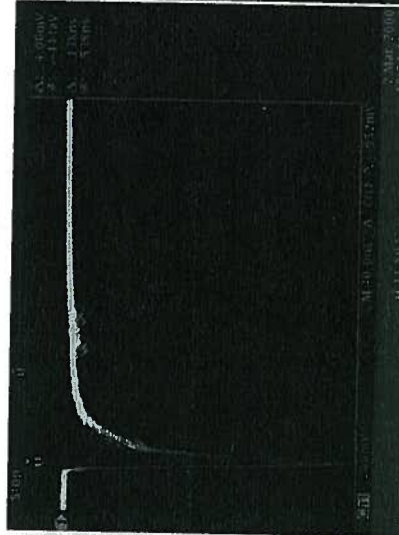
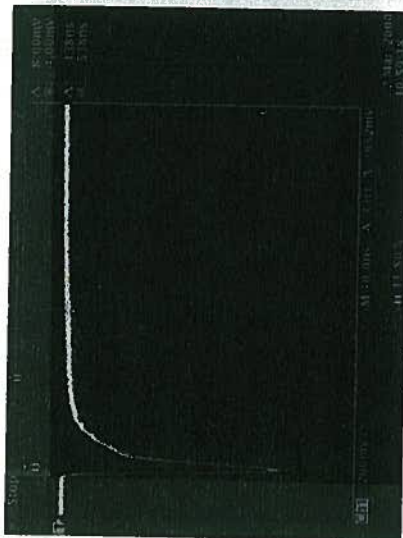
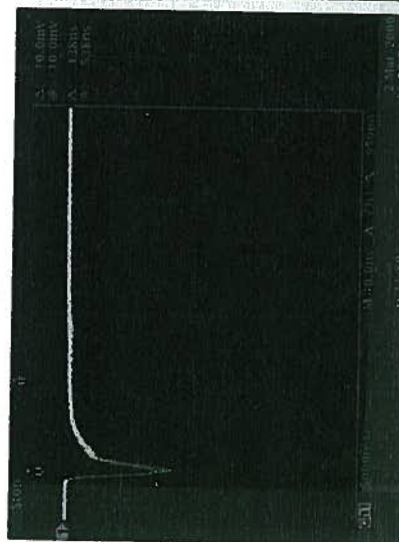
Ar/CO<sub>2</sub>  
HV = 1751 V  
↓

80/20 (Bottle label analysis says 20.1% CO<sub>2</sub>)  
HV = 1801 V  
↓

Ar/CO<sub>2</sub>  
HV=1852V  
↓

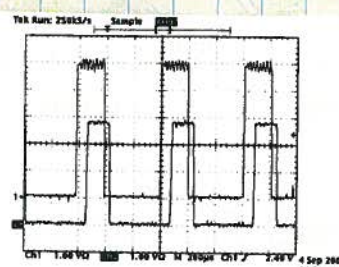
Looking at demo boards from Okw. Scope FET probes are at data in & out pins of transmitter & receiver. Chan 1 of scope, upper trace, is data in of transmitter. Chan 2 is data out of receiver. Waveforms are taken when button, which causes data LED to light, is pushed.

button pressed briefly ↗

when button is held down  
the sequence repeats, until  
button is released

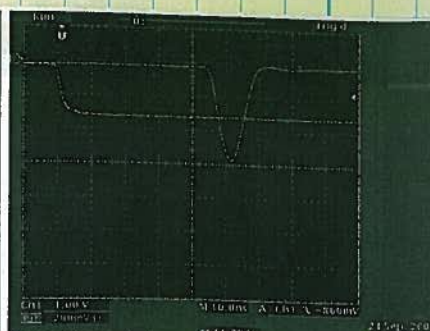
288 FC Change of scale  
560mV
