**COMPUTATION NOTEBOOK**

Subject Misc Hardware IV

Name Segal

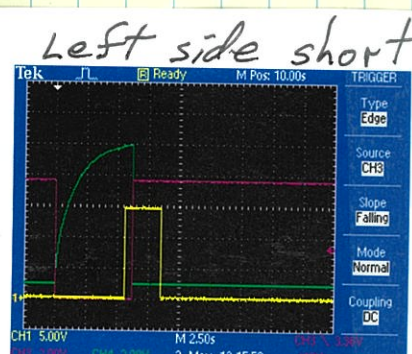
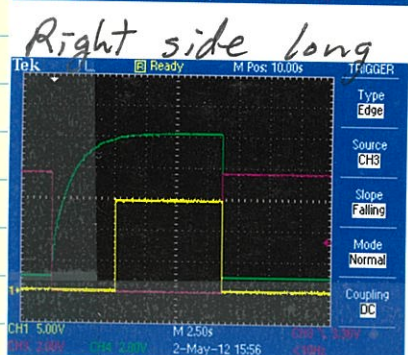
After 7 Days

Same setup as on p. 10  
Optocouplers are the usual method.

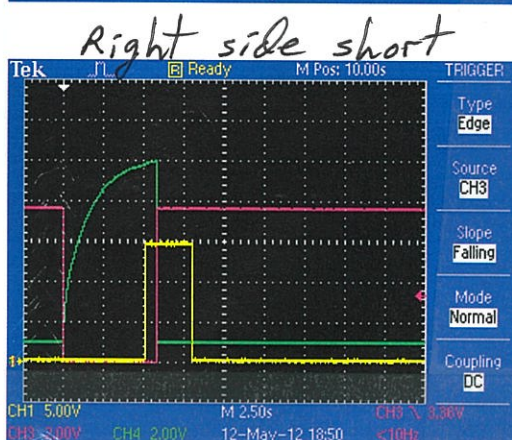
Same setup as on p. 10.  
 Optocouplers are the usual method. A-F Tek Ø-Tek 5  
 Left display reads 74.4. Trip is 59.2. Tek 6-7  
 Right display read 74.6. Trip is 39.1. Tek 8-9

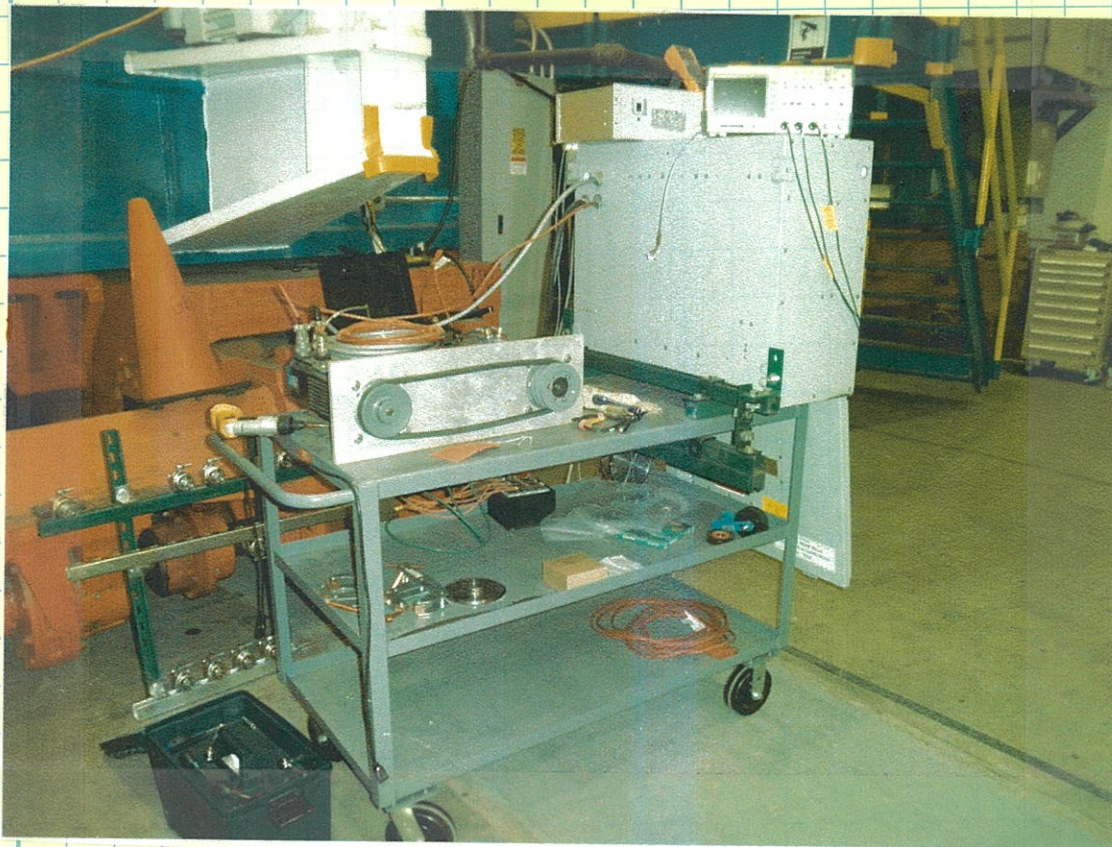
The setup has one bogie motor and a 12VDC motor as a load. The bogie motor is on the left, the 12V on the right. The V-belt has enough slack that the pulley can be slipped off the bogie motor. The 12V motor has a resistive load made of nine 2 ohm resistors in parallel.  $\frac{2}{9} \approx 0.22 \Omega$ . The resistors are mounted on a heat sink visible on the middle shelf of the cart.

The panel box on the right of the cart was from the controls for the inner bogies. It has the power supplies, drive module, and brake board.

The small box on top of the controls has switches and a potentiometer to mimic the VME controls.

Revisiting the test stand I put together for the bogie drives. This is the same setup used on pages 19-26 of this volume.

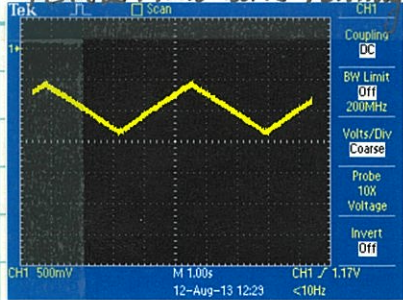
Tek 2 Automatic Tuning

NMR Signal

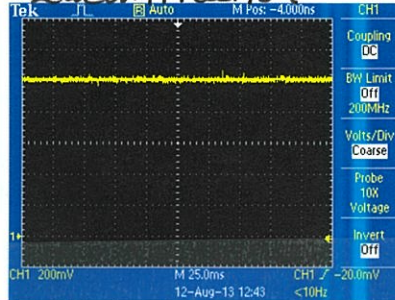
Tek 7 RF input

Identification

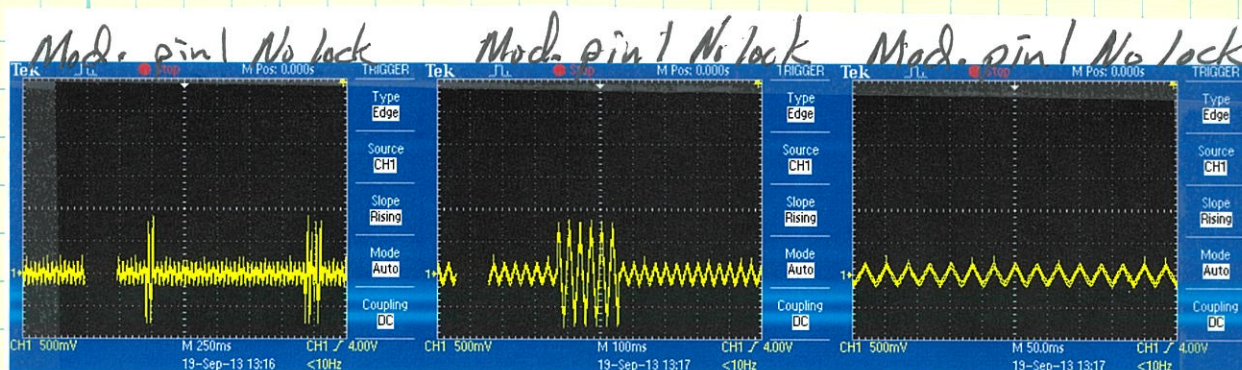
NMR on pins 7 of 8 pin, Tek 33

*S/N 3989 ("NEW")*  
*NMR pin 7 lock*

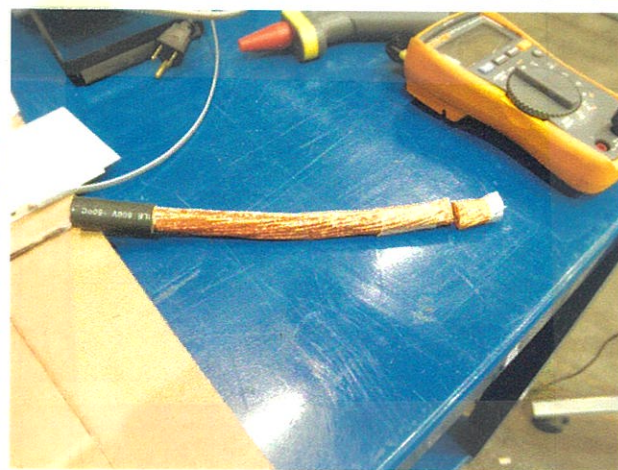
I dipped the end of the cable into  $\sim 180^\circ\text{F}$  solder for  $\sim 15$  seconds.

After cooling, I cut off  $\sim 1\frac{1}{8}$ " from the end of the cable.

All the wires at the cut seem to move freely. It does not seem that the solder wicked that far up the cable.

Bending the wires back on the piece of the tip I see a bit of greenish residue on the wires. It looks like the flux wicked up that far.

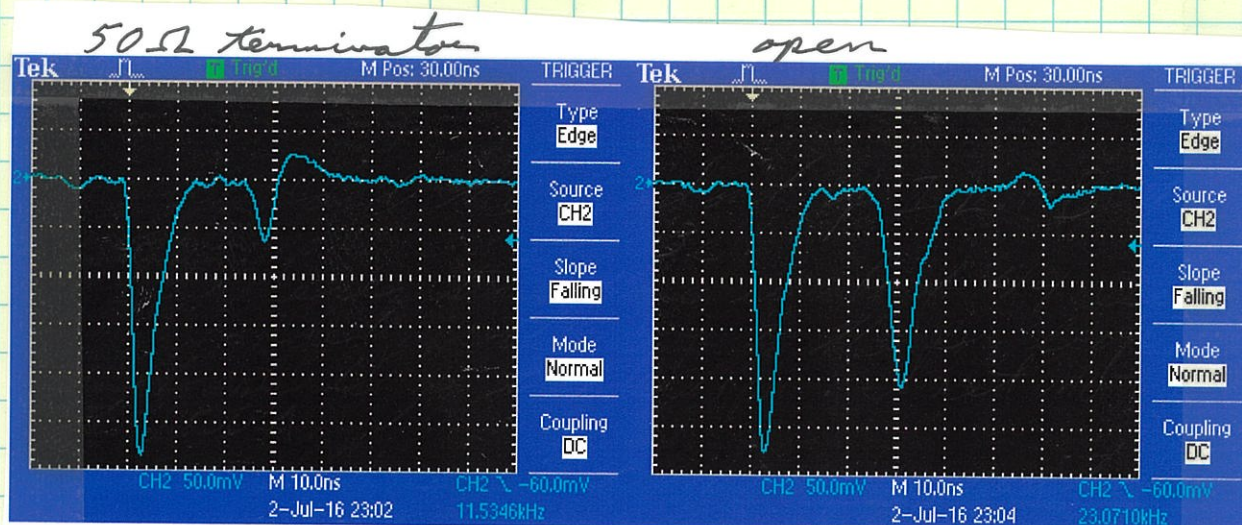
The 34 pin that plugs into the 1881M has a 34 pin 50Ω terminator we had made for an amplifier. It is 50Ω across each pair of pins.

I then tried nothing on the 1881M side. A 51Ω 1/8W carbon comp. and a 91Ω 1/8W carbon comp. resistor.

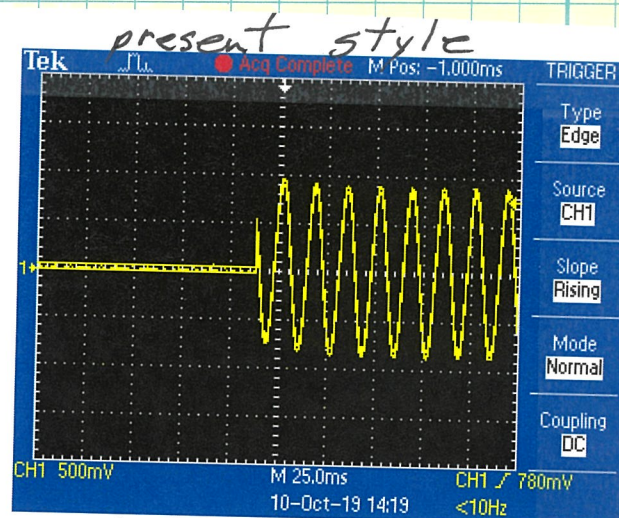
We plugged them into a power strip and used the switch to turn them on. We want to see the initial current draw.

The scope had a current clamp on Ch 1.  
 a Tektronic i200s set to 100mV/A.  
 The scope was set to peak detect.

The present style heater has about  
 850mV peak AC draw. For an RMS of 6 amps.
