3 x APV Backplane Issue and Fix

21/July/2021
Paolo, Fausto, Evaristo

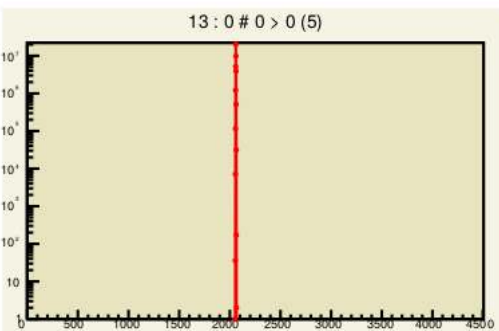
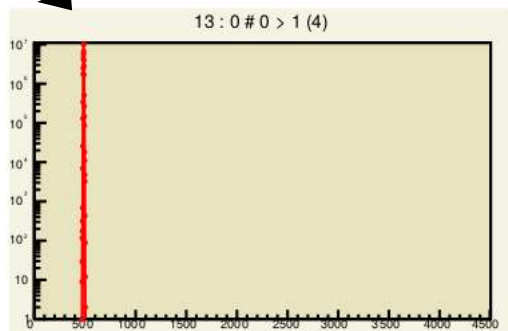
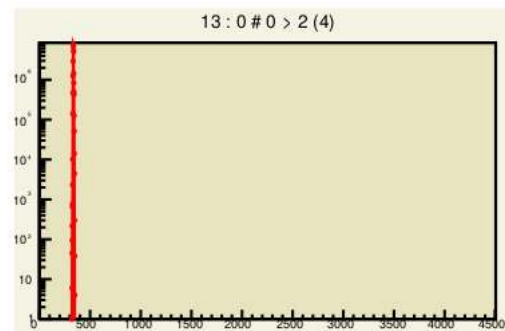
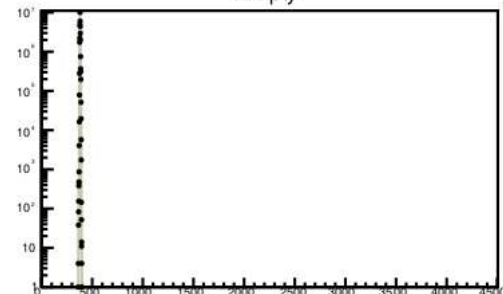
No card connected

Bad histograms

Empty

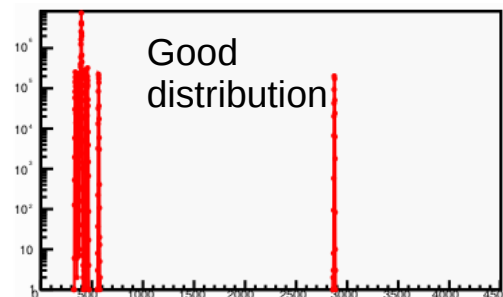
Sean did the “histo low-level” test and observed that:

- 1) all cards show bad distributions of their APV dataframe
- 2) the first channel is not connected, the last is bad

Issue 2 is related to the connections of the analog HDMI cable: does not compromise the APVs functionality but is a limitation combined to the 15 channels MPDs.

Can be fixed in different ways:

- ← dirty: connect the two lines from ch3 to ch0 (yellow lines)
- a) firmware: either restore the last channel in the MPD or **allow to select the channel to disable**
- b) hardware: reroute by a male-female adapter

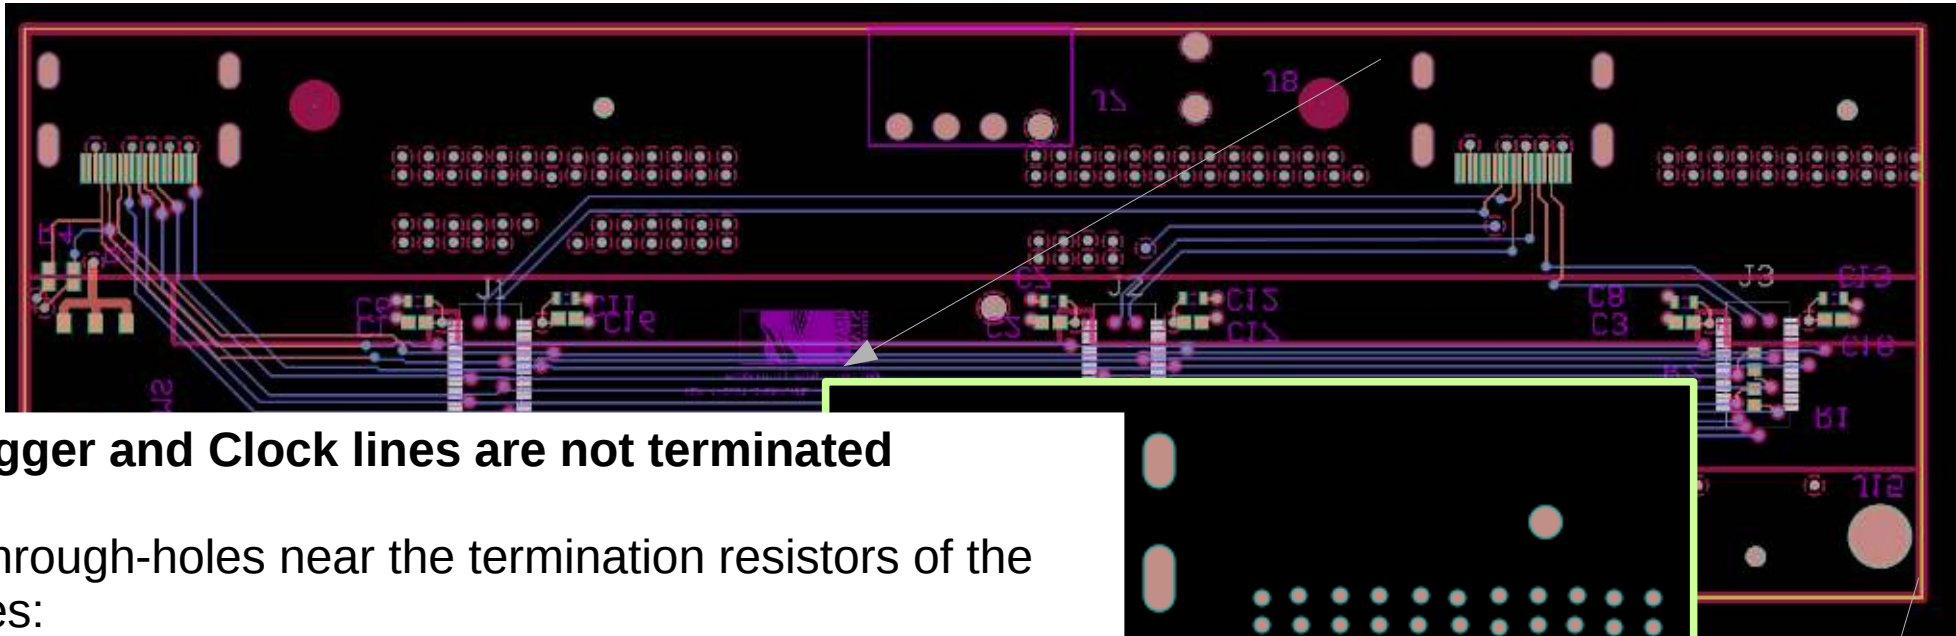
Trigger and Clock lines are not terminated

3 through-holes near the termination resistors of the lines:

- Trigger-positive
- Trigger-negative
- Clock-positive

are not connected on both sides as should be (red arrows) [the Clock-negative is fine]

the original 4APV-backplane have through-holes (not used and not connected, except the Clock-n) on all cards except the last one where they are connected; we removed the last card to shorten the backplane; we did not noticed the difference!

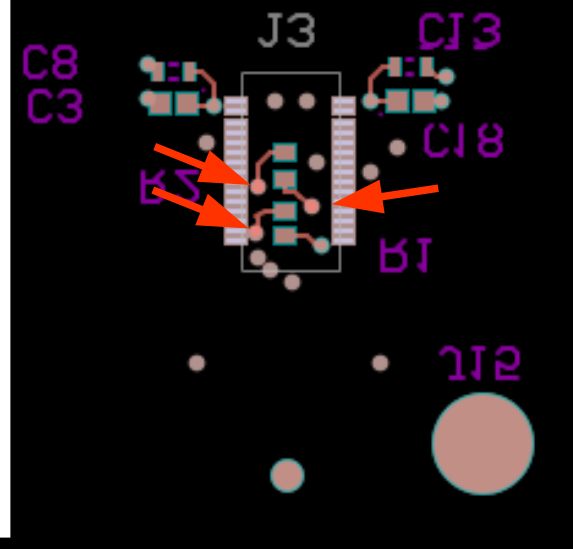
the through-hole are behind the connector

- 1) unsolder the J3 connector (right →)
- 2) drill the three through-holes (0.4 mm bit)
- 3) fill the holes with conductive glue or similar to make contacts between the two sides
- 4) solder back the J3 connector

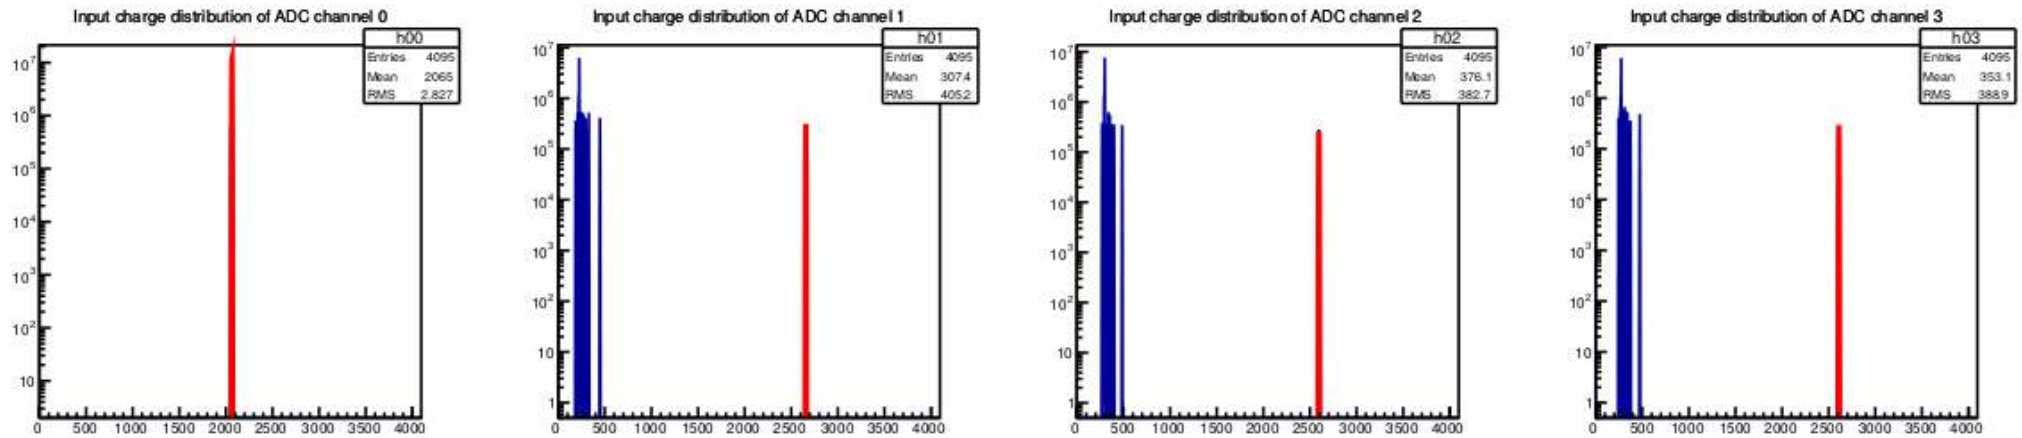
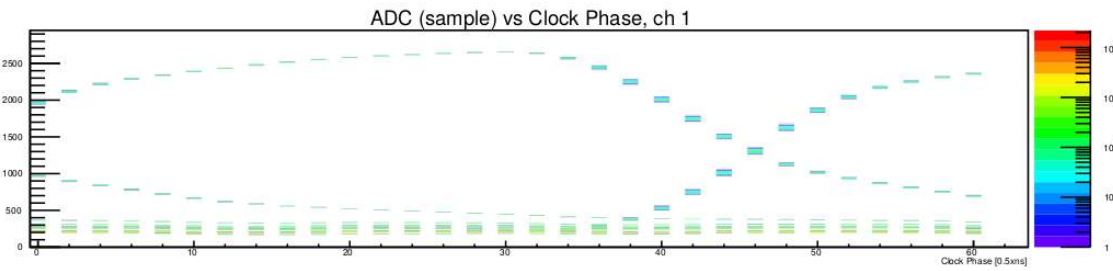
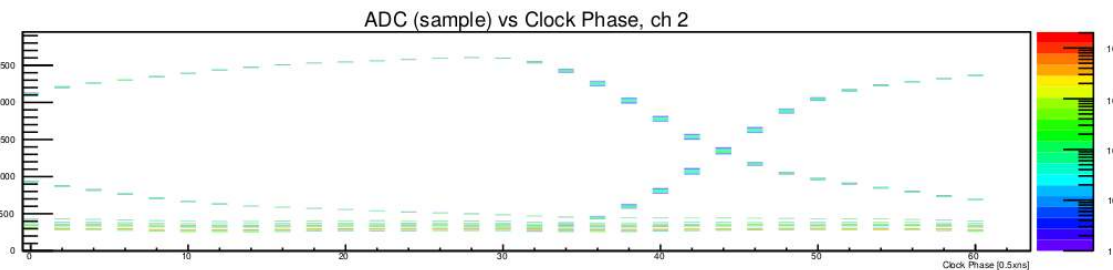
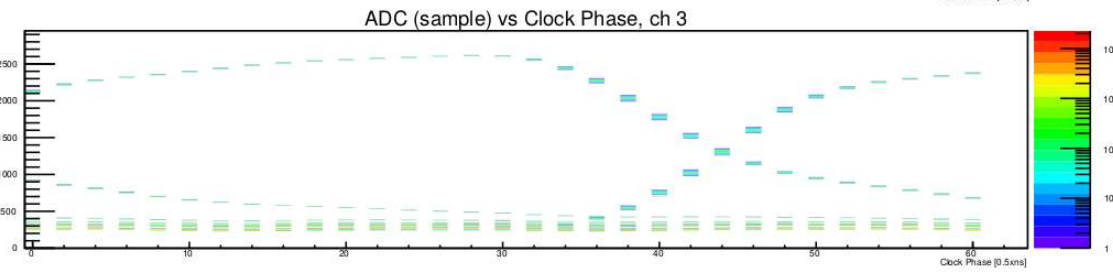
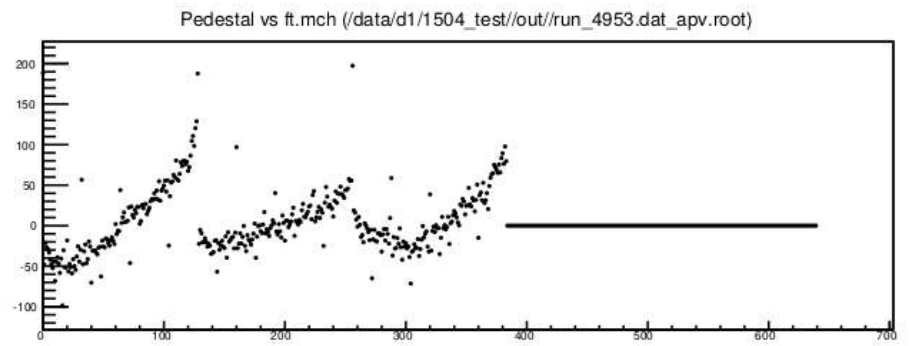
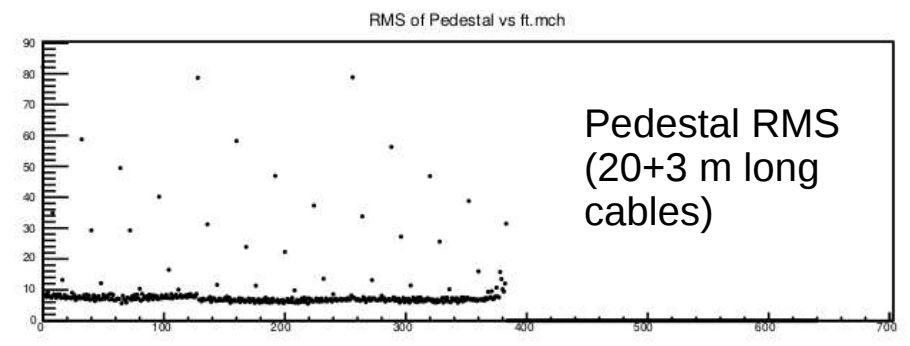
Tests after fixing look fine
