Corrosion of Glass Windows in DIRC PMTs

P. Bourgeois¹ and J. Va'vra²

Abstract

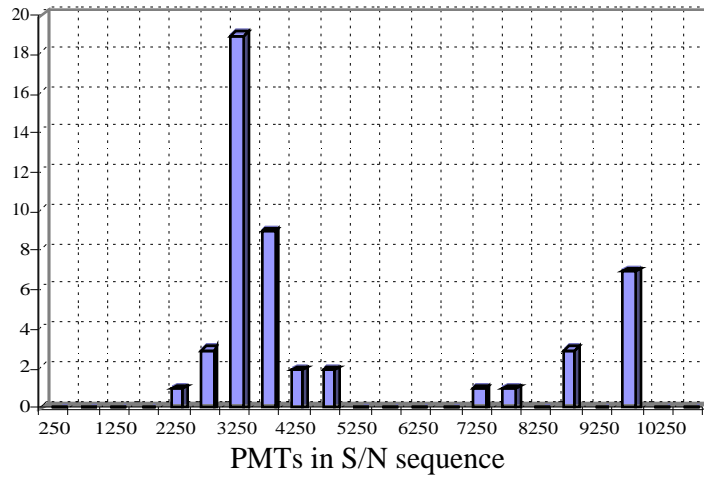
Frequency of 'frosted' PMTs in bins of 500 delivered

Figure 4. ETL company’s estimate how the “frosty” PMTs taken out of SOB correlate with serial number production. It appears that most of them came as one bad batch.

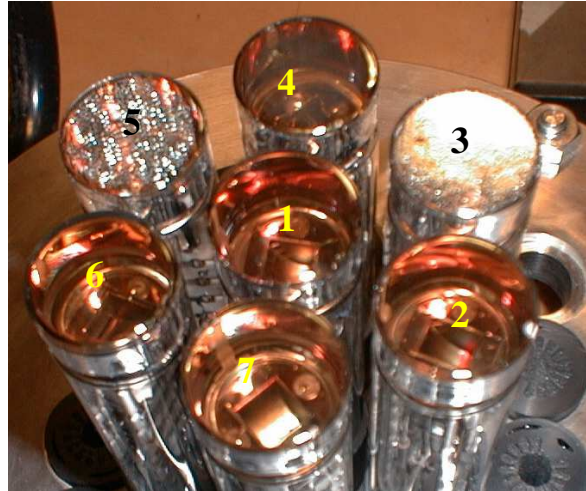
We have taken pictures of PMTs at different stages of the corrosion test - see Figures 7-10. One can see that four clear PMTs become rapidly milky, followed by scratches appearing on the window surfaces. The “frosty” PMTs become progressively frosted, spreading to the edges of the window. One can also see that the characteristic color of the photocathodes disappear on the dead PMTs, as if the surface was wet.

Figure 7. Appearance of seven PMTs, as the beginning of the corrosion test. One can see four “clear” PMTs on the bottom, two “frosty” on each side, and one “milky” at the top right-hand side.

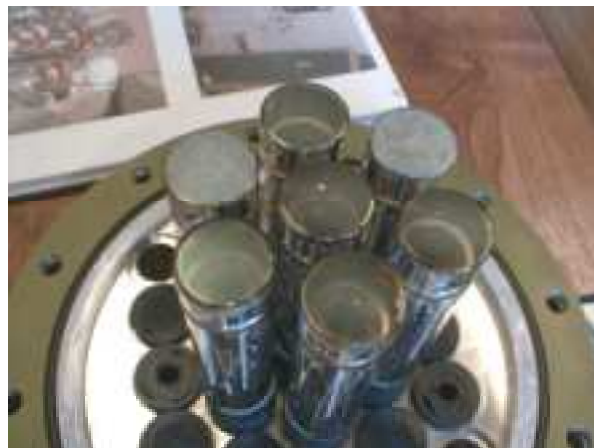
Figure 8. The same PMTs as in Fig. 7, after the first immersion in hot water for up to 40 days (equivalent to 17 months at 28°C). Notice that the four “clear” PMTs shown in Fig. 7 became “milky.”

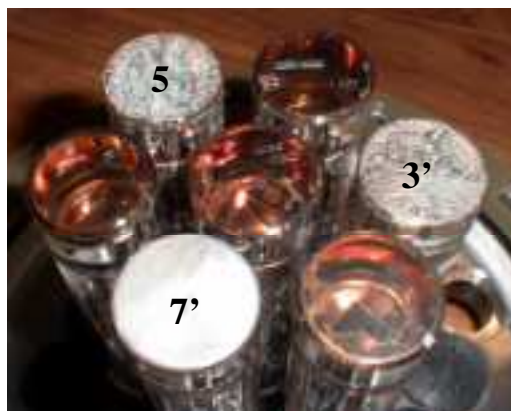
Figure 9. The same PMTs as in Fig. 7, after the second immersion in hot water for 30 days (equivalent to 12 months at 28°C). Scratches appeared on four “milky” PMTs, and edges of the “frosty” PMT # 5 also became “frosty.” It is the first immersion for PMT #3’ and 7’.

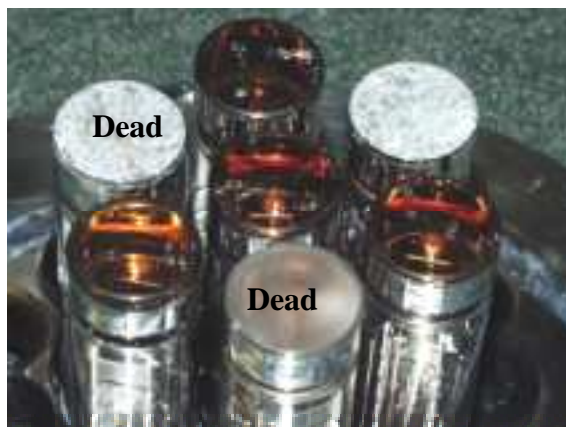
Figure 10. The same PMTs as in Fig. 7, after the third and fourth immersion in hot water for 174 days (equivalent to 82 months at 28°C); it is the second and third immersion for PMT #3’ and 7’. There are more scratches on four of the “milky” PMTs and the “frosty” PMT appears much more “frosty” when dry.

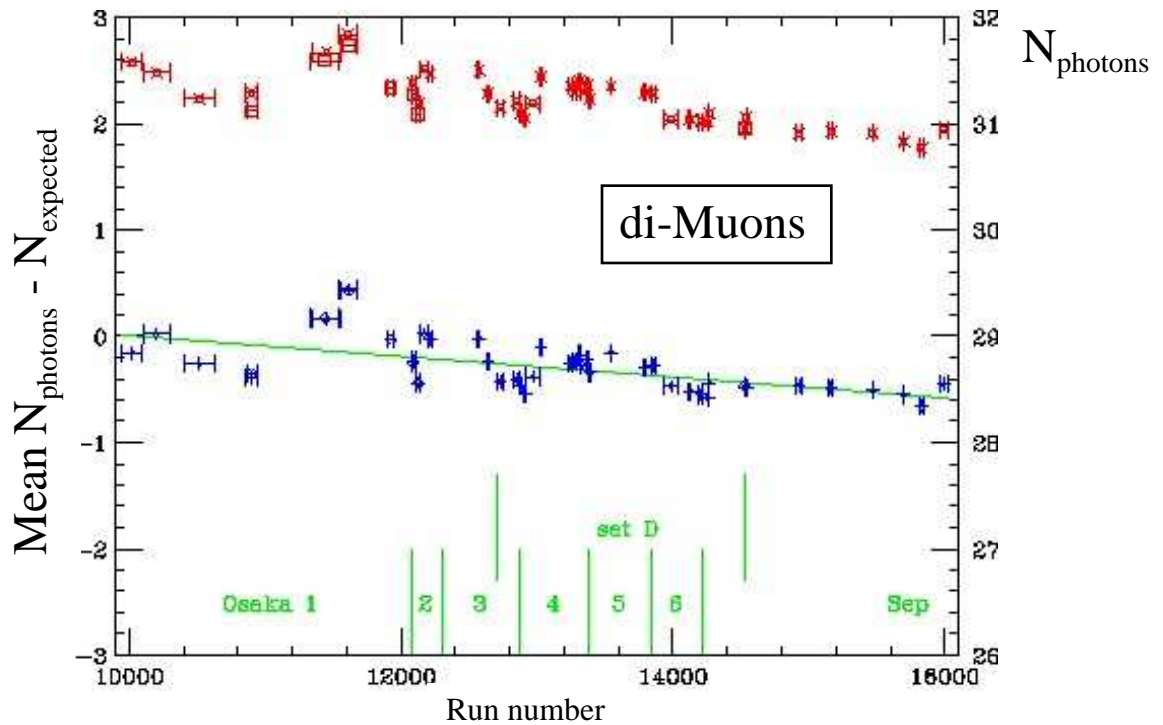
Figure 13. Average number of Cherenkov photons per ring from di-muon analysis (x points) as a function of the BaBar run number [14]. The figure also shows a relative difference from the expected number (+ points). Both curves indicate a decline at a level of 2-3%/year.

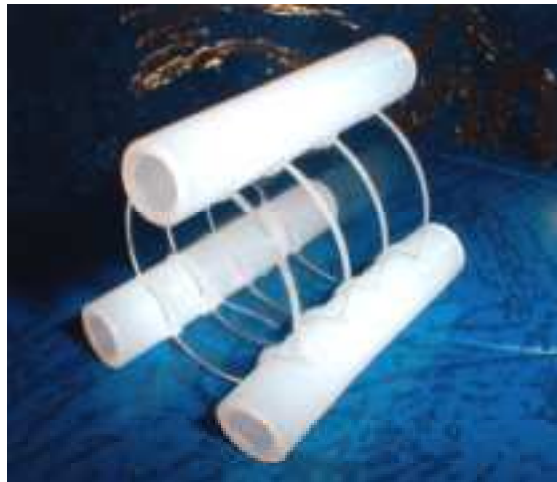
The weight loss measurement was done using front window coupons of B53 glass obtained from ETL Co. Four coupons were placed vertically in the PMT vessel, attached to three pieces of PVDF hose used for the water system, as shown in Figure 14.

Figure 14. Four B53 glass window coupons with supports.

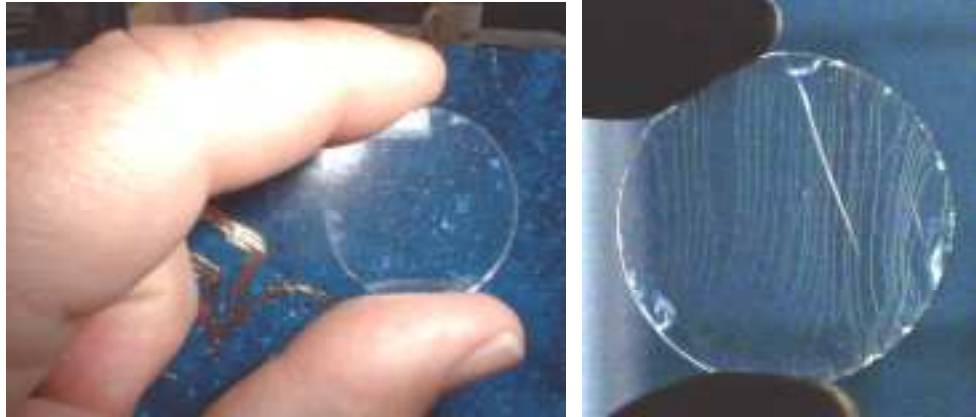
Co., Model Lambda 16). We have also taken pictures which show milky spots only at the beginning and at the level of the hose contact, then more and more scratches (see Fig. 15).

Figure 15. (a) B53 glass window coupon after the first immersion in water, and (b) after the third immersion.

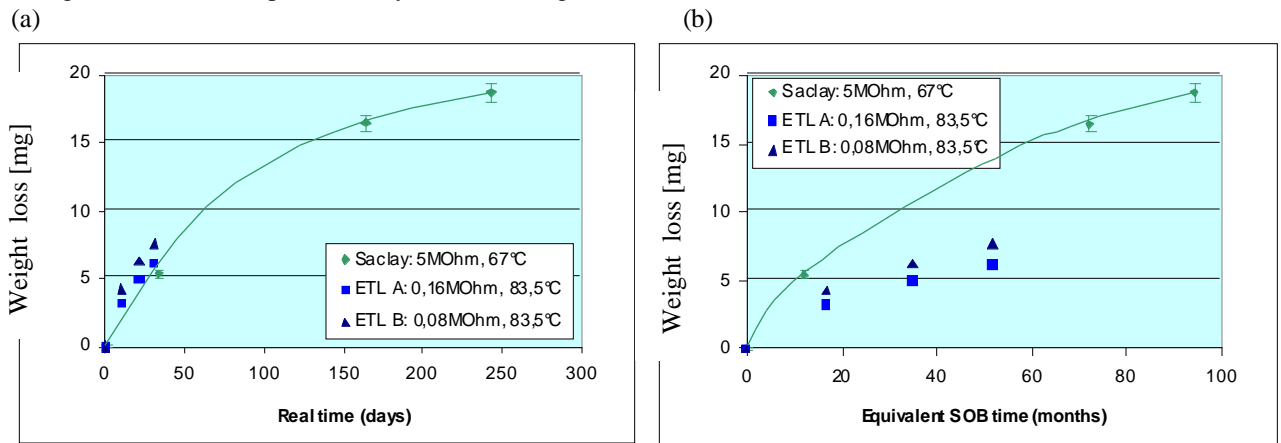
Figure 16. B53 glass coupon weight loss as a function of (a) the real time and (b) the SOB equivalent time.

Our results compared with those of ETL are not in complete agreement given that testing was not done in the same experimental conditions. For example, the temperature is higher in the ETL data, and the ETL water resistance is lower. Figure 16 and Table 11 summarizes the results of the measurements. The equivalent SOB time has been calculated with an acceleration coefficient of two, and a reference temperature of 28°C; this gives ETL an acceleration factor of 50. However, ETL's conclusion is still valid, i.e., the PMTs equipped with the B53 glass should not implode in 10 years of running.

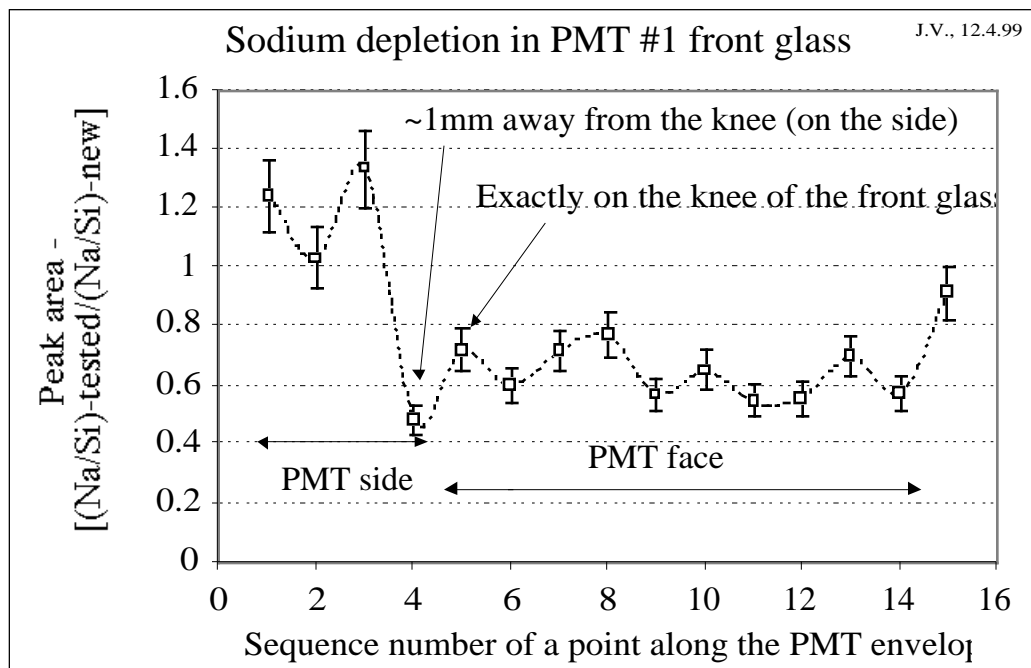
Figure 25 shows similar sodium depletion, although to a lesser extent. The front PMT glass surface (#1 or S/N 050038) used in early verification tests at Orsay, is designed to show that there is no water induced PMT glass corrosion. Indeed, one can confirm that there was no visual effect. However, more precise X-ray tests show that corrosion is present in terms of sodium depletion on the front of the PMT glass.

Figure 25. Sodium depletion in the front-glass of PMT #1 (S/N 050038) used in early tests at Orsay to verify the absence of glass corrosion by water. A sequence of numbers follows the glass envelope as described on Fig. 23. The Si X-ray peak was used as a normalization of the X-ray detector response due to solid angle changes during the surface sweep.

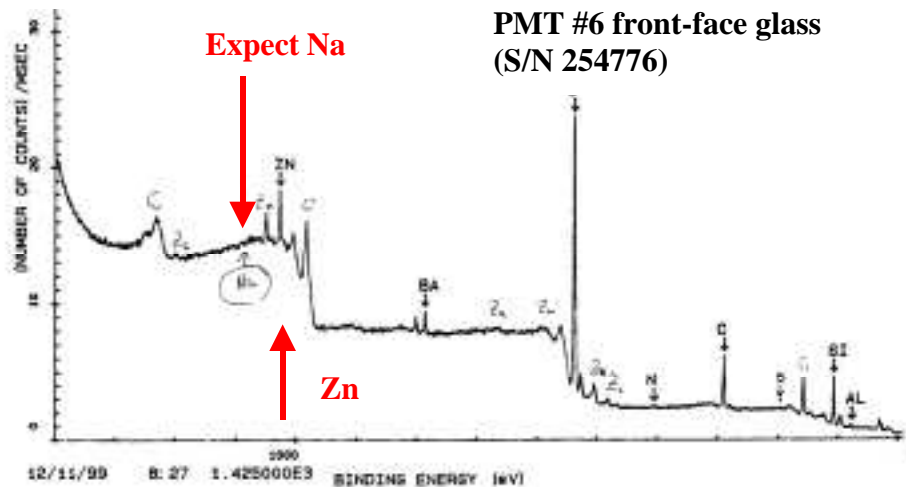
Figure 26. ESCA analysis of front-face glass of PMT #6 (S/N 254776), which was judged as “milky,” and removed from the SOB vessel during the October 1999 shutdown. Zn is clearly detected, which is taken as a proof that the glass was indeed B53 glass. This result is consistent with the “milky” appearance; however, there is no sign of Na.

The analysis was done on several tubes: (a) “milky” PMT #6 (S/N 254776), (b) “milky” PMT #8 (S/N 255140), and (c) “frosty” PMT #4 (S/N 268893). The last two were broken up to allow a cross-sectional analysis of the front glass. Figure 26 clearly shows that Zn is present in the front glass of the “milky” PMT #6, although we do not see any Na, because it is already depleted from the front surface. Figures 27 and 28 show that both elements, Zn and Na, are present in the “milky” PMT #8. This means that zinc is present not only on the outside surface (Fig. 27), but also in the volume (Fig. 28). This is evaluated as consistency proof that the “milky” appearance corresponds to B53-type glass, which confirms the ETL results. On the other hand, Fig. 29 shows that we clearly do not see Zn in the “frosty” PMT #4, although we do see Na. This agrees with the ETL observation that only the “frosty” PMTs do not have Zn element in the front glass. The milky PMTs, as well as all clear PMTs, do have Zn in the form of ZnO. Our tests were done on PMTs taken out of the SOB vessel in IR-2 after being immersed in water for ~ 8 months at temperatures between 26-28°C.
