INFN GEM Chambers – 14/Nov/2018

Report on ongoing GEM Commissioning

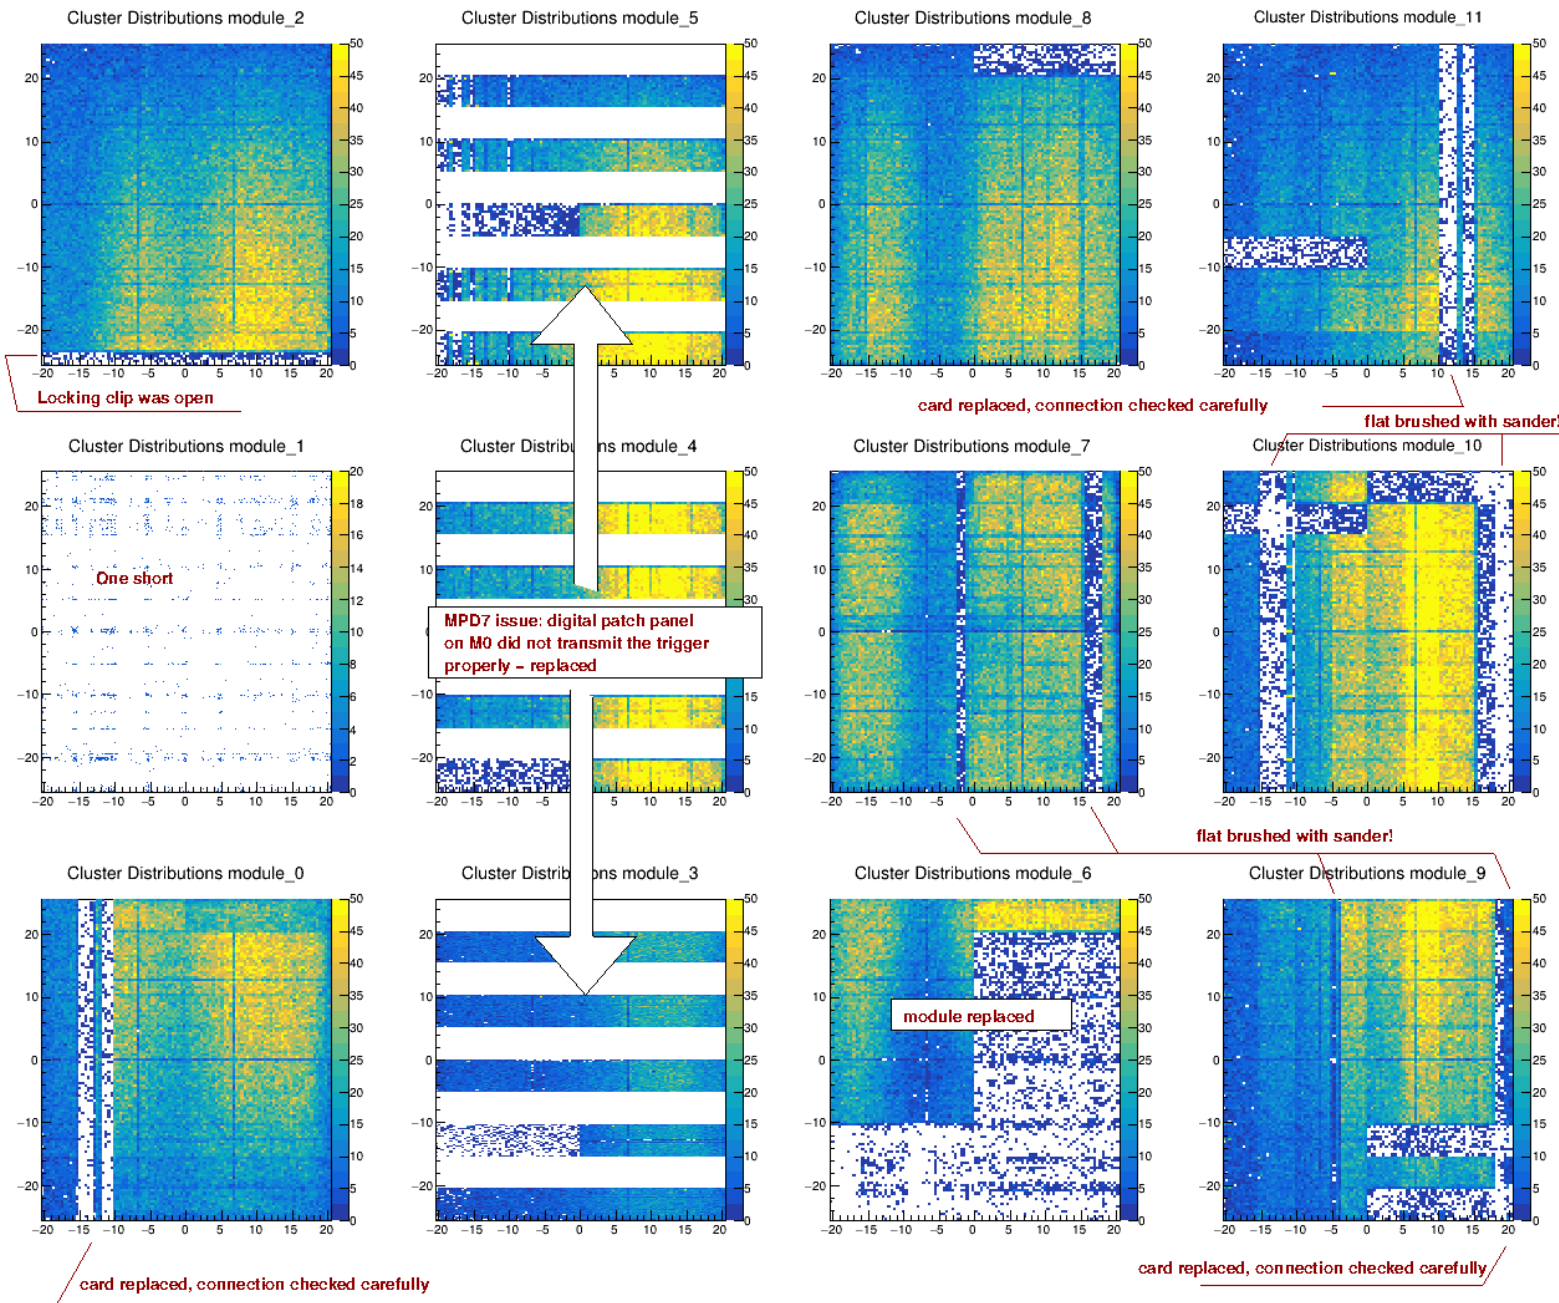
BigBite Front Gem – As of end of October/2018

Apparent MPD7 problem causing half of chamber J1 being off

(Vertical) blank bands

Puzzling, partially dead GEM module_6 (J2M0)

Short in one GEM module_1 (J0M1)

Apparent MPD7 problem causing half of chamber J1 being off
bad trigger distribution in a digital patch panel - replaced

(Vertical) blank bands
Flex strip terminals brushed and reconnected into ZIF with additional care

Puzzling, partially dead GEM module_6 (J2M0)
Module replaced (but source of the problem remains unclear)

Short in one GEM module_1 (J0M1)
protective resistor identified and removed; modules in J0 reorganized

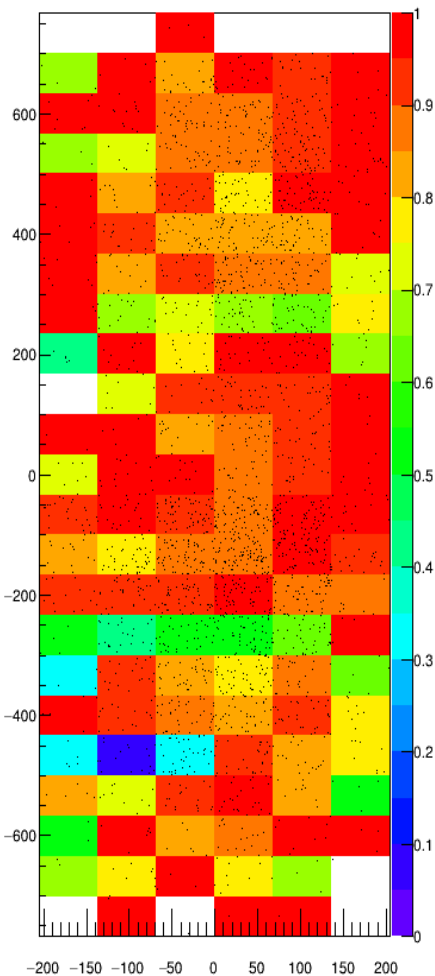
Efficiency: matched/reco hits in J0

HV = 4000 V (effective 3955 V)
Gas Flow ~ 140 ccpm/chamber
Statistics ~ 150 kevents

Manual course alignment, no HV tuning
Condition: Hit Position Residual < 3 cm
