GRINCH Status

Bradley Yale

11/16/2020

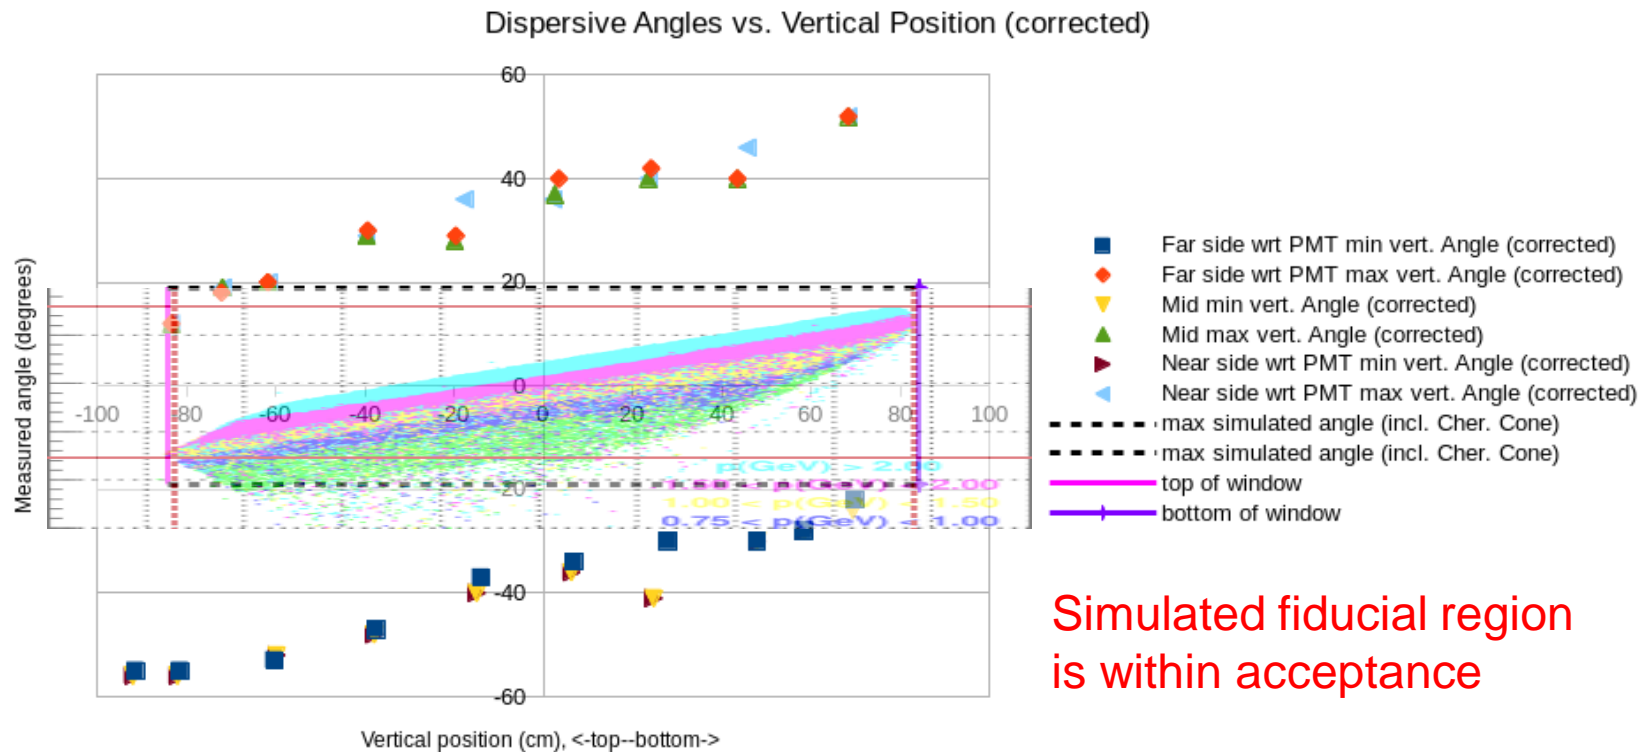
Angular acceptance (vert.)

Simulated fiducial region
is within acceptance

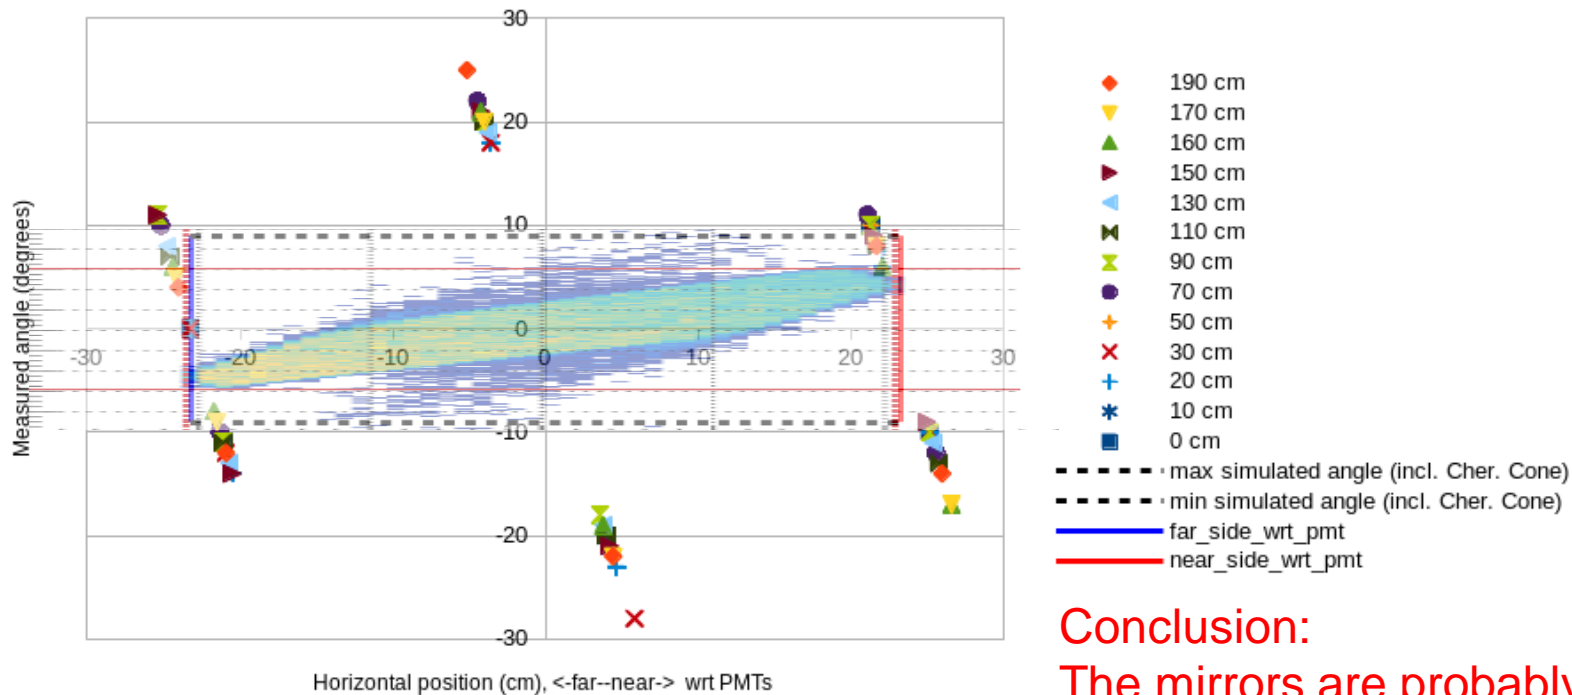
Angular acceptance (horiz.)

Non-dispersive Angles vs. Horizontal Position (corrected)

Conclusion:
The mirrors are probably fine!
