BigBite Timing Hodoscope SBS Weekly Meeting Update

Hall A Jefferson Lab

Ralph Marinaro

September 21, 2020

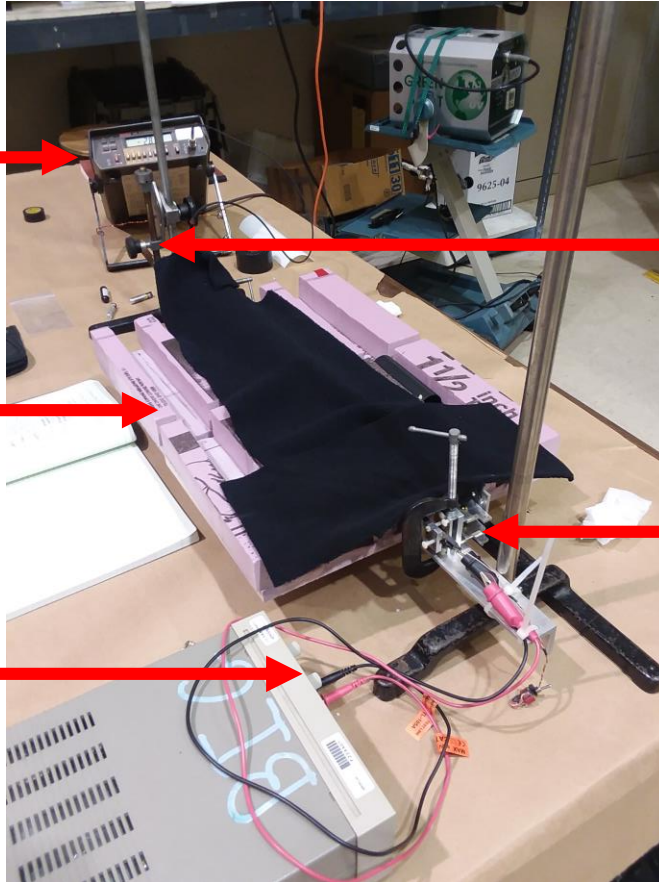
- Transparency reduced by **5.54%** between single light guide (smooth) and double light guide (smooth w/ glue)
- Proof that chosen optical glue minimally reduces transparency for polished light guides

- Transparency reduced by **1.71%** between double light guide (smooth w/ glue) and double light guide (rough w/ glue)
- Proof that roughness (400 grade) minimally reduces transparency, glue fills abrasions, agrees with Glasgow results Feb. 2020
