Department **PHYSICS**  
Subject **WANG DIPOLE**  
Name **SCOT L. SPIEGEL**  
Address **CEBAF / HALL A**

# WANG CIRCUIT CARD VOLTAGE CONDITIONER

# WANG QUENCH PROTECTION

WANG  
INTERLOCKS  
CHASSIS

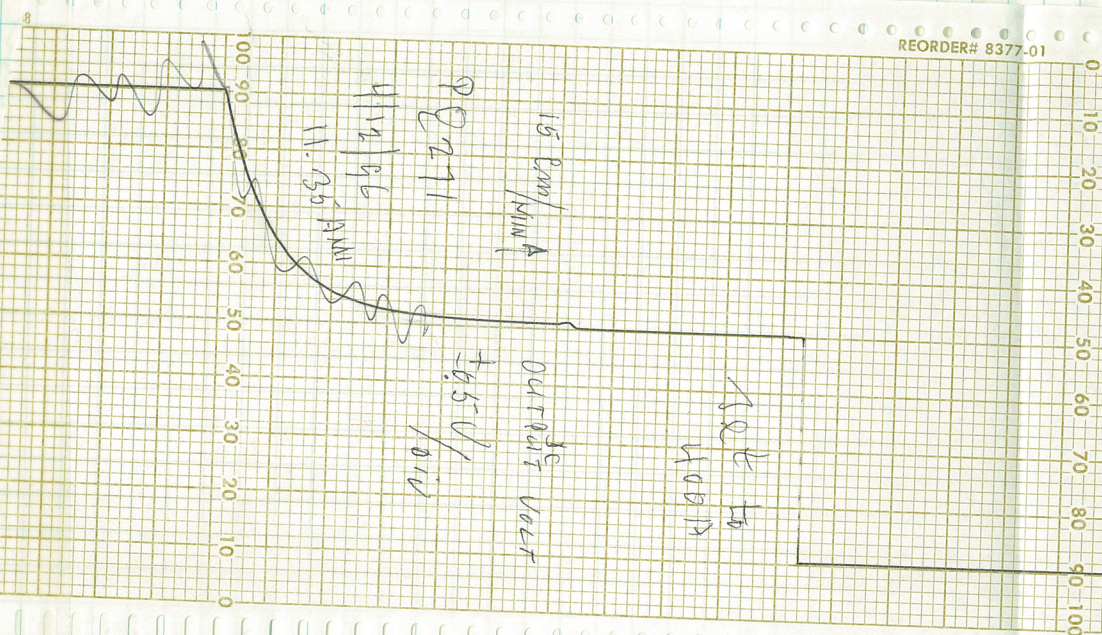
DC Voltage & Temp  
0.29 Vdc  
21.7 mK

26 A

Dump

0900 Fixed closed wires at magnet leads.  
Ran P.S. temporarily to  $\sim 50$  A, 1V limit. OK  
Now shut down and check lead voltage  
trip level setting to make sure nothing changes.

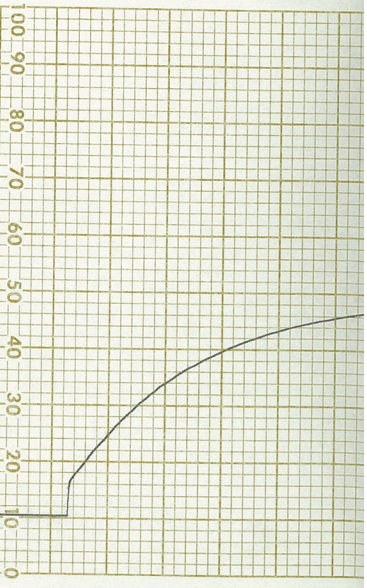
2V

Set 100A
