**INVESTIGATION REPORT
OF THE
FIRE IN THE
WIDE BAND LABORATORY
AT
FERMI NATIONAL ACCELERATOR
LABORATORY
BATAVIA, ILLINOIS
OCTOBER 3, 1987**

**U.S. DEPARTMENT OF ENERGY
Chicago Operations Office**

FIRE IN THE WIDE BAND LABORATORY

OCTOBER 3, 1987

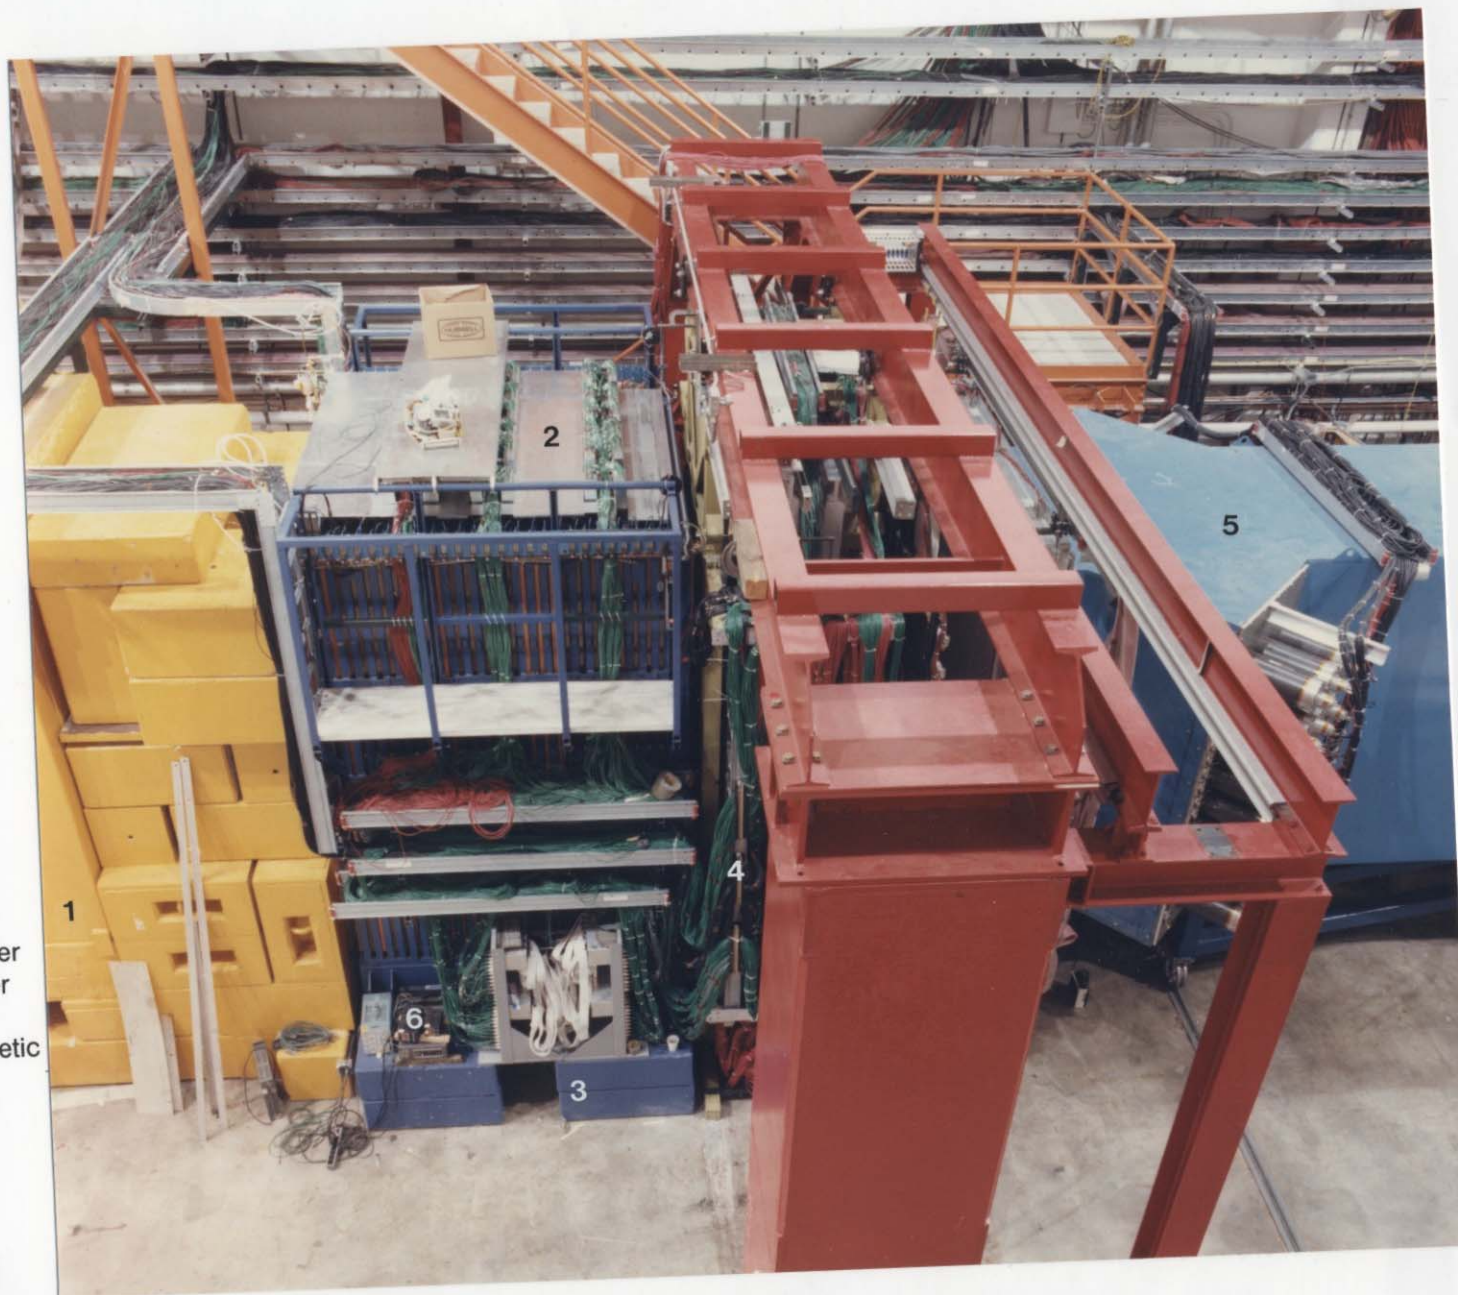
Figure 4. Pre-fire condition, west side of E687 beam line. Note positions of UC, HC, dynode sum box, power supplies, and C3. IEC, HxV, and P4 are hidden by support structure.

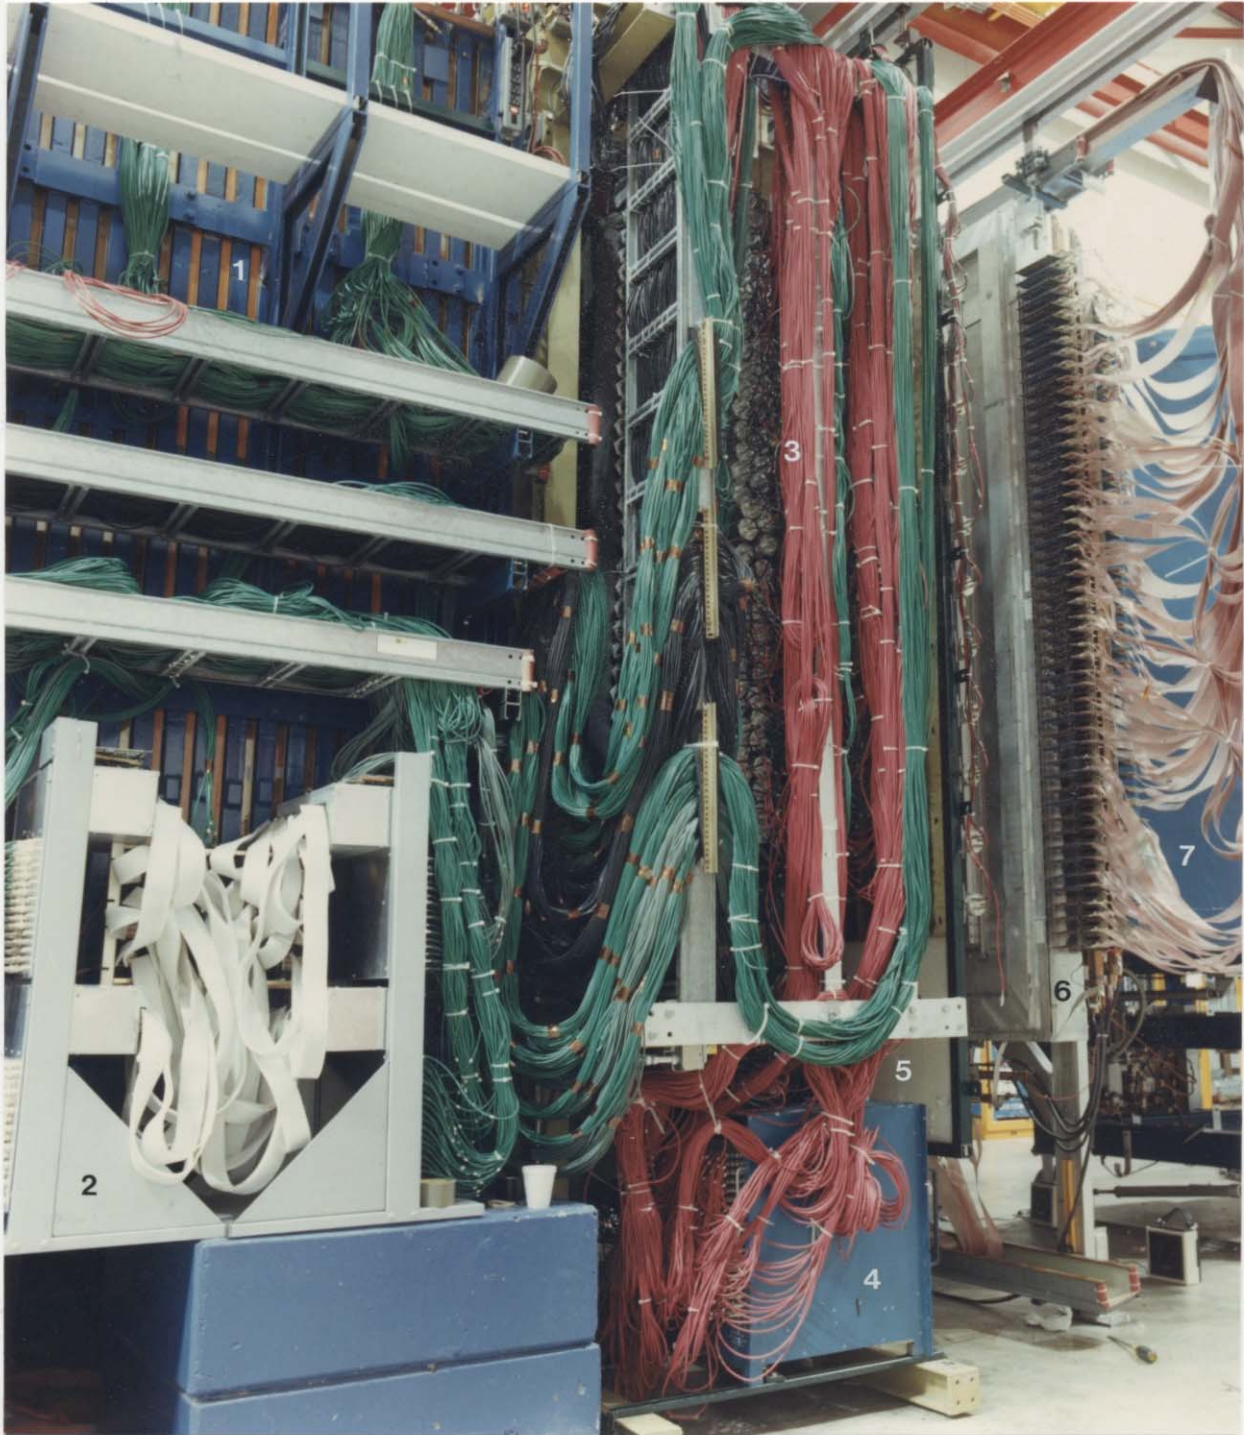
Figure 5. Pre-fire condition, west side of beam line looking southeast. Note HC, dynode sum box, IEC, HxV, P4, and C3. MF7 power supply is visible below IEC.

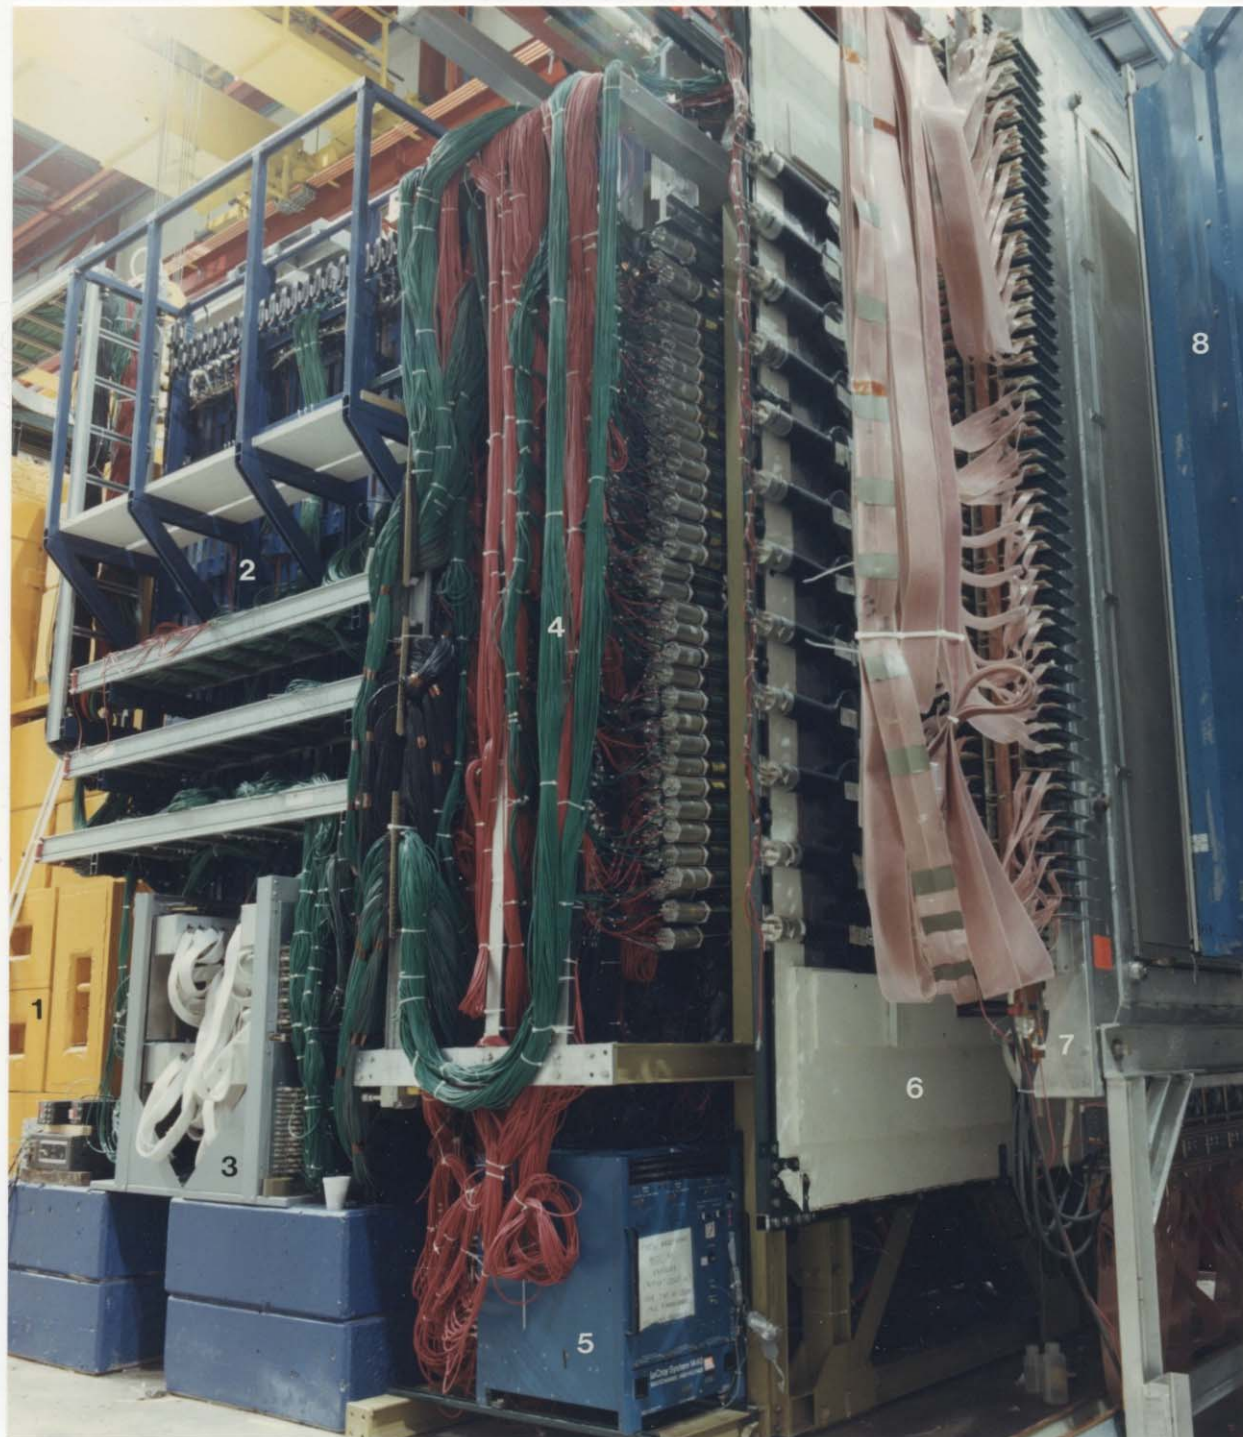
Figure 6. Pre-fire condition, west side of beam line, looking northeast. Note UC, HC, dynode sum box, IEC, HxV, P4, C3, and MF7.

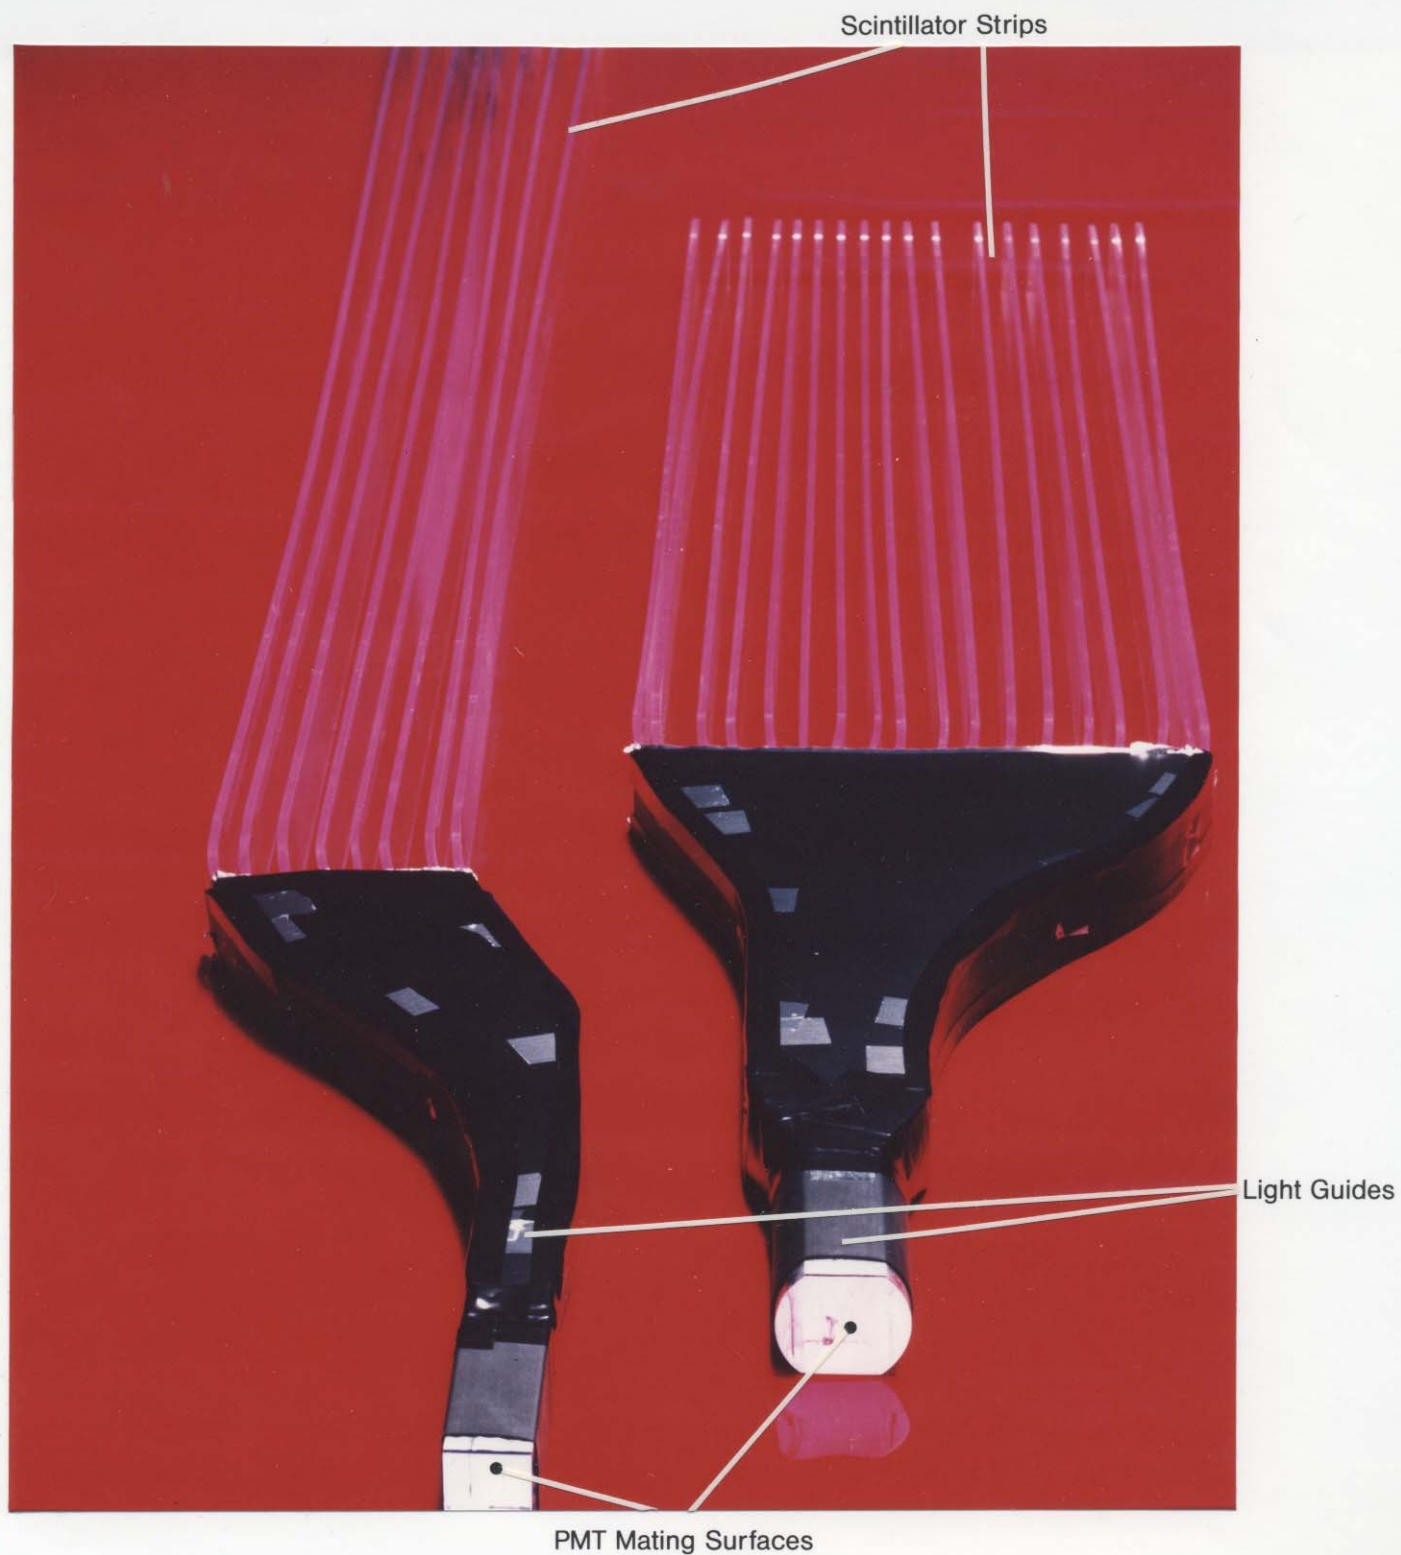
Fig. B-1. Typical IEC scintillator assemblies. Vertical assembly for first module is on left; horizontal assembly for second module on right.

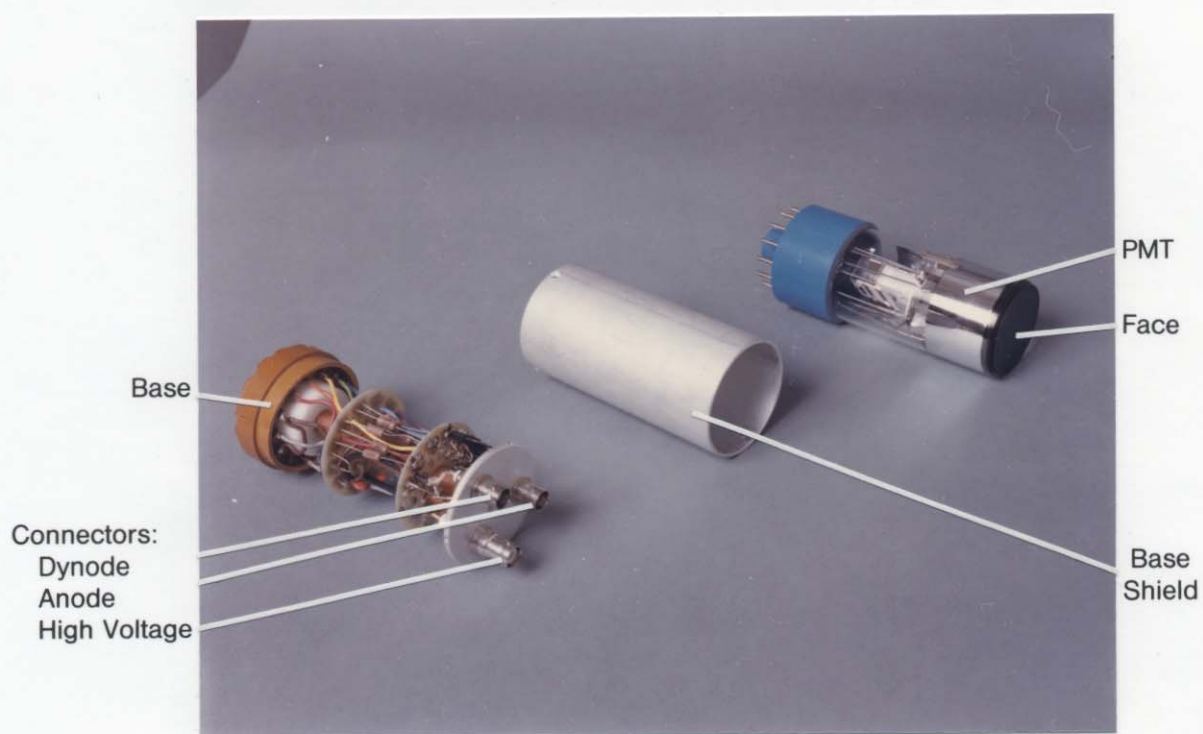
Fig. B-2. Photomultiplier tube and base of same types used in IEC. Shield has been removed from base to expose internal components.

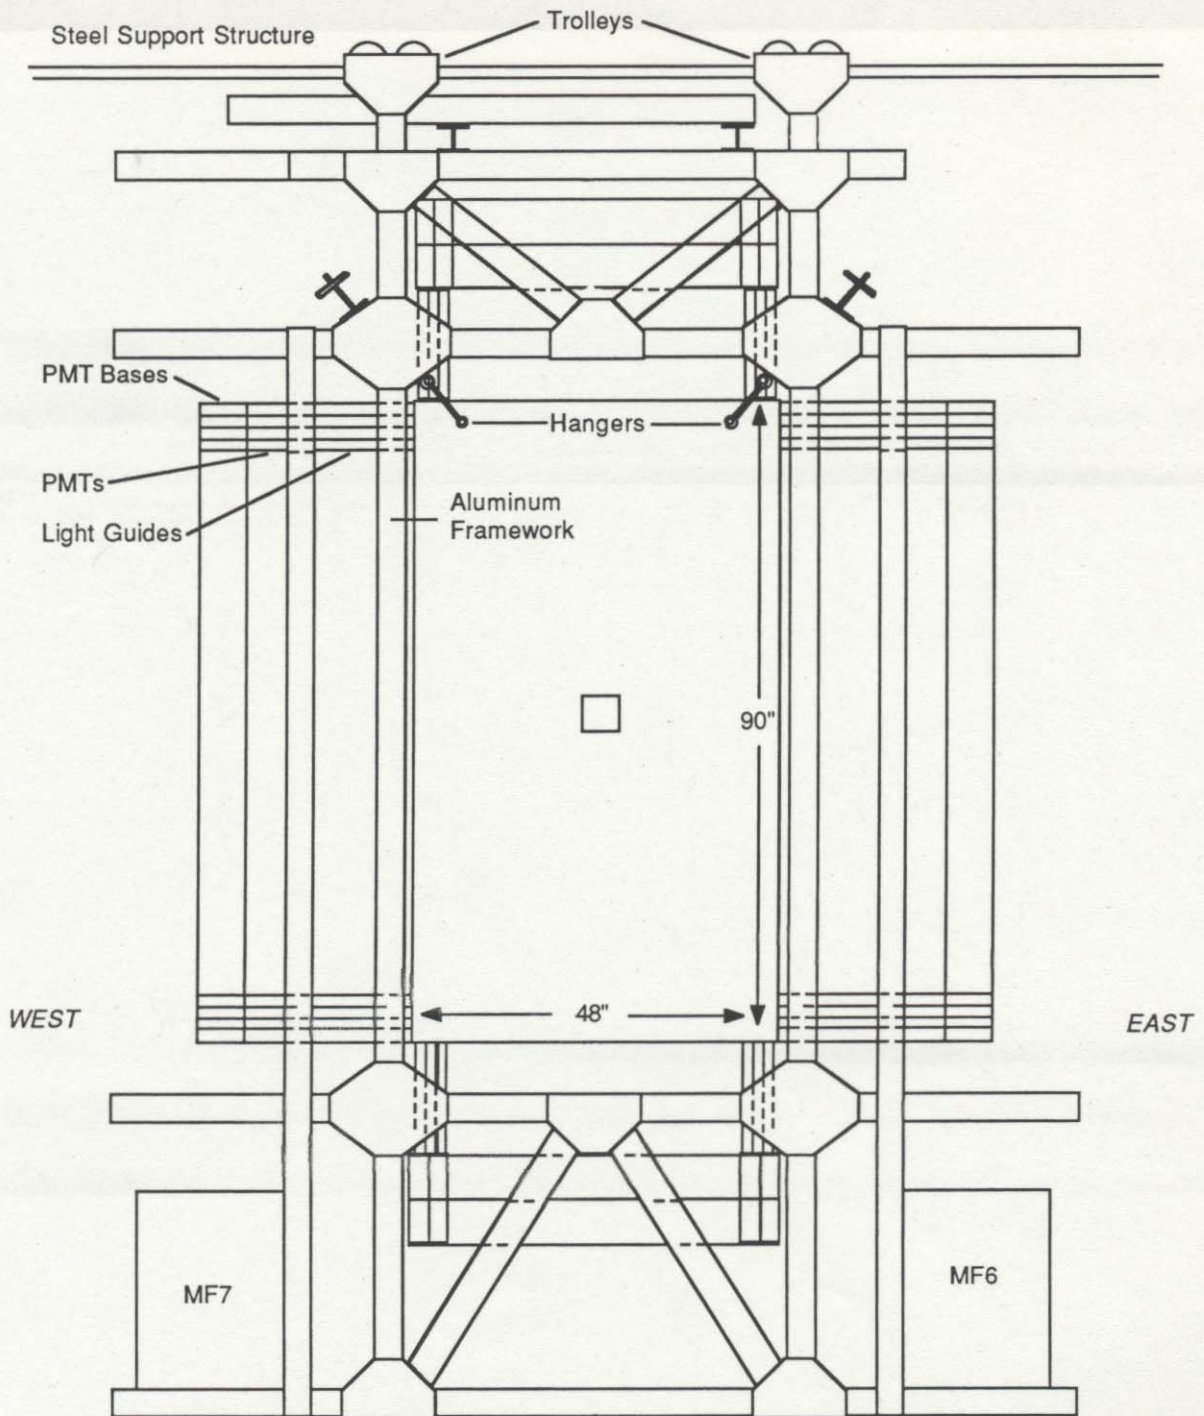
Figure B-4. Front (Upstream) View of IEC.

Figure B-4 is a sketch of the front (upstream) view of the IEC. Each module has protective aluminum sheets on the front and back surfaces. A side view sketch is shown in Figure B-5. Tiebreaker detail has been omitted for clarity.

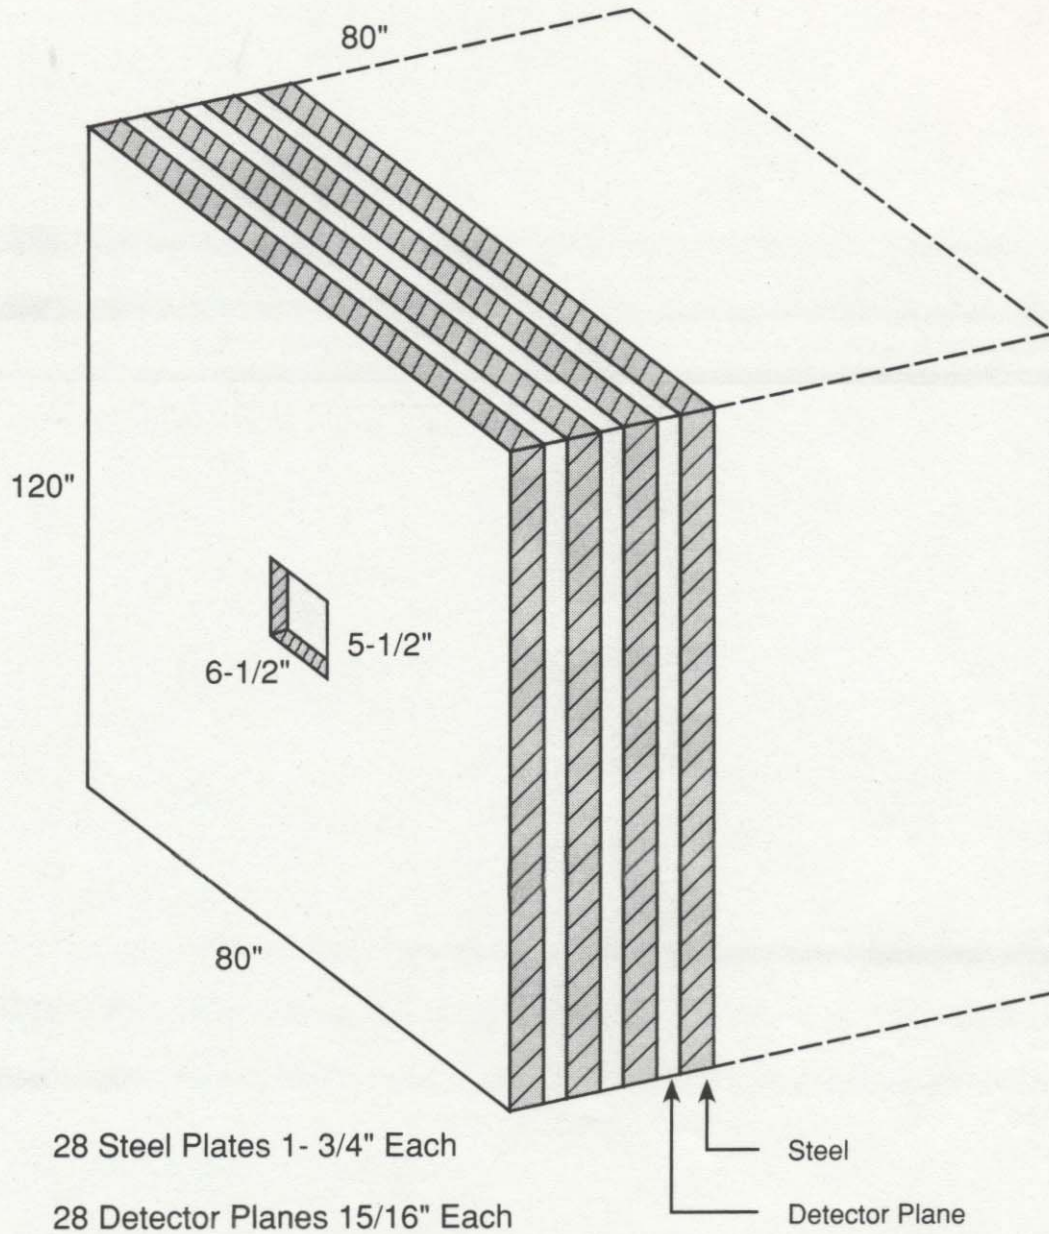
Figure C-1. Basic Construction of Hadron Calorimeter.

The hadron calorimeter consists of iron plates interspersed with detector planes. The basic construction is shown in Figure C-1. The detectors consist of multiple layers, which include aluminum proportional Iarocci tubes, copper coated glasteel (a material similar to G-10), cardboard, and PVC.

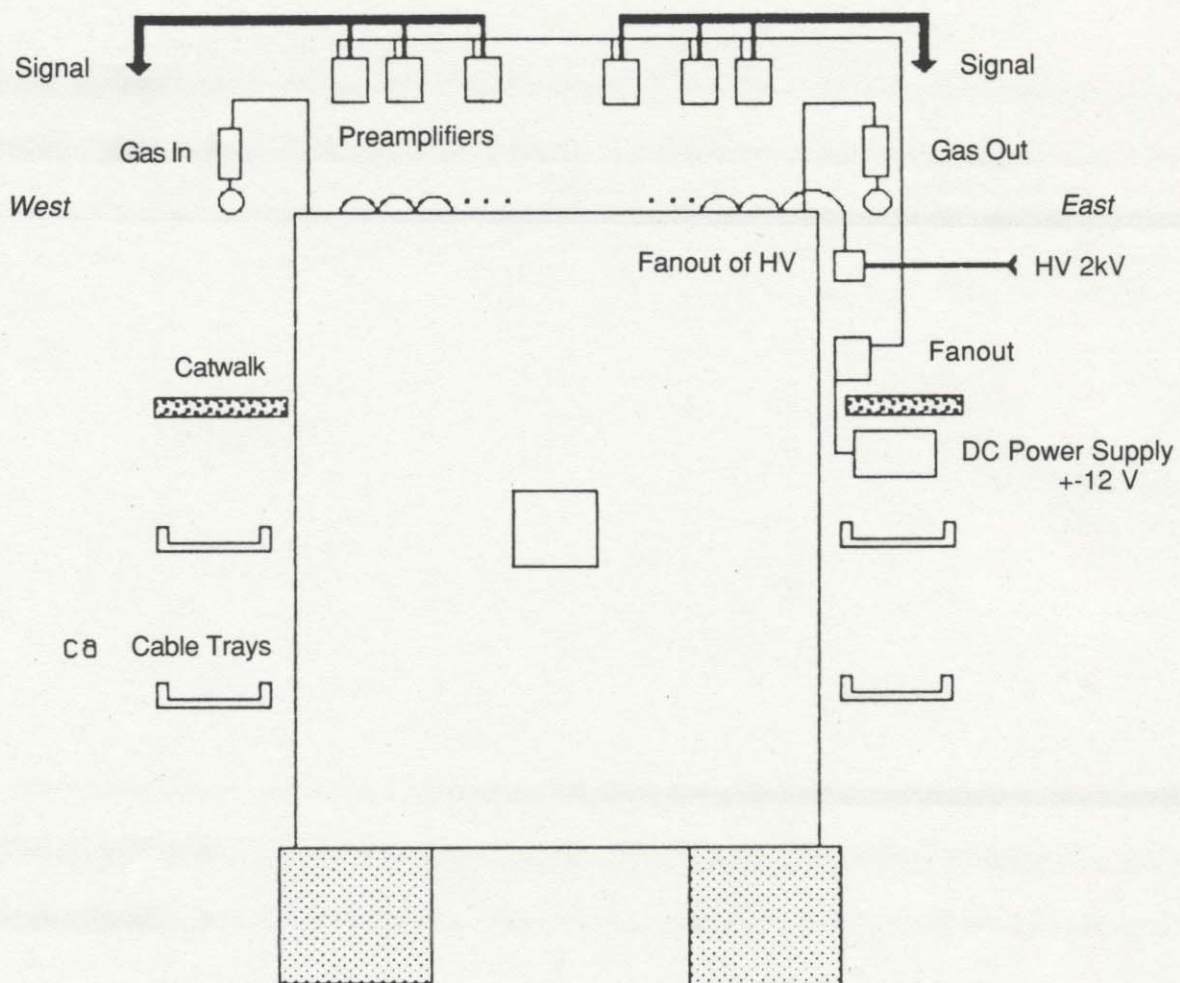
Figure C-2. Schematic of HC and Support Systems.

Figure C-2 is a schematic sketch of the device and its support systems. Some details of the gas system are shown in Figure C-3.
