Facilities

Earth Shielding Surveys

June 2019

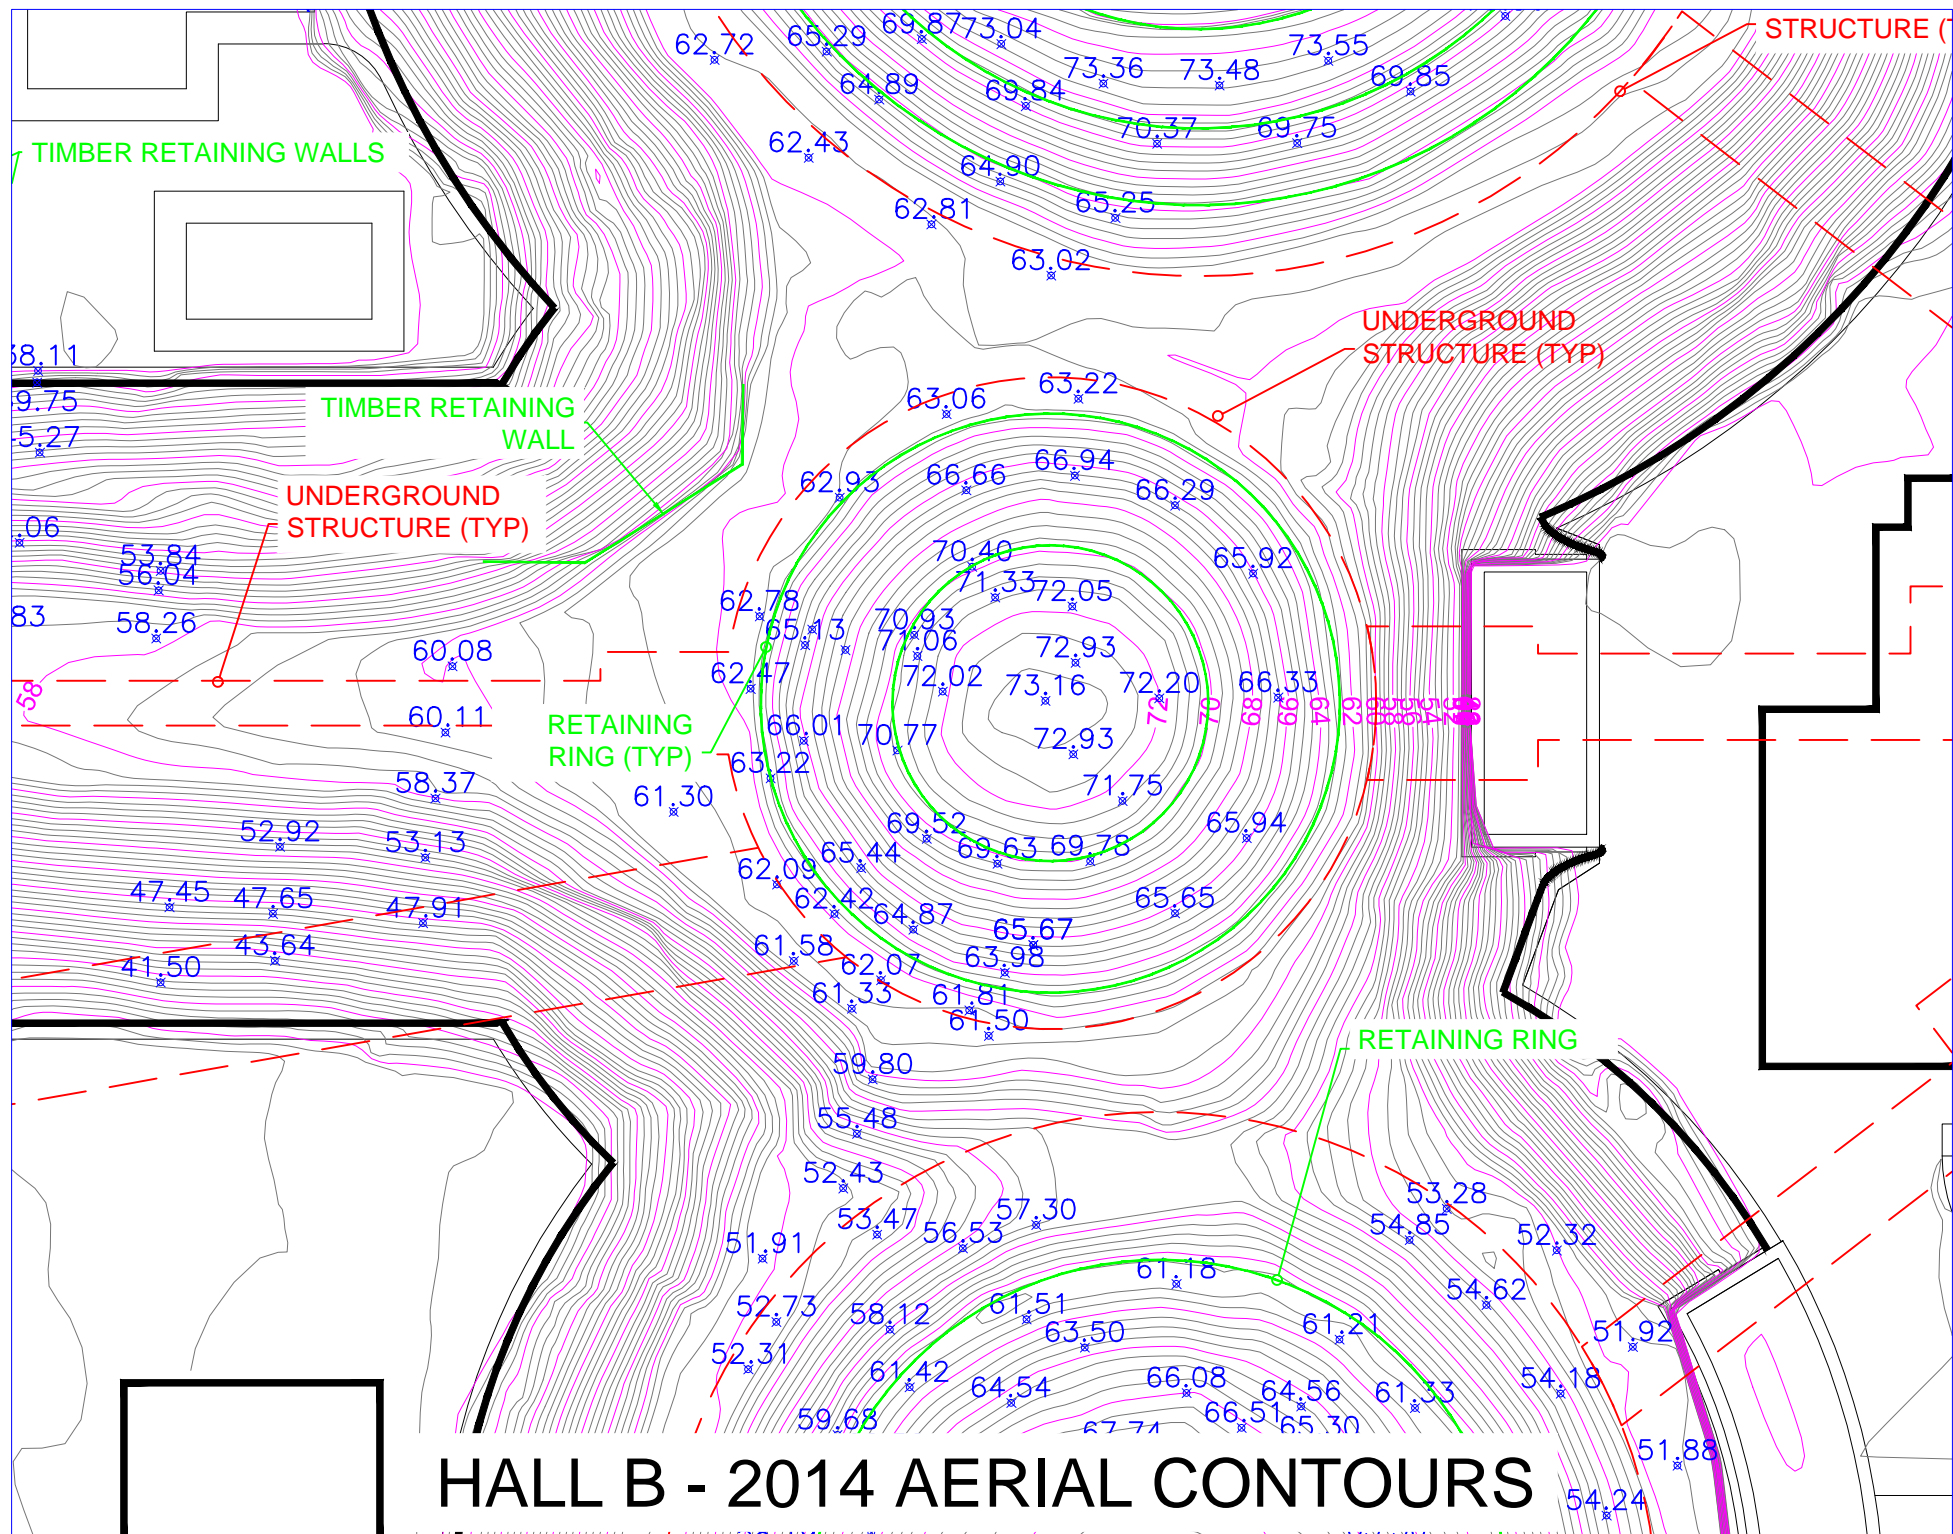
HALL B - DESIGN CONTOURS

End Station B: The entire dome is covered in heavy vegetation and there is no evidence in the observed elevations of any notable soil movement. Both soil retention rings appeared to be in good condition with little observed soil movement adjacent to either ring.
