INFN GEM Update:

5/12/21-5/18/21

TEDF Activities (May 12-18)

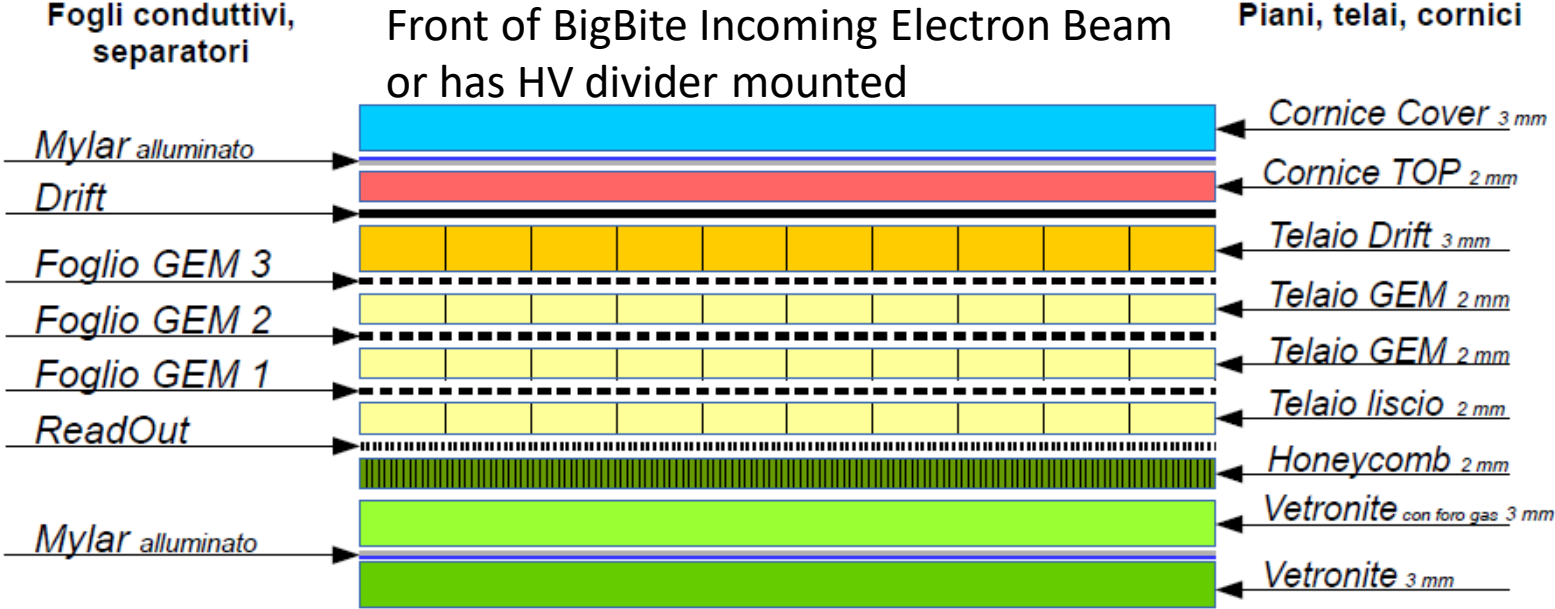
Foglio = Foil

What's going on: After turning on HV over the weekend electrostatic forces are present that have caused the exterior aluminized mylar to be attracted or connect to the drift foil. **This is not a good thing! Causes changes in data.**

Side that faces other GEM layers and GRINCH or has gas tubes mounted

Possible solution: Since the two foils are disconnected. Connect a 1 GigaOhm resistor between the top exterior aluminized mylar and the drift foil, in essence creating a small Faraday cage effect and then the two foils will not connect again. This exterior mylar is then at the same HV as the drift foil. This solution has already been implemented by UVa. This problem is not thought to appear for INFN modules when horizontal. Working with Jack to do this modification.
