Update on SBS Back Tracker GEM @ UVa

Design of 50 ×50 cm² Back Tracker GEM

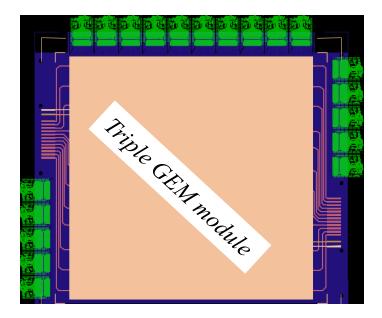
- Module of $50 \times 50 \text{cm}^2$ to replace the $40 \times 50 \text{cm}^2$
 - 32 modules to be built instead of 40 for the 8 SBS Back Tracker
 GEM chambers → Reduce the overall cost and dead area
- No protective resistors on the GEM foils \rightarrow external resistor board
 - Individual HV test of all the sectors at different stages of the assembly and safer to operate during the assembly
- Wider GEM frames and readout honeycomb support along x-axis
 - 30 mm instead of 8 mm, alignment holes away from active area
 - Room for strips connectors and GEM HV sectors electrodes
 - Holes for mechanical positioning of the chamber on the frame

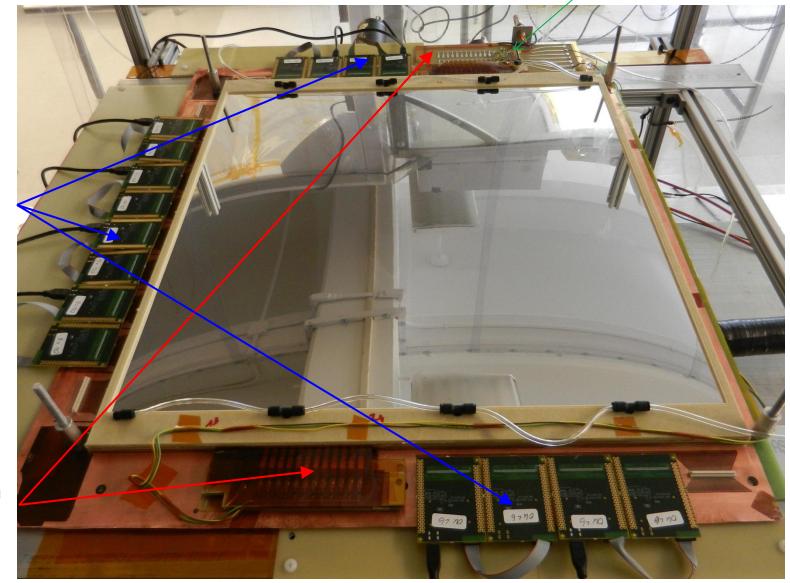
SBS Back Tracker GEM module Proto 1

HV divider

Apv25-SRS FE cards

Spark protection resistors Board

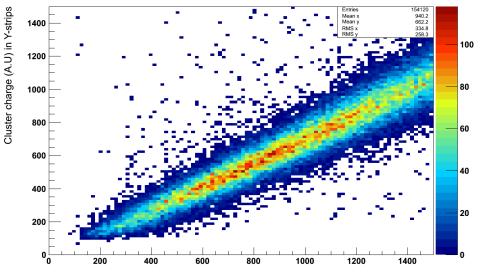
X/Y strips charge sharing correlation

Cluster charge (A II) in X-strins

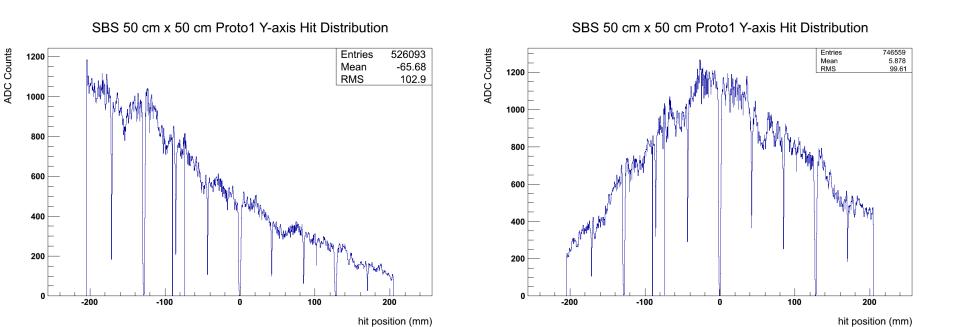
Non uniformity from the scintillator counters

We use 2 set of 3 scintillators paddle in coincidence for the trigger on cosmic

Changing the arrangement of the paddles in the set up lead to a big changes in the hit distribution profiles Main source of the non uniformity here

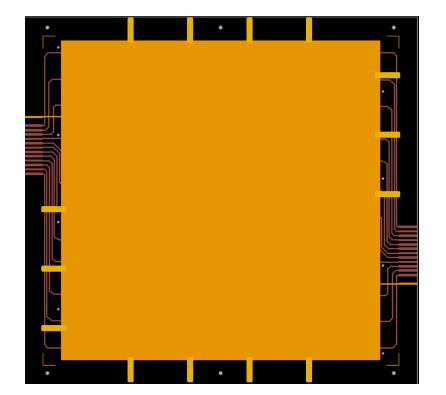
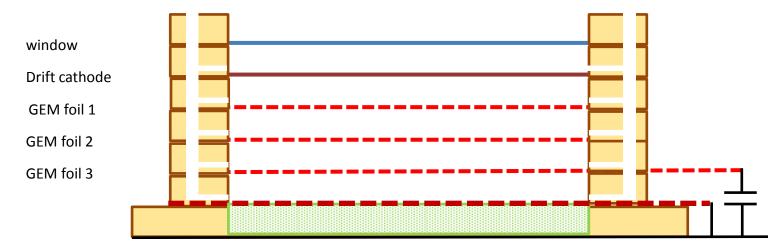
Faraday cage shielding using GEM foil common electrode

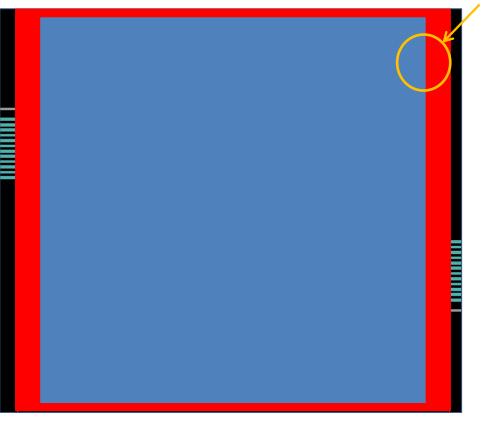
Current design

Problem

- No space between the GEM Frame (inner part)and the GEM foil active area
- Glue can leak onto the foil during assembly \rightarrow

Sector will spark at high rate \rightarrow but Can be cured

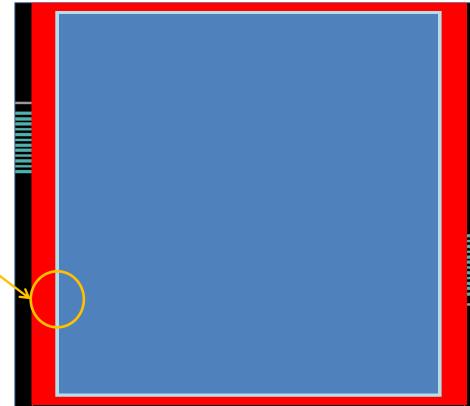
Proposed modification

We propose 1 mm clearance between the frame (inner part) and the GEM foil active area → Kapton foil with no holes

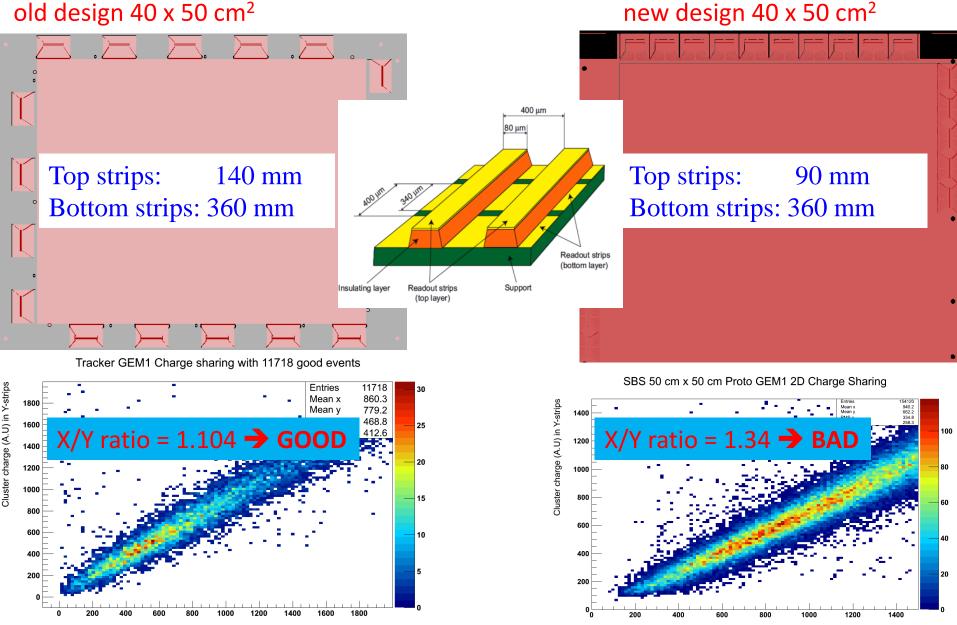
Charge sharing and 2D readout strips width

Cluster charge (A.U) in X-strips

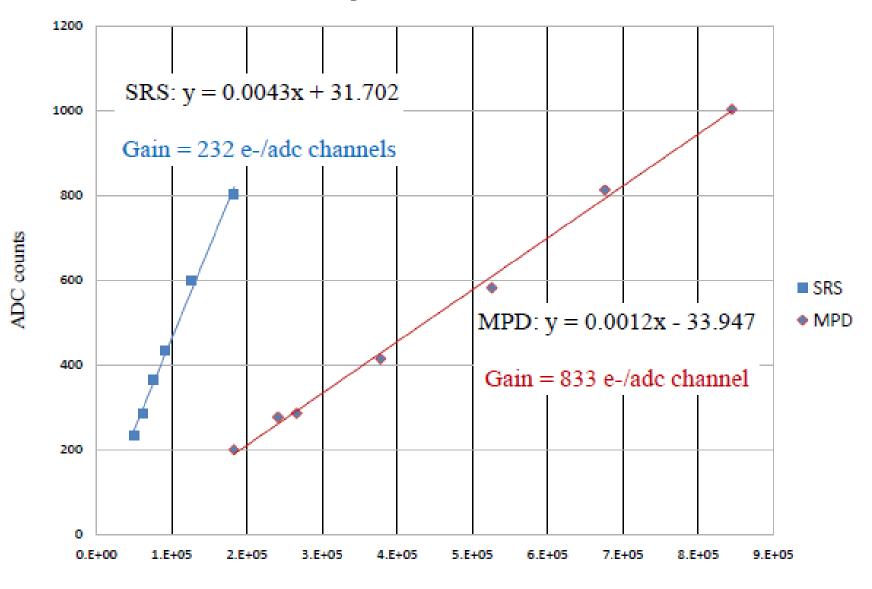
APV25 Gain: MPD vs SRS

apv25 Gain

number of injected charges

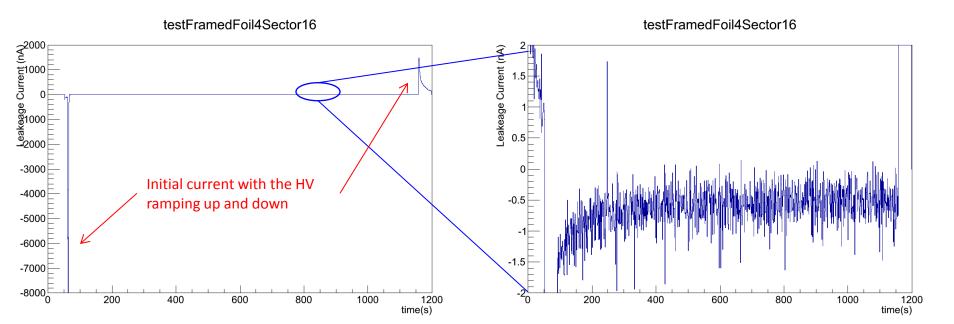
HV test of the GEM sectors

- We use an Iseg EHS 6 kV HV module in a Wiener crate, HV controlled through an internet protocol.
- Fast ramp up mode at a rate of 1200 V/s.
- The leakage current in the GEM is measured using a Keithley 6487 picoammeter, at sampling rate of 120 ms with a Labview interface and saved in txt file.
- HV GEM sector ~ 2 nF and with a resistance the HV module is ~ 50 MΩ, (once the voltage is achieved this resistance is shunted automatically within the supply).
- HV of 550 V, the initial current is a couple of μA , then quickly drops and stabilizes to less 1 nA leakage.
- We leave the HV for about 2 min and if no spark \rightarrow sector is good

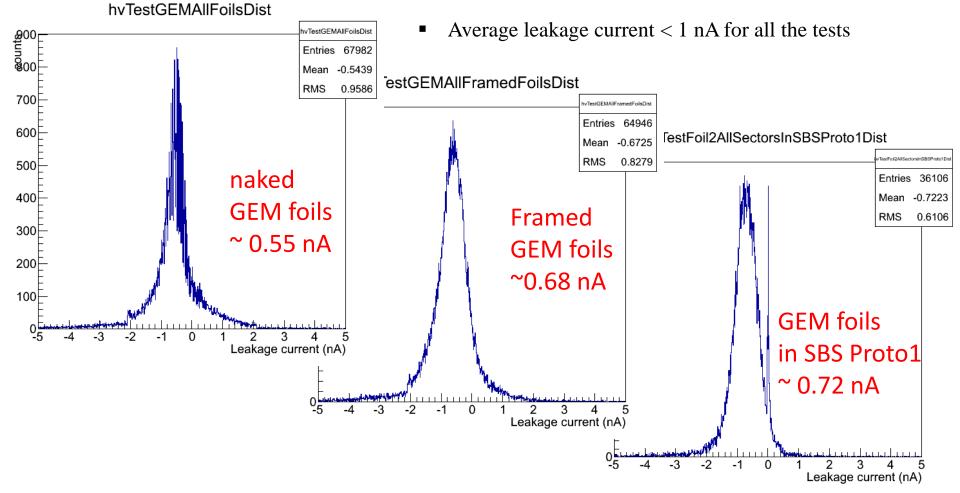
HV test of the GEM sectors

- Distribution of leakage current over all the 72 sectors (24 sectors per GEM foil and 3 foils per chamber)
- HV Test is performed at 550V in N2 for naked, framed foils and in chamber foils

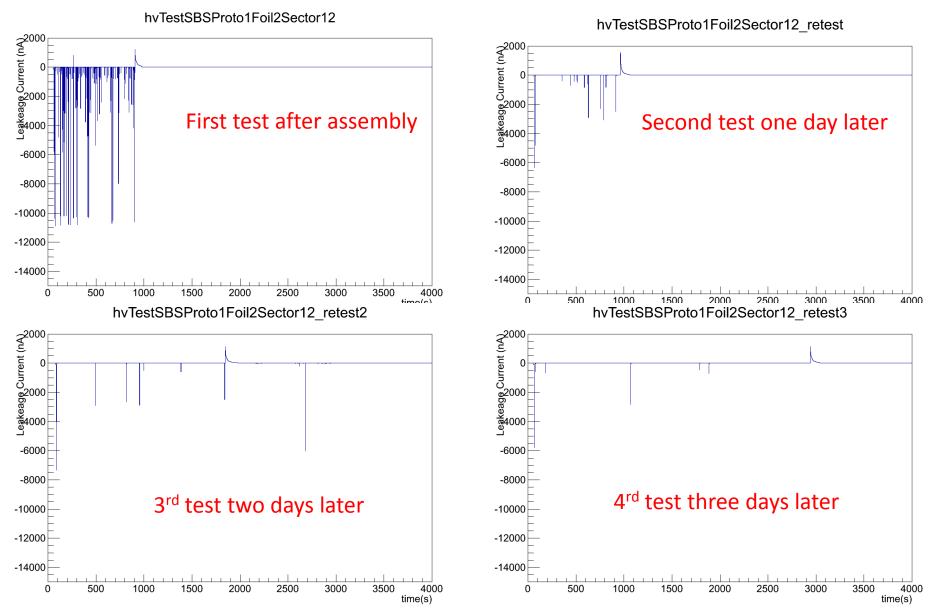
Recovering of a bad HV sector

Excess of glue leaked onto the sector during assembly \rightarrow sector recovered after curing on N2 or at 50 degree
