### **Coordinate Detector fabrication status**

V.Baturin for Idaho State University 18 May 2016

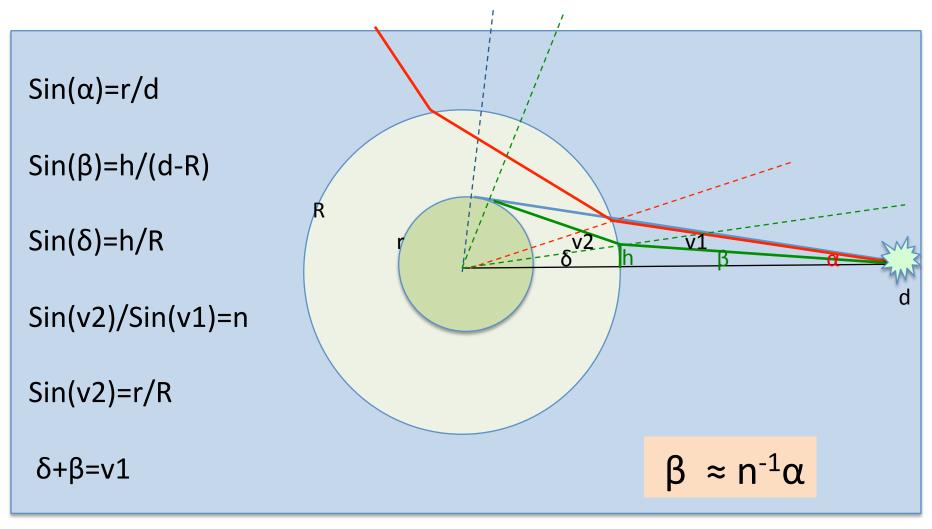
### Refraction and Fiber Acceptance.

◆ Acceptance with Air Channel is **n** times lower.

- Refraction on fiber channel and scintillator response.
- Fiber treatment and optical properties.
- Module assembling accuracy.

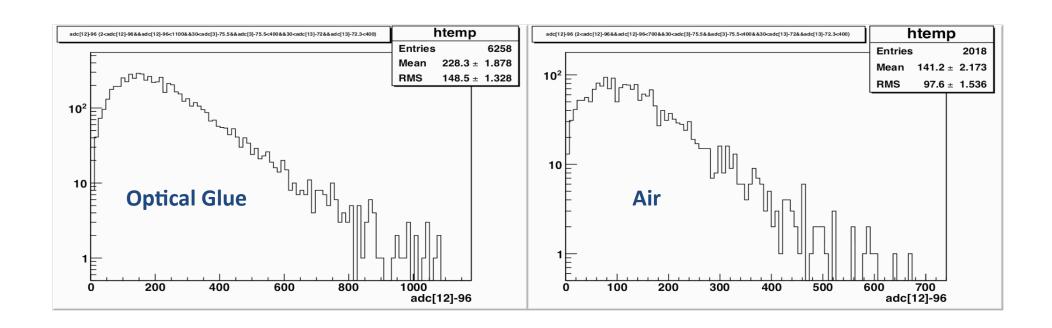
# Refraction and Number of Primary Photo Electrons (NPPE). Measurements.

◆ Optical Glue in Scintillator Channel results in 1.6 higher NPPE.

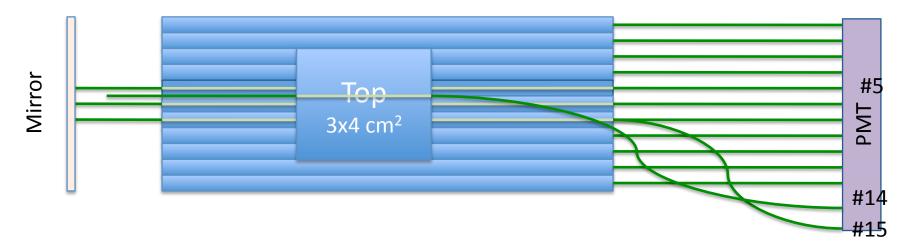
#### Test setup

- 1) Standard CDet Block of 14 scintillators + Top & Bottom Trigger telescope.
- 2) Range of cosmic particles ~4 cm (normal to slide);
- 3) Acceptance ±20° along fibers; ±2° across fibers.

pedestal subtracted spectra for adc(5) provided:

- 1) good signal from Top and Bottom-
- 2) no signal in two adjucent scintillators-

$$adc(4) < 5 \& adc(6) < 5$$

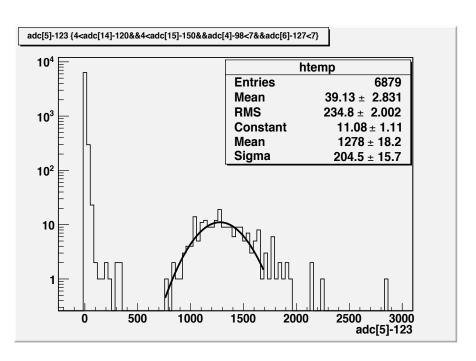
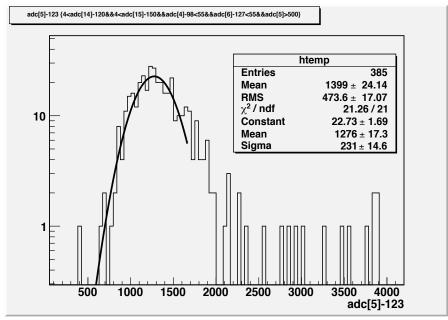
## **Quality assurance.**Results for Number of Primary Photo Electrons.

Provided pure statistical fluctuations

NPPE= (Mean/Sigma)\*\*2

- igoplus Depending on the fit area we find NPPE  $\approx 30 \pm 4$ .
- Do we need to improve NPPE?

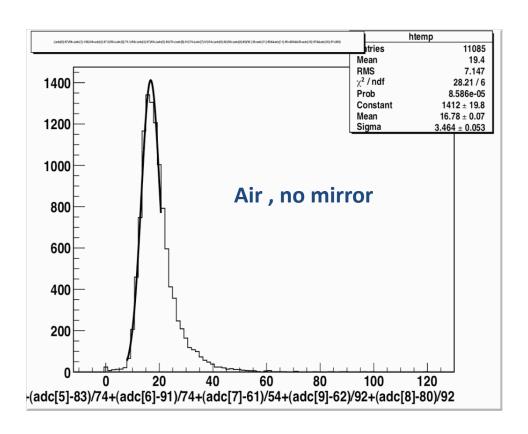
# Comparison with Data obtained in 11/06/2015. Cumulative Response of 10 scintillators to cosmic tracks.

Mean ≈ 
$$N_{ppe}$$

Sigma ≈  $\sqrt{N_{ppe}}$   
 $N_{ppe}$  = (Mean /Sigma)<sup>2</sup>  
 $N_{ppe}$  = (16.8/3.46)<sup>2</sup>  
 $n_{ppe}$  = 4.7 cm<sup>-1</sup>

- Expectations with mirror (×1.6): NPPE ≈ 30 along 4 cm side of CDet.
- Agrees with previous slide: (30 ± 4).
- Do we need to improve NPPE?

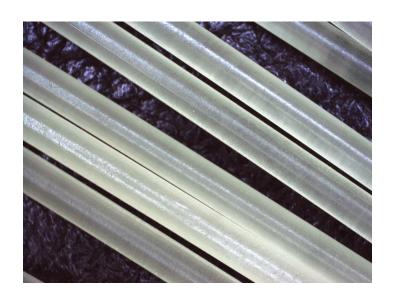
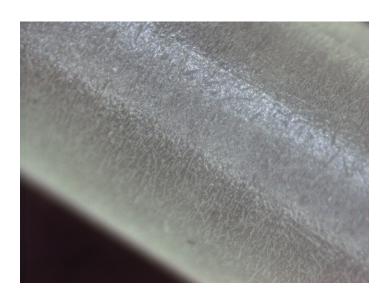
# **Quality Assurance. Effect of cleaning using alcohol containing mixtures.**

A bundle of 16 fibers has been used for scintillator block's testing

- Cleaning fibers using alcohol results in obviously worse fiber transmittance.
- Damaged 16 fiber bundle was replaced with a new one.
- ◆The last shows similar damages after insetting into several scintillator blocks.
- Apparently because scintillator's channels were cleaned using alcohol.
- What may happen to the inner surface of fiber channels?

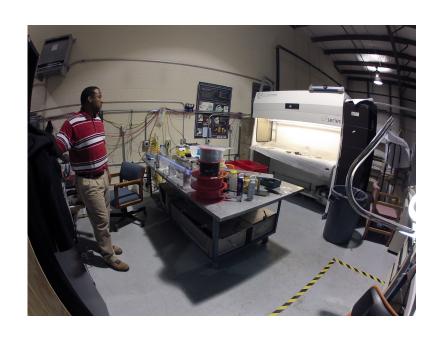
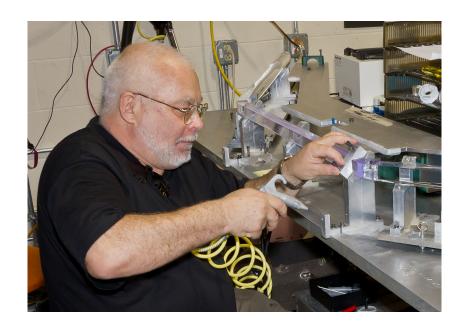
# **Quality Assurance. Using Compressed Air Line for Hall B upgrade in 2010-2014.**

- ◆ Air flow at room temperature is safe and efficient
- ◆ May be used for CDet construction.

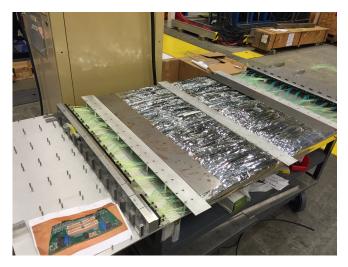
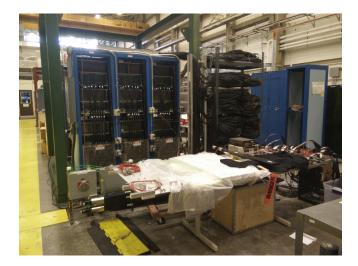
## **Central Module Assembling**

- PMT Readout and DAQ successfully tested and NPPE estimated.
- Top+Bottom+Central modules must create uniform surface.
- ◆ Therfore Scintillator **Blocks must be positioned with sub-millimeter accuracy.**
- Some annex parts should be designed for precise adjustment.
